Pan American World Airways Inc., Boeing 707-121B, N 708PA, accident on Chance Mountain, Montserrat, West Indies, on 17 September 1965. Civil Accident Report No. EW/B/019, dated September 1967, released by the Board of Trade, United Kingdom

1. - Investigation1.1 History of the flight

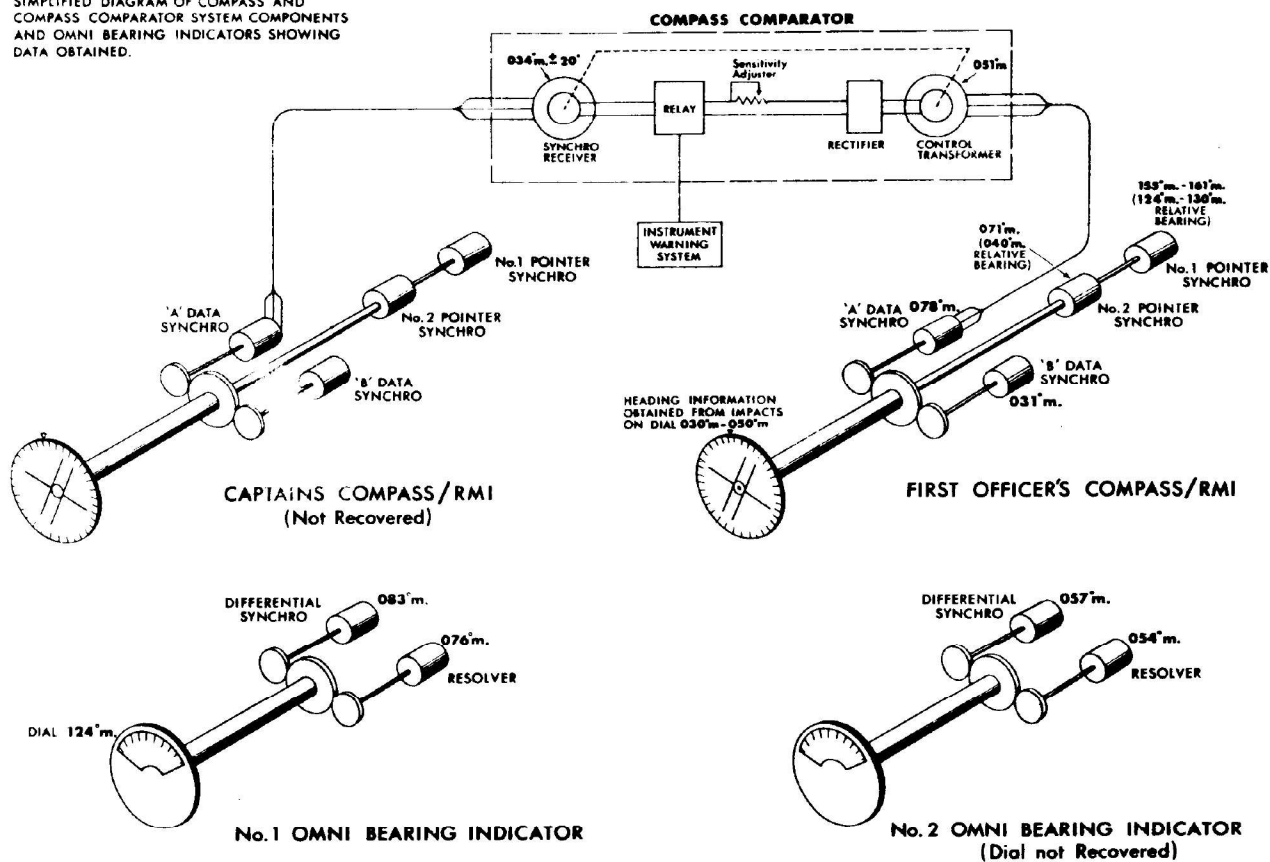
The captain's RMI was not recovered. However, the readout of the synchro receiver of the compass comparator which receives heading information from the captain's RMI indicated an azimuth heading of 034°M  $\pm$  20° at the time of impact. During the initial examination of this synchro, it was found that the stator winding (yellow lead) was open circuited. This open circuit appeared to be buried in the matrix of the windings and further investigation was carried out at the manufacturers. After prolonged soaking of the windings to remove the sealing varnish, the open circuit was established to be a fracture between the third coil of the yellow phase and the junction with the other two phases. This fracture shows evidence of shear and electrical erosion. The evidence of erosion indicates that the disconnection, possibly of an intermittent nature, had existed for some (indeterminate) time and the evidence of shear, in the absence of evidence of impact damage, suggests that this may have occurred during manufacture.

Tests have shown that, with such a disconnection in the system, relationship between the captain's RMI (heading) and the receiver synchro of the comparator would exist only in the arc of azimuth of  $0^{\circ}$  to  $120^{\circ}$ . Further tests showed that the open circuit would not affect the heading of either of the RMI compass cards. A readout of heading indication of  $051^{\circ}$  was obtained from the compass comparator control transformer. On inspection of the badly damaged compass comparator, it was found that the lock nut of the sensitivity adjuster was loose and that the resistance was set to 20 000 ohms. Tests showed that such an adjustment would permit the compasses to differ by up to  $43^{\circ}$  before a warning was given.

Damage to the dial of the first officer's RMI indicated that a compass reading within the band  $030^{\circ}$  to  $050^{\circ}$  existed at the time of impact. The 'A' data synchro transmitter gave a readout of  $078^{\circ}$  but the drive gear was loose on its shaft which was free to rotate. This reading was therefore not considered to be a reliable indication of the compass reading at impact. A readout of  $031^{\circ}$  was obtained from the 'B' data synchro transmitter and, because of the manner in which it had been damaged, was considered to be a reliable indication of the compass reading on impact.

Examination of the aircraft and its equipment revealed no evidence of pre-crash failure, except for the desensitization of the compass comparator and the broken yellow lead of the synchro receiver in the same unit.

SIMPLIFIED DIAGRAM OF COMPASS AND  
 COMPASS COMPARATOR SYSTEM COMPONENTS  
 AND OMNI BEARING INDICATORS SHOWING  
 DATA OBTAINED.
