No. 18

Skyways Coach Air Ltd., DC-3, G-AMWX accident at Mers-les-Bains (Somme), France, on 17 December 1965. Report, not dated, issued by the French Secretariat of State for Transport. Released by the Board of Trade, United Kingdom as C.A.P. 289

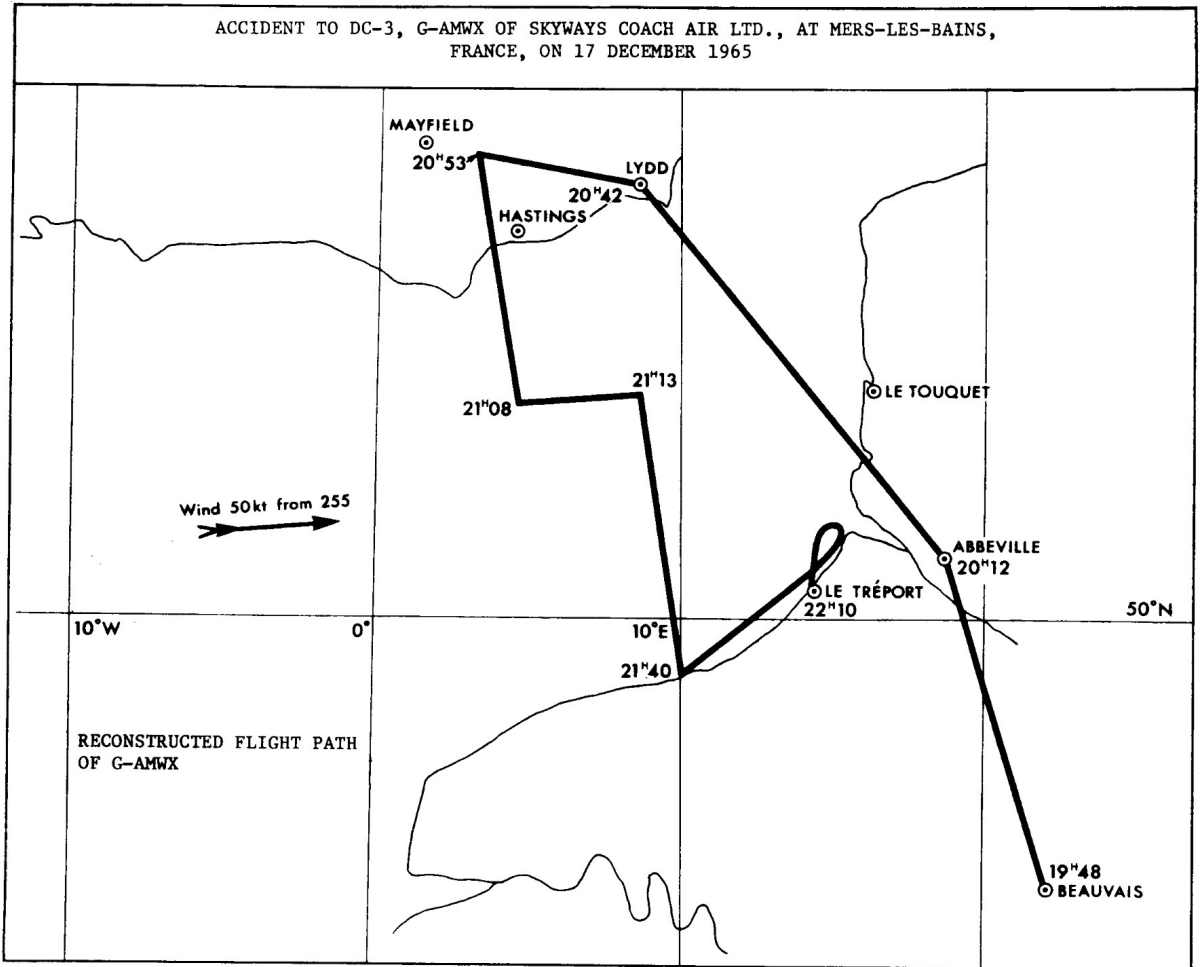
Fig. 18-1

identify. The aircraft arrived in the vicinity of Le Tréport at 2140 hours (See Fig. 18-1). After flying over the town a number of times the crew fired Very lights but saw no response on the ground, although local authorities and members of the aero club went to En-Mers/Le Tréport airport and illuminated the landing strip with car headlights. During this time the pilot-in-command saw a beach lit up by the lights of a promenade and suitably orientated for a landing, taking into account the direction of the wind at the time. The pilot-in-command then decided that unless he could determine his position with certainty and therefore be able to reach Beauvais in absolute safety, it was preferable to attempt an emergency landing on such a beach rather than run the risk of landing, short of fuel, in the open in the French countryside without any visual reference to the ground and with the danger of colliding with some unknown obstruction. After having flown up and down the coast, in an attempt to determine his position, he finally decided to land when the starboard engine showed signs of fuel failure. He immediately switched the starboard engine on to the port main tank, which contained about 20 gallons more than the starboard main tank. He made his last circuit at about 500 ft, with the landing lights on and the undercarriage up, and came in to land on a WSW heading in the area lit up by the promenade lighting, as near as possible to the shore. The landing was relatively soft, although at the end of the run the port wing tip struck a concrete groyne. The accident occurred at 2240 hours GMT. The location of the beach was 50°04'N 01°23'E.
