No. 7

BOAC, Boeing 707, G-APFE, accident at the foot of Mount Fuji, Japan,
on 5 March 1966. Report released by the Board of Trade,
United Kingdom, C.A.P. 286.

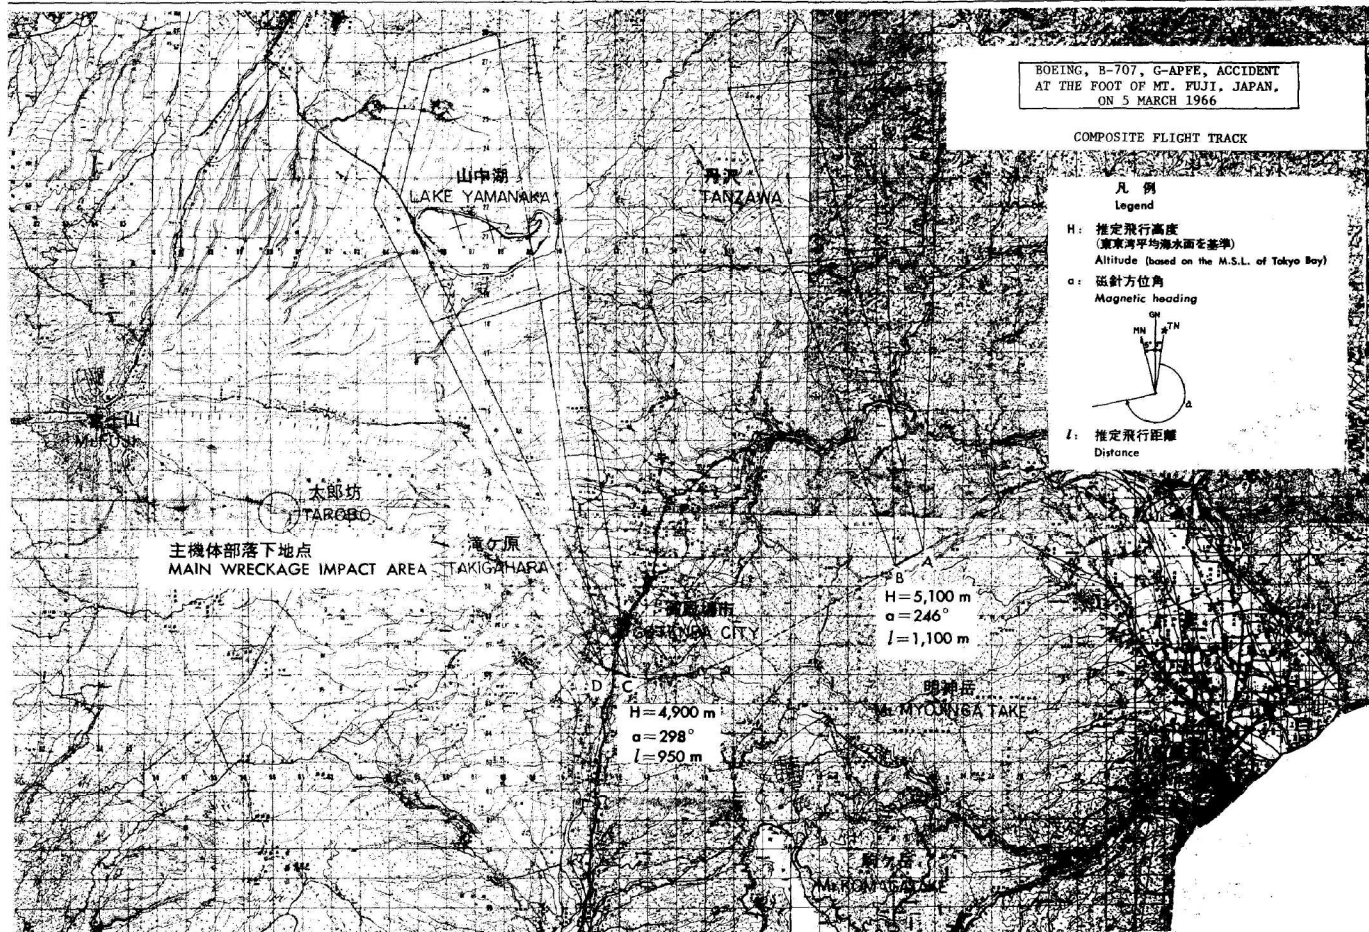
FIGURE 7-1

The aircraft subsequently flew over Gotemba City (see Fig. 7-1, between C and D) on a heading of approximately 298°M at an altitude of approximately 4 900 m and indicated airspeed of 320 to 370 kt. (Immediately after this, the film skipped two frames, followed by vague pictures of something like the passenger seats or cabin carpet, and suddenly came to an end.)

Based on the analysis of this film and the photogrammetry of each frame, the flight altitude and path of the aircraft were assessed as indicated in Fig. 7-1. The airspeed was also assessed based on these data.

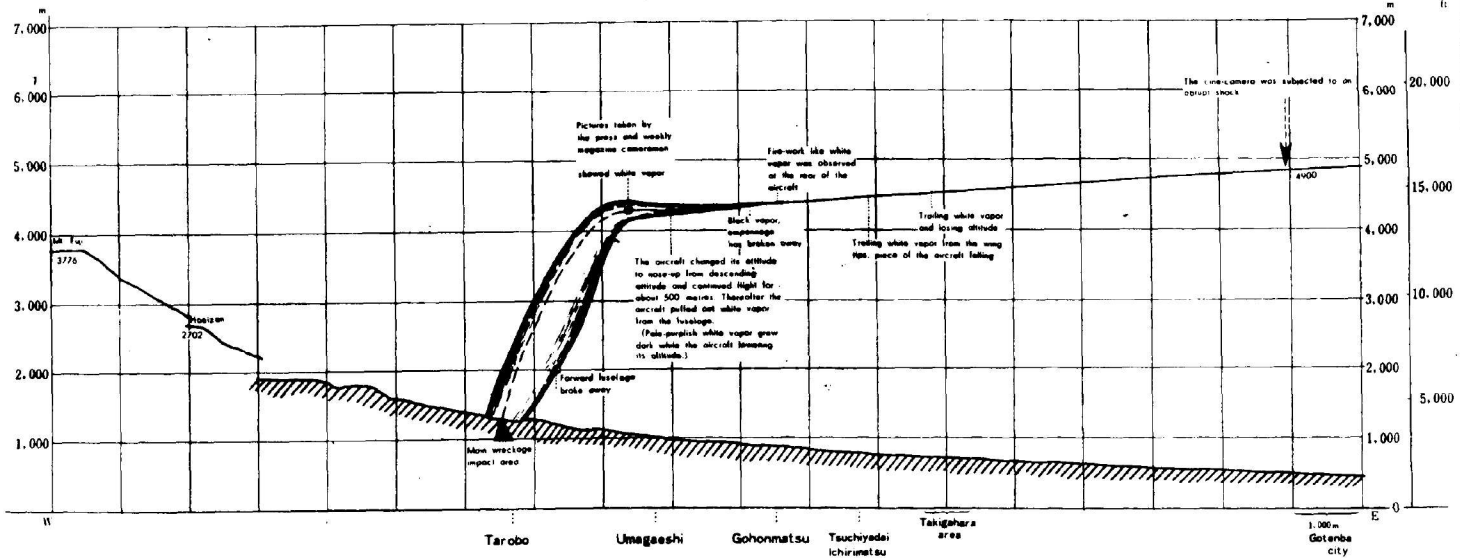
FIGURE 7-3

The estimated flight path from Gotemba City to the crash site, based on the statements of many witnesses and the pictures is as follows (see Fig. 7-3):

The aircraft, trailing white vapor, was losing altitude over the Takigahara area, and parts of the aircraft began to break away over Tsuchiyadai and Ichirimatsu.

Finally over Tarobo at an altitude of approximately 2 000 m, the forward fuselage broke away. The mid-aft fuselage together with the wing, making a slow flat spin to the right, crashed into a forest* at 2109, Nakahata, Gotemba City at approximately 1415 hours.
