Braniff Airways Inc., BAC 1-11, N 1553 accident near Falls City, Nebraska, on 6 August 1966. Report, File 1-0008, dated 18 April 1968, released by the National Transportation Safety Board, U.S.A.

ACCIDENT TO BAC 1-11, N 1553, OF BRANIFF AIRWAYS, INC.,
NEAR FALLS CITY, NEBRASKA, ON 6 AUGUST 1966

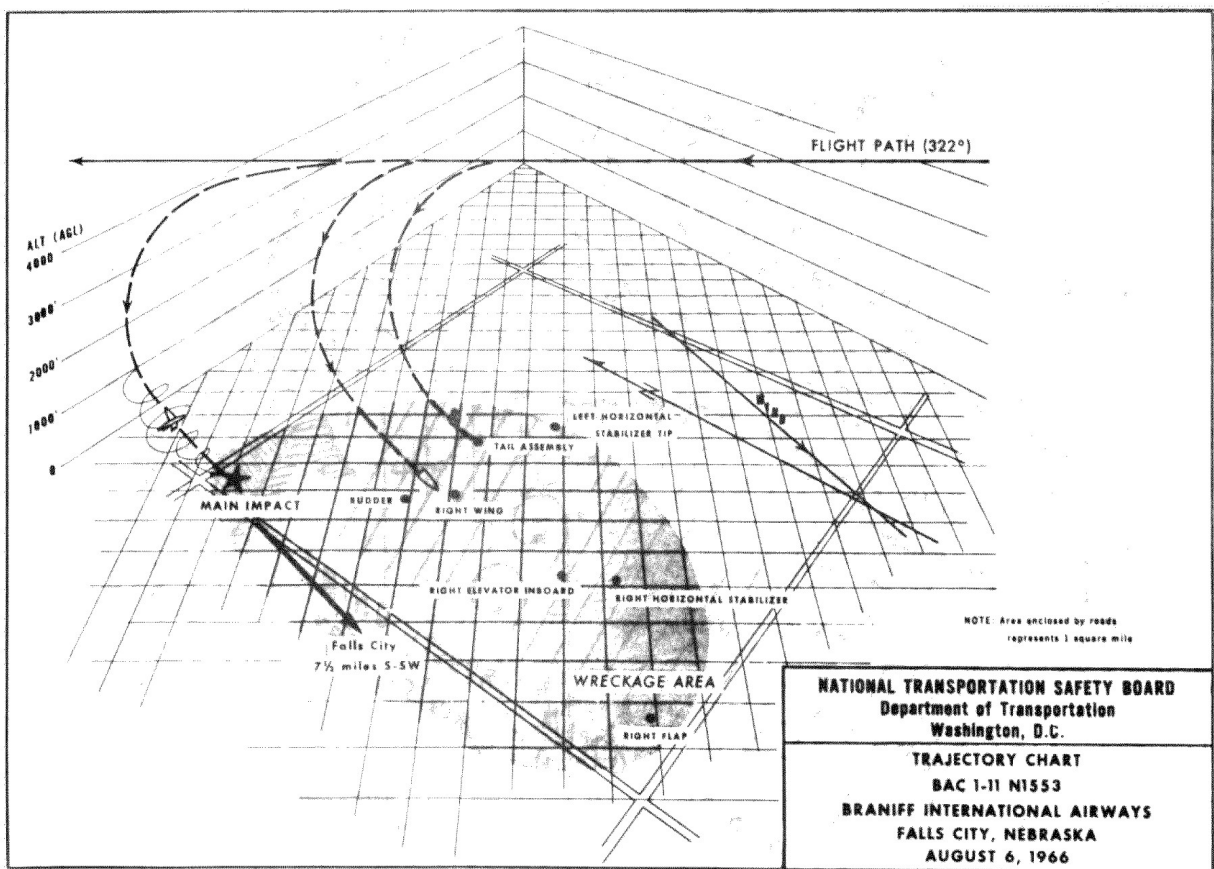
Fig. 2-1

any horizontal displacement after initial impact. Portions of the right wing and the empennage were not found at the impact site. The right wing had separated near Rib 11 and the outboard section was found 2 503 ft from the main impact site on a true bearing of 147°. The separated portion of the vertical fin with the left tailplane and part of the right tailplane attached was found 131°/2 752 ft from the site, while the piece of the right tailplane outboard of Rib 3 was located 159°/4 375 ft from the site. These and all other major pieces of the aircraft were found within a one square mile area located to the south and east of the site. (See Figure 2-1.)

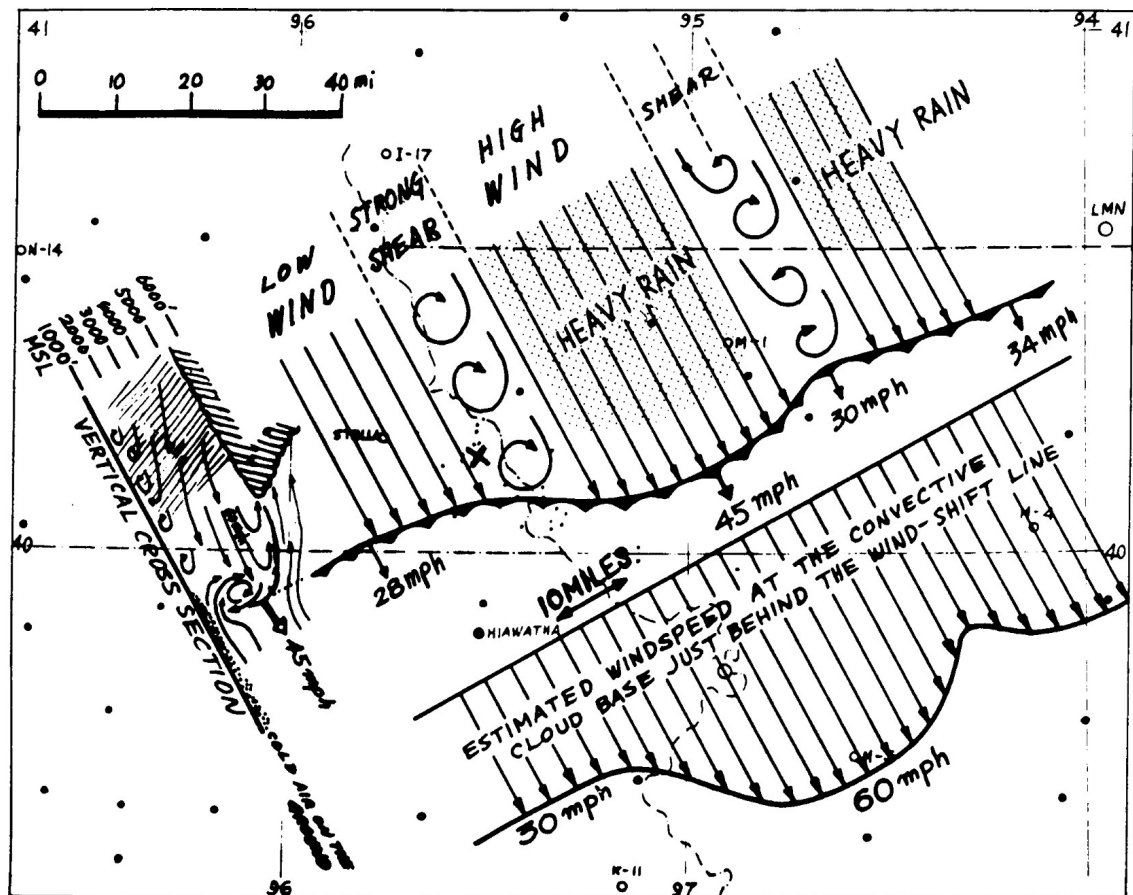
An independent study of the weather conditions at the time and place of the accident was conducted by a specialist in meso-meteorology. He stated that the amount of excess atmospheric pressure, and the outflow wind speed, of a weather system is proportional to the amount of surface rainfall if the height of the convective cloud base remains unchanged. Having used data from the Weather Bureau to determine the precipitation patterns and to locate fine lines, which may be regarded as wind-shift lines near the ground, he stated that at 1800 hours the squall line was accompanied by a well-organized squall line circulation of medium intensity. He also estimated that the pressure-jump line as a whole was in its maturity around 2300 hours. He concluded that the pressure field of the mesohigh pressure system as a whole was medium to strong and that the precipitation amount averaged over a large area of the squall line was light to medium although the variation of the precipitation from one location to another, was unusually large. As the rainfall in an area located about 30 miles northeast of the accident site was observed to be over four times that to the west of the site, he concluded that the rain-induced cold air mass to the east was about four times larger than that to the west of the site. The effect this variation has on the velocity of the wind-shift line and/or the first speed just behind that line is shown in Figure 2-2. It will be noted that between the masses of air of different velocity there is a zone of strong horizontal wind shear and accompanying eddies.

Fig. 2-2 - Schematic diagram showing how clock-wise vortices were produced over the area of the accident.
