CIVIL AERONAUTICS BOARD

# AIRCRAFT ACCIDENT REPORT

UNITED AIR LINES, INC.  
BOEING 727, N7030U  
SALT LAKE CITY, UTAH  
NOVEMBER 11, 1965

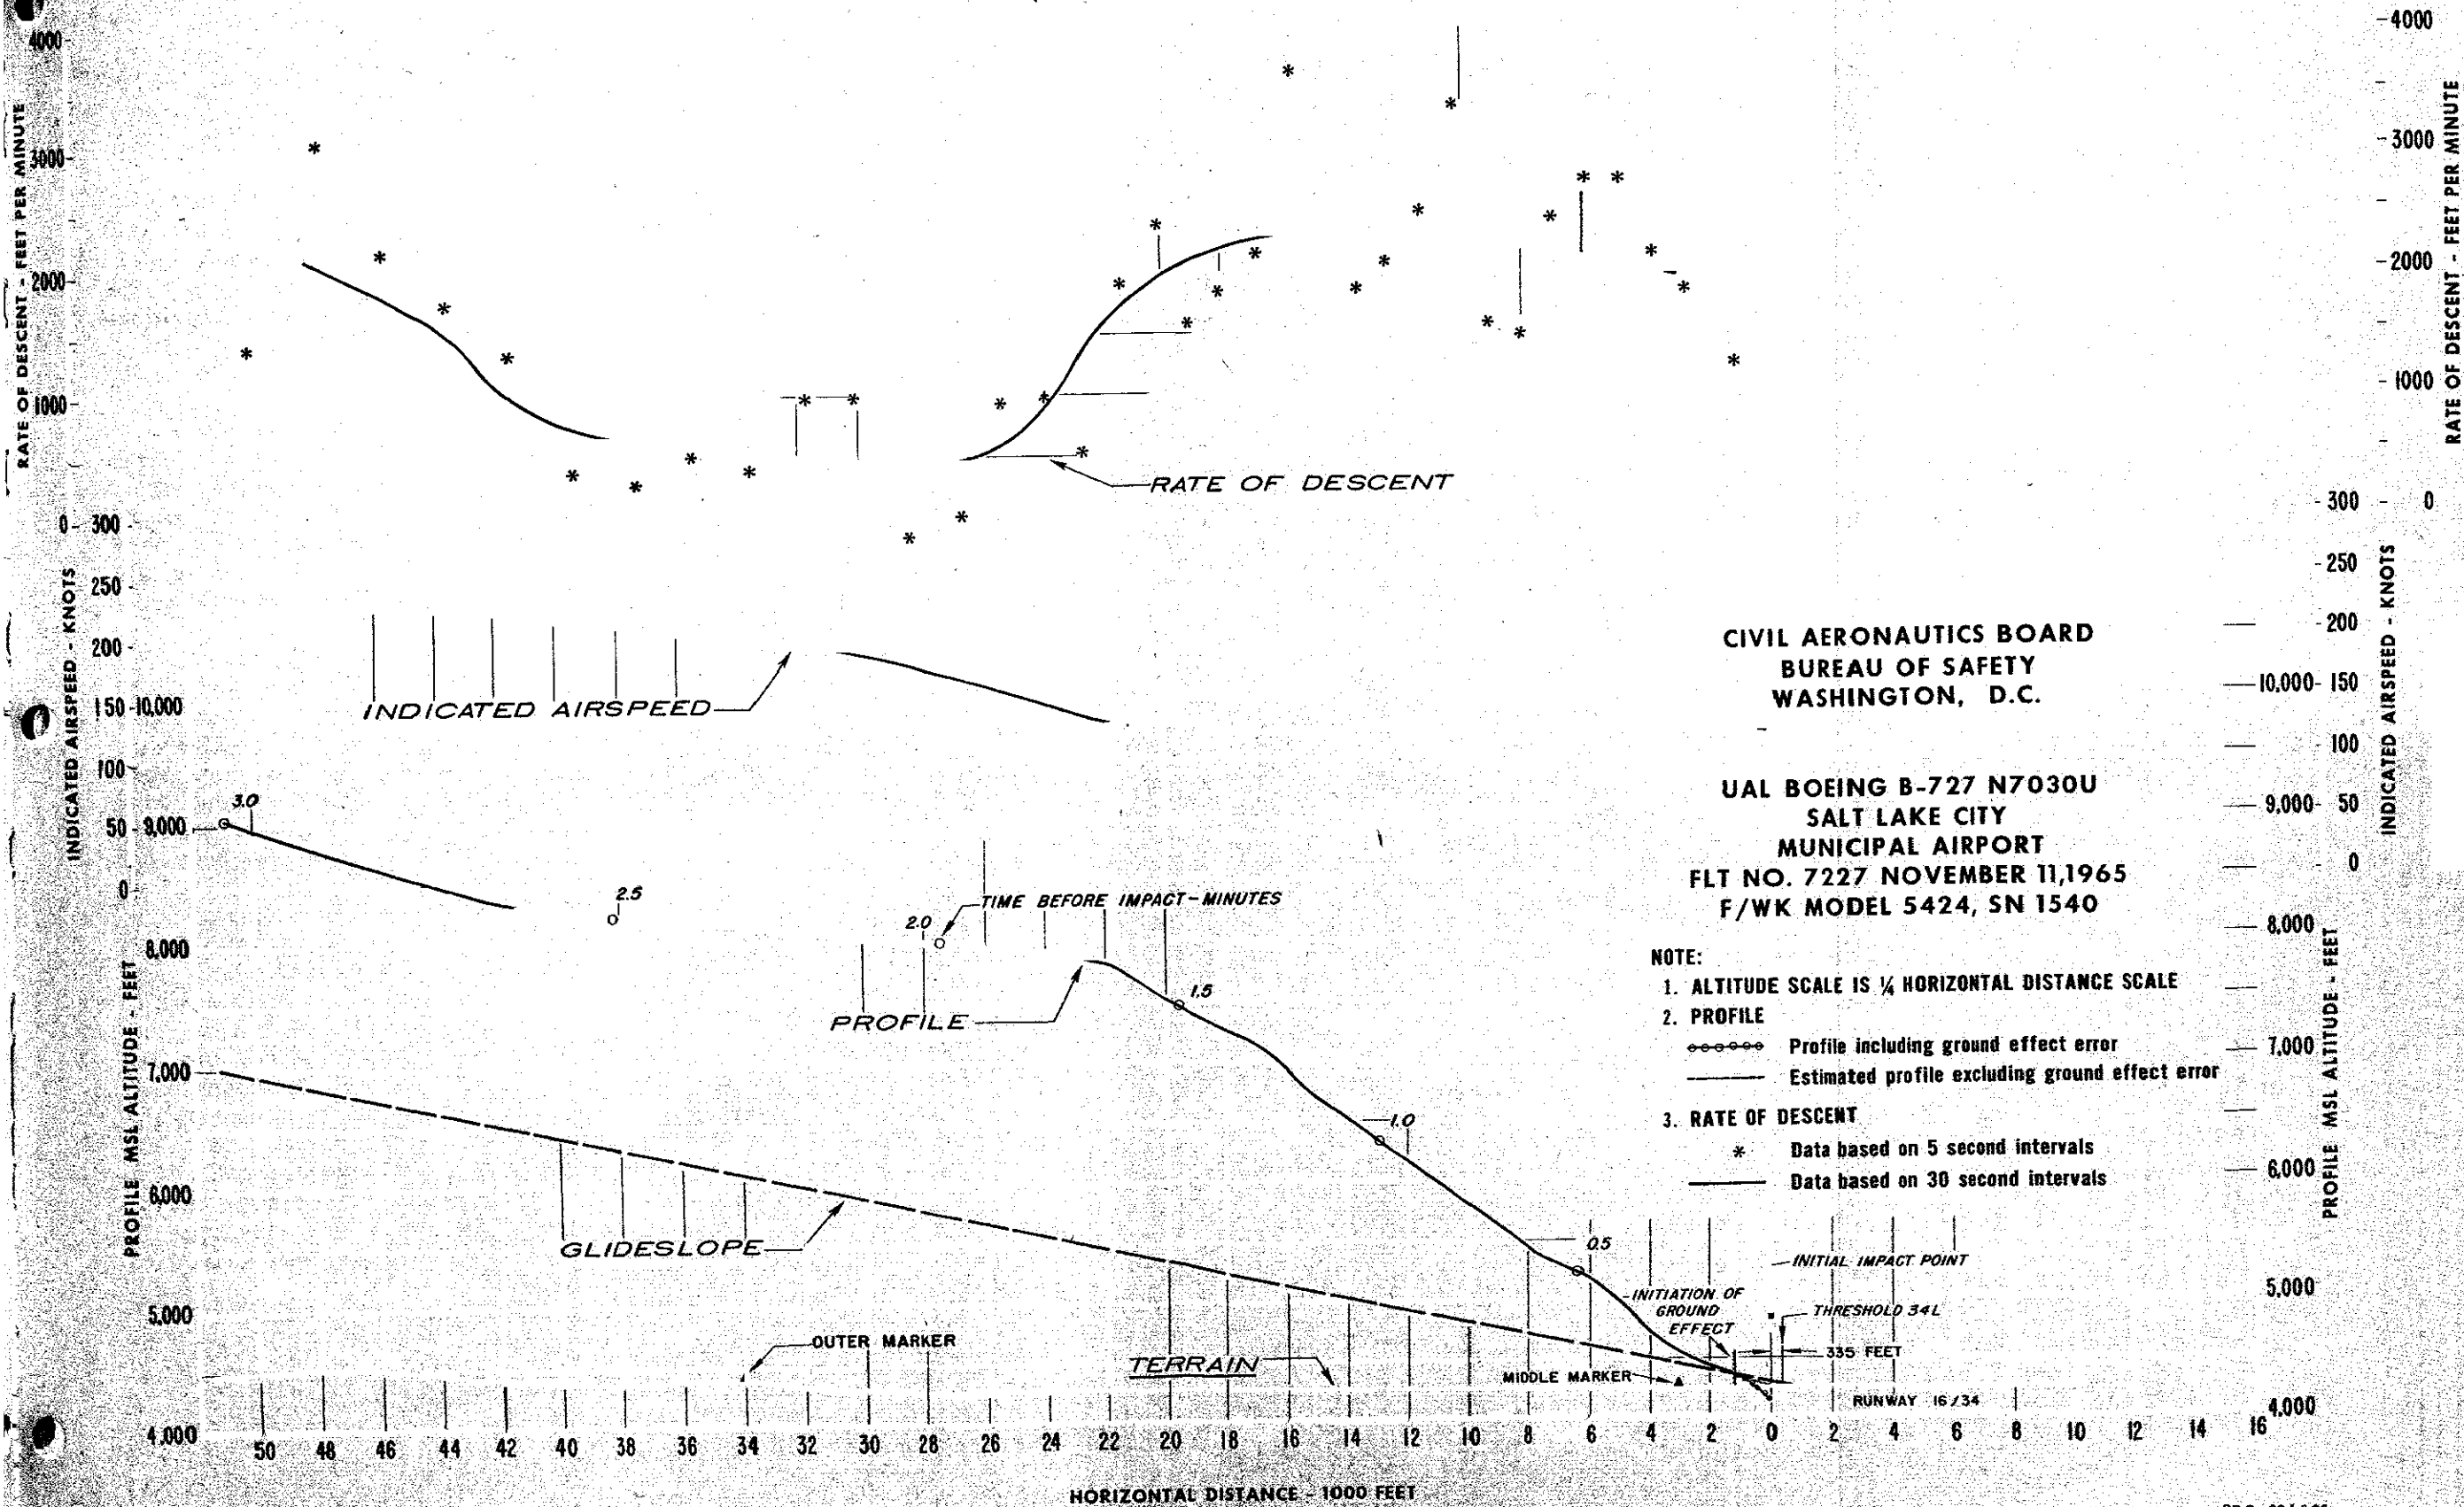
ATTACHMENT A

(BASED ON FLIGHT RECORDER DATA)

UAL BOEING B-727 N7030U  
SALT LAKE CITY  
MUNICIPAL AIRPORT  
FLT NO. 7227 NOVEMBER 11, 1965  
F/WK MODEL 5424, SN 1540
