No. 4

Air Ferry Limited, Douglas C-54A (DC-4), G-APYK, accident near Mont Canigou, Pyrénées Orientales, 50 km southwest of Perpignan Airport, France, on 3 June 1967. Report, dated 25 April 1968, released by the French Ministry of Transport. Also published by the United Kingdom as C.A.P. 312

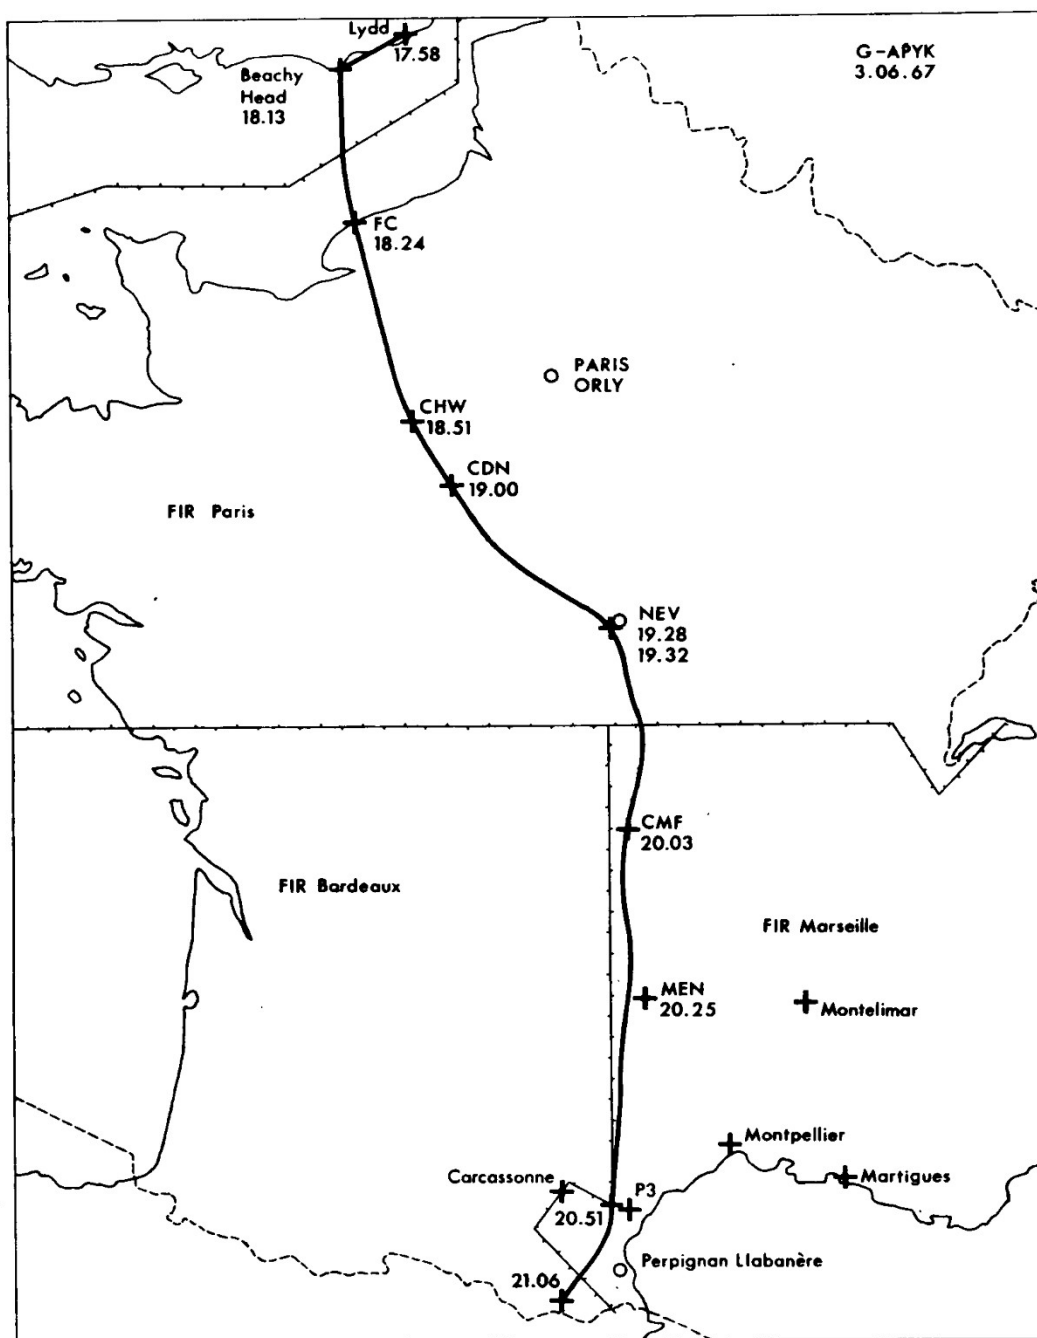
The last part of the route starting from the passage over the reporting point prior to reaching the FIR boundary was reconstructed. It showed that at 1932 hours the aircraft was climbing to flight level 90, where it became stabilized at about 1935 hours on a track which was practically due south. Then, some alterations in heading were made until passage over Clermont-Ferrand VOR (CMF) at 2003 hours. Still within airway A 27, the aircraft continued until a short distance from Mende NDB (MEN) when it turned slightly southwest, Mende was passed to the west of the beacon shortly after 2025 hours, and although some two minutes later the aircraft resumed a heading approximately parallel to A 27, its route continued to turn towards the southwest after passing abeam Montpellier at about 2043 hours.

Figure 4-1. Reconstruction of the entire route

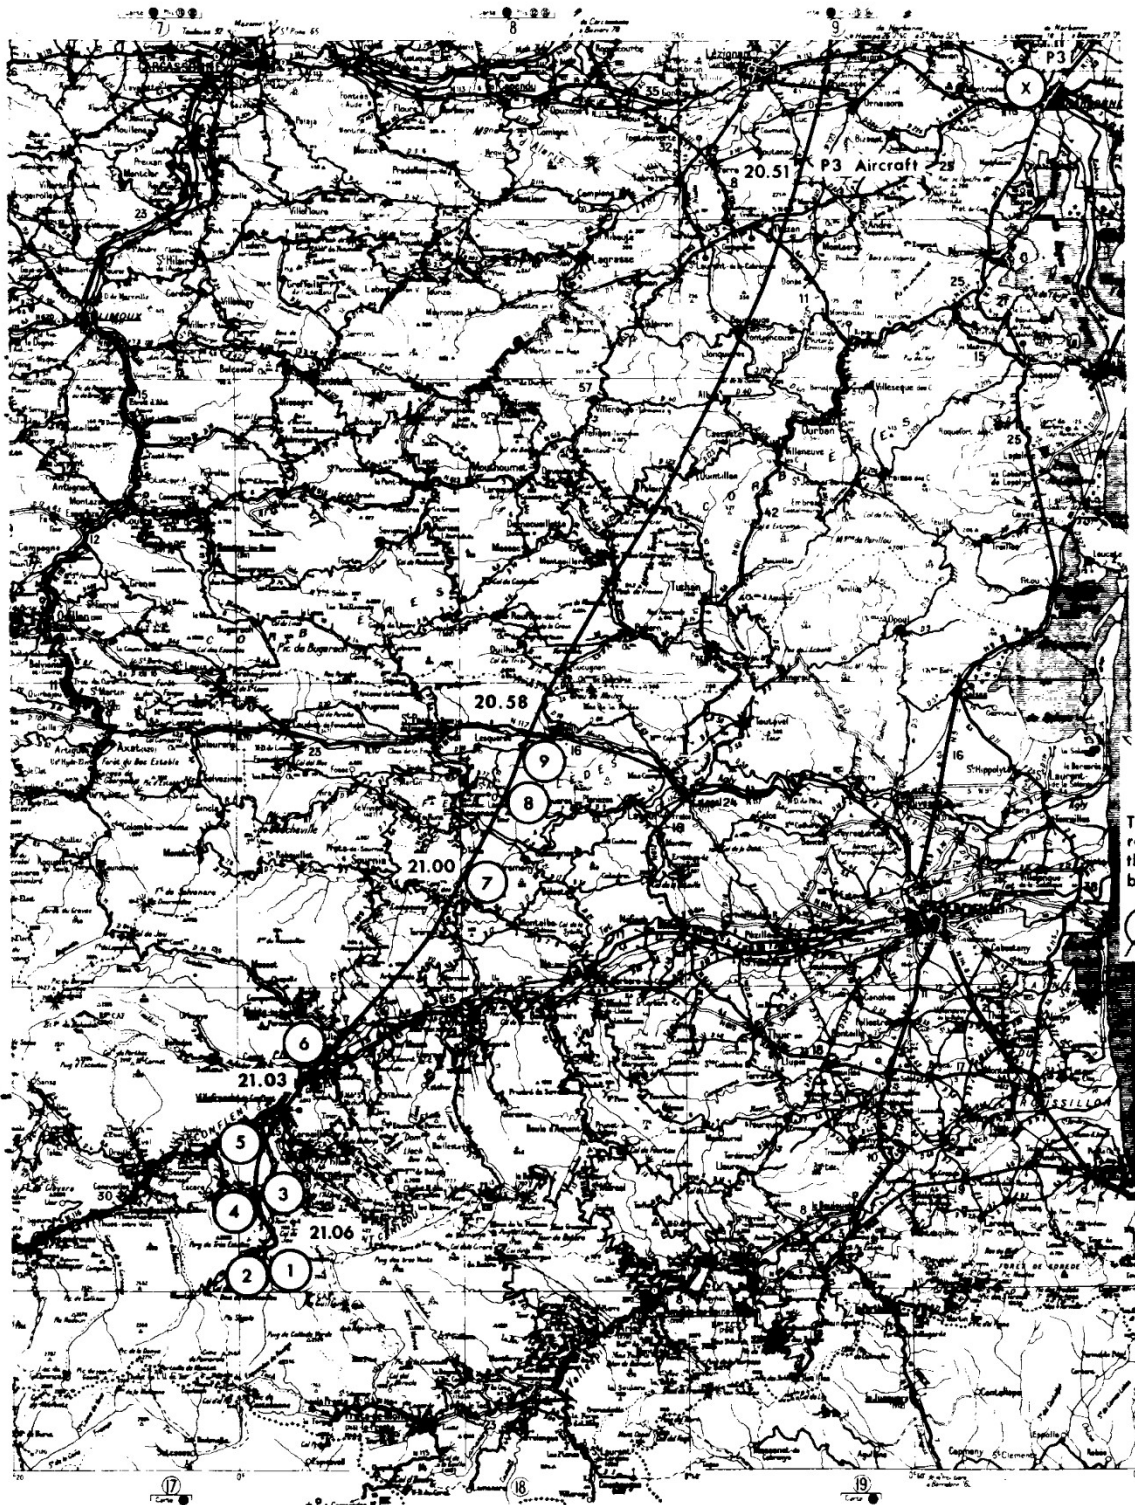
The aircraft passed about 15 km west of the point Papa 3, at about 2051 hours (see Fig. 4-2), when it was leaving flight level 90. At that moment the track made good was about 200° and continued to deviate towards the southwest. Flight level 70 was reached shortly after 2055 hours and the aircraft was approaching flight level 50 at about 2100 hours. The flight path was at this moment headed clearly for Prades, when at 2059 hours the aircraft was less than 30 km west of Perpignan airport, descending to about 5 700 ft and making good a track of about 225°. The aircraft flew over Prades at about 2102 hours and then, some three minutes before the impact, when it was at about 4 400 ft, went into a wide left-hand turn for two minutes, then into a fast right-hand turn of about 90°, immediately followed by a steep left-hand turn during which normal acceleration peaks of as much as 2g were recorded as well as a clear variation in altitude in both senses. The impact occurred shortly after 2106 hours, on a northerly track at an altitude of about 3 800 ft.

Figure 4-2. Final phase of the flight reconstructed from the read-out of the flight data recording. Circles indicate the witnesses location.

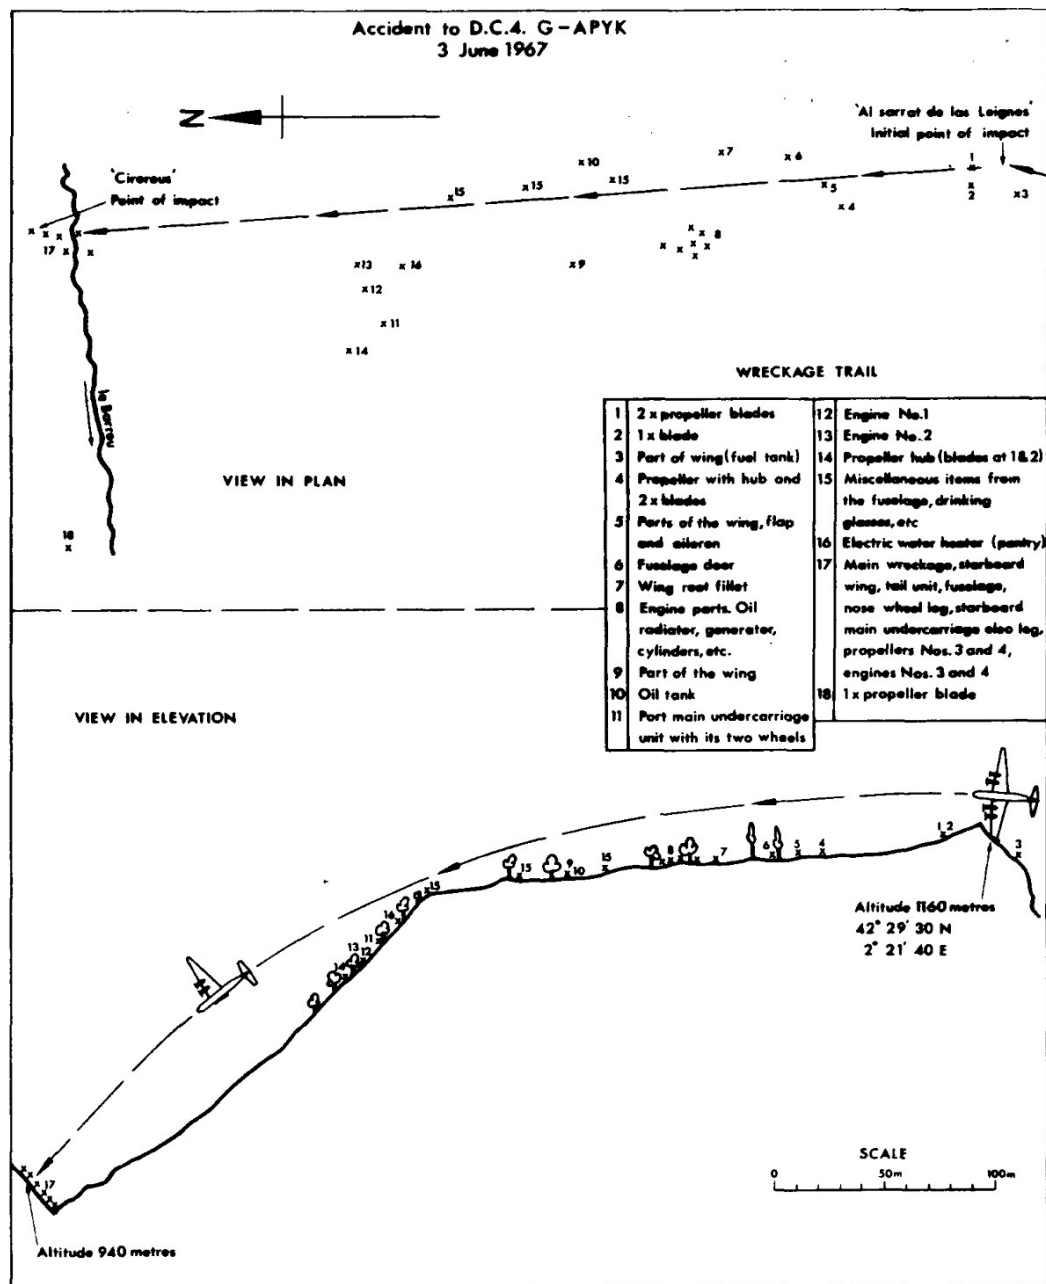
Figure 4-3.

The initial point of impact was situated in the territory of the commune of Py (Pyrénées Orientales) at the place known as 'Al sarrat de las Leignes', 50 km southwest of Perpignan aerodrome and 80 km south of Carcassonne, at an elevation of about 1 160 m (see Fig. 4-3).

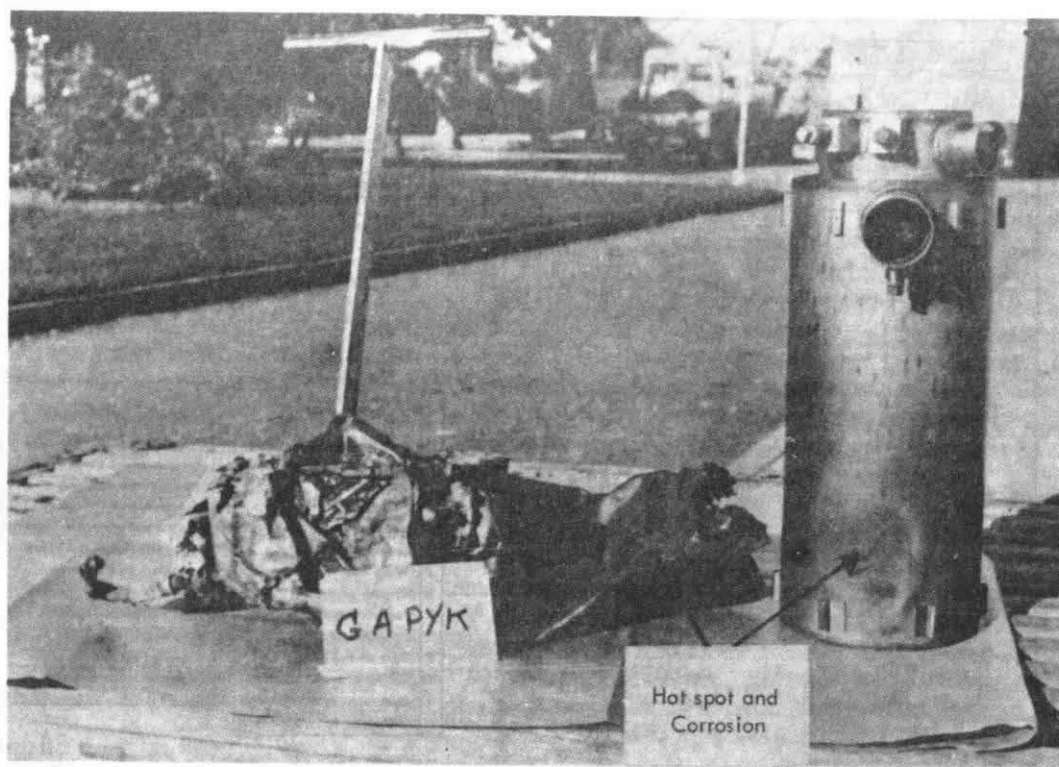
Figure 4-4. The Janitrol Heater

The cockpit heater was found at the point of impact of the aircraft's nose, buried under stones and the ashes of various pieces of wreckage, and it had probably been subjected to heating in the fire. Its outer jacket showed only slight oxidation, but it had been heavily deformed by impact. The heater combustion chamber was cut open and fairly marked internal oxidation was found. Folding of the sheet metal had occurred as a result of the impact and numerous fine cracks were detected. A small piece of metal where oxidation had occurred had become detached, revealing a hole resulting in intercommunication between the internal part of the combustion chamber and the annular section serving as a passage for the air to be heated. This hole was situated exactly at the localized hot spot found on all the heaters. Such deterioration could not have been detected during a routine inspection, apart from dismantling and pressure testing as required solely during general overhaul.

The metallurgical examinations of the cockpit heater carried out at the Centre d'Essais des Propulseurs de Saclay, including spectrographic analysis and micrographical examination, revealed oxidation through the whole thickness of the sheet metal of the heater, which could only have taken place over a long period of time, and the presence of lead both inside the heater and in the warm air circuit. These findings tended to prove that there was definite intercommunication between the inner and outer portions of the heater, thereby bringing the burnt gases into contact with the clean air to be heated.

The only possible source of carbon monoxide contamination during the flight was the cockpit heater system. Examination of the Janitrol heaters, and in particular the heater and one of the warm air ducts of the cockpit, revealed cracks, considerable oxidation and the presence of lead. However, flight tests carried out in England did not produce contamination conditions similar to those revealed by the toxicological examinations. The fact that the nose undercarriage compartment is not sealed means that carbon monoxide could pass into the cockpit if the joints of the exhaust pipe were defective. The positive evidence obtained from examination of the heater and the warm air ducting led the Commission to regard the cockpit heater system as a direct factor in the accident.
