No. 5

SADIA S/A Transportes Aéreos, Dart Herald 214, PP-SDJ, accident at Piraquara, Morretes Municipality, State of Paraná, Brazil, on 3 November 1967. Report dated 25 March 1968 released by the Aviation Accident Investigation and Prevention Service, Department of Aeronautics, Inspectorate General, Brazil

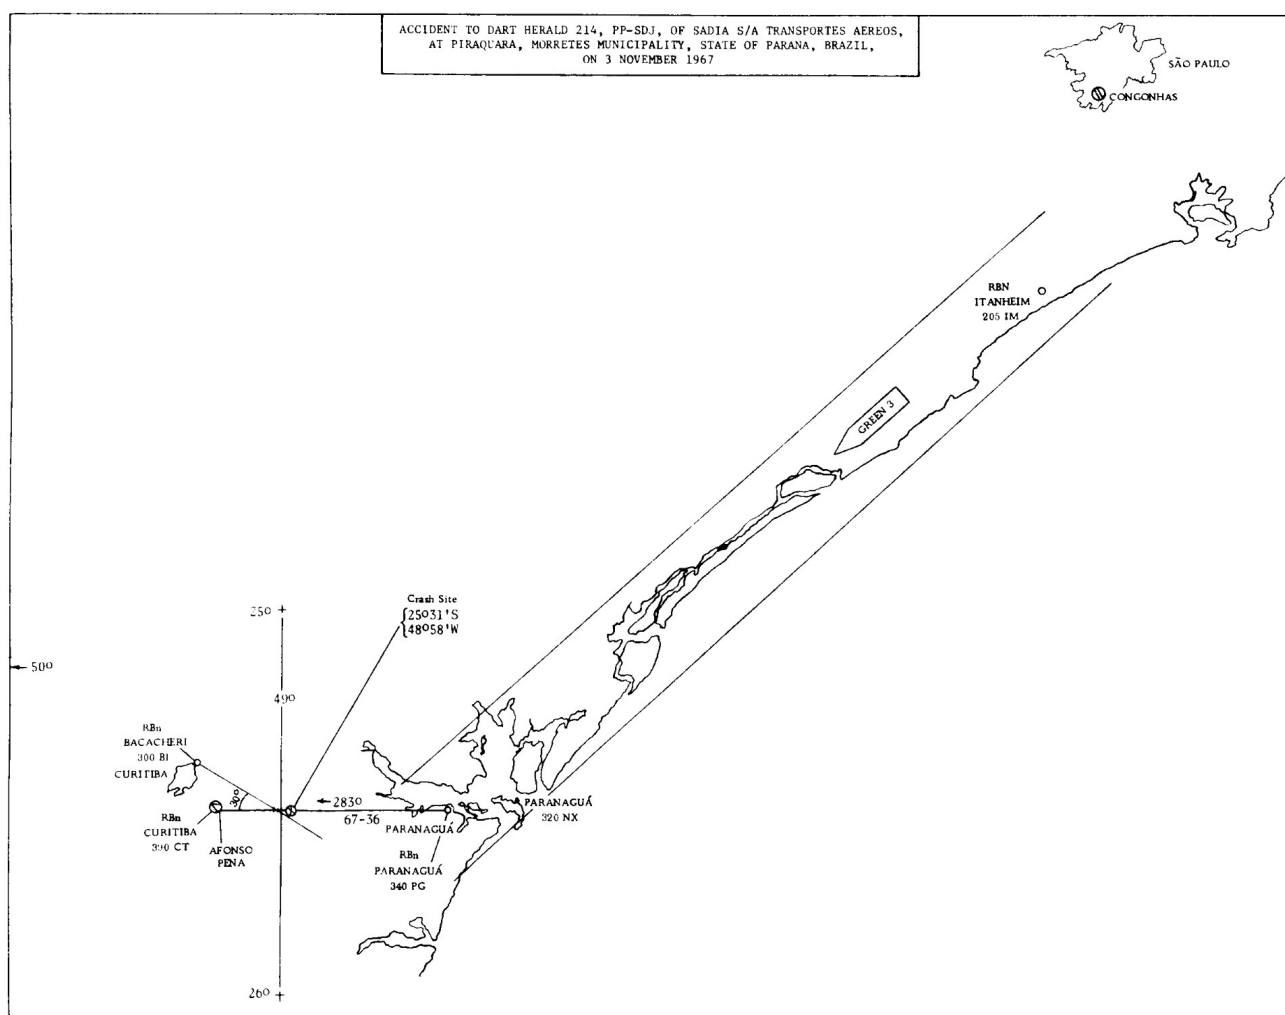
Fig. 5-1

Without a correct fix being obtained over Paranaguá (see Fig. 5-1) the position report was transmitted at 1117 hours Z to Curitiba Control and the aircraft changed heading, approaching Curitiba on a magnetic heading of 283°. The ADFs were then set respectively on the frequencies of the Curitiba NDB (CT-390 kc/s) and the Bacacheri NDB (BI-300 kc/s).
