No. 15

United Arab Airlines, DC-3, SU-AJG, accident approximately 5 km southeast of Al Mahalla-Al Kobra, United Arab Republic, on 15 January 1968.  
Report, not dated, released by the Director General of Civil Aviation, United Arab Republic

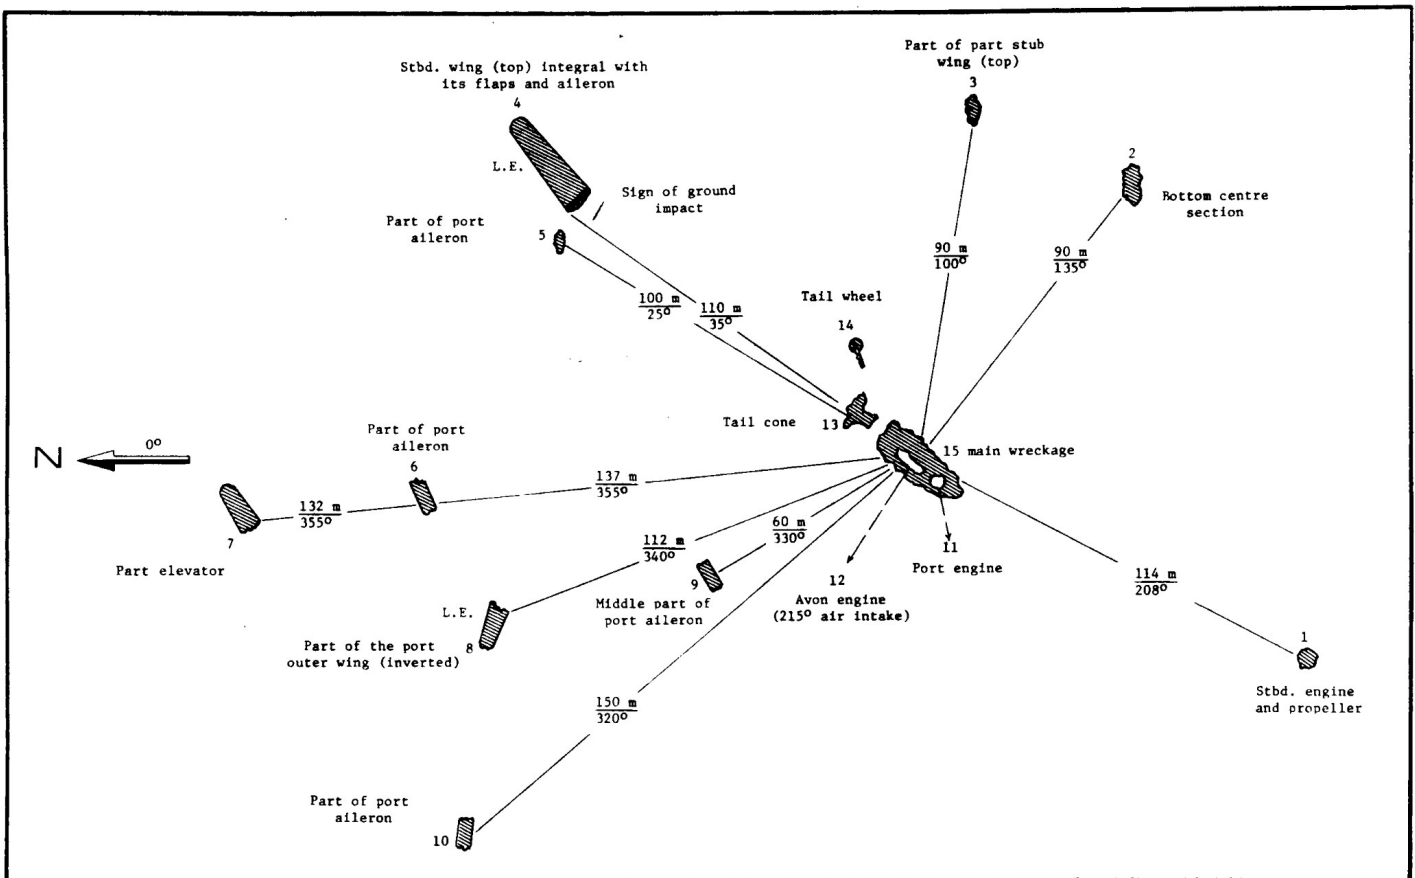
Figure 15-1. Wreckage plot of the aircraft

The following parts were found scattered around the main wreckage (see Fig. 15-1) with no traces of fire:

- the starboard wing, complete with flaps and aileron, was found at a distance of 110 m from the main wreckage;
- the starboard elevator was found at a distance of 132 m from the main wreckage;
- the port wing was found inverted at a distance of 112 m from the main wreckage;
- parts of the port aileron were found at various locations and distances from the main wreckage;
- the starboard engine was found at a distance of 114 m from the wreckage.
