No. 5

MacRobertson-Miller Airlines Pty., Viscount 720C, VH-RMQ accident
near Port Hedland, Western Australia, on 31 December 1968.
Report, dated September 1969, released by the
Department of Civil Aviation, Australia

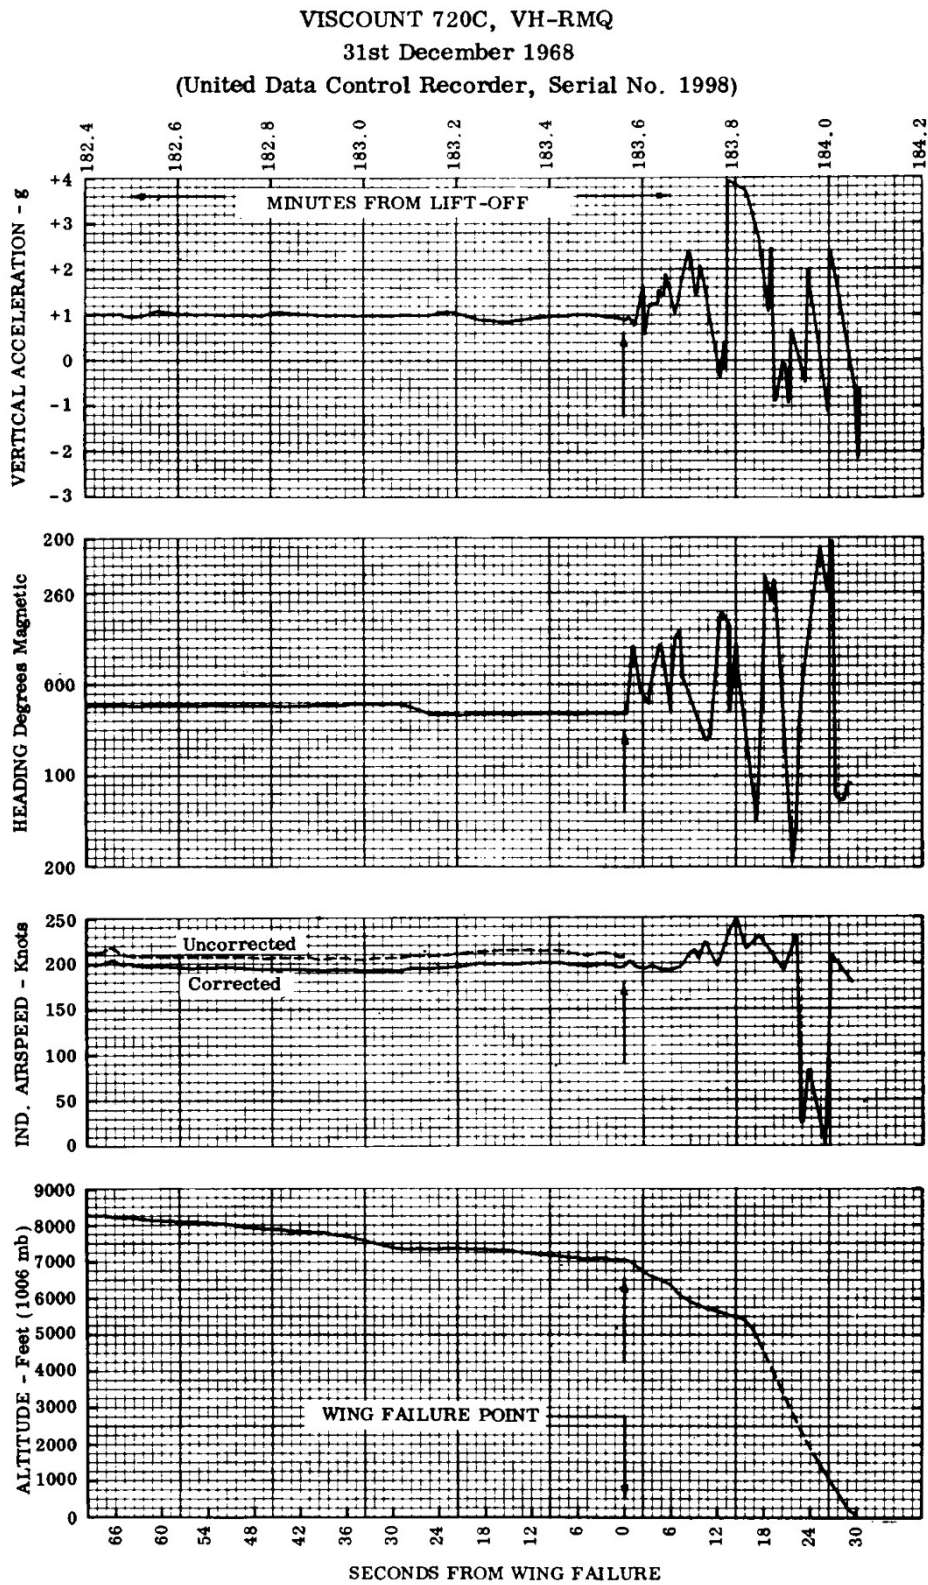
Figure 5-1. Graph of Flight Data Recorder Readings

descent modes. The presentation of indicated airspeed at Figure 5-1 therefore shows the read-out of the actual record as a broken line and the corrected airspeeds as a solid line.

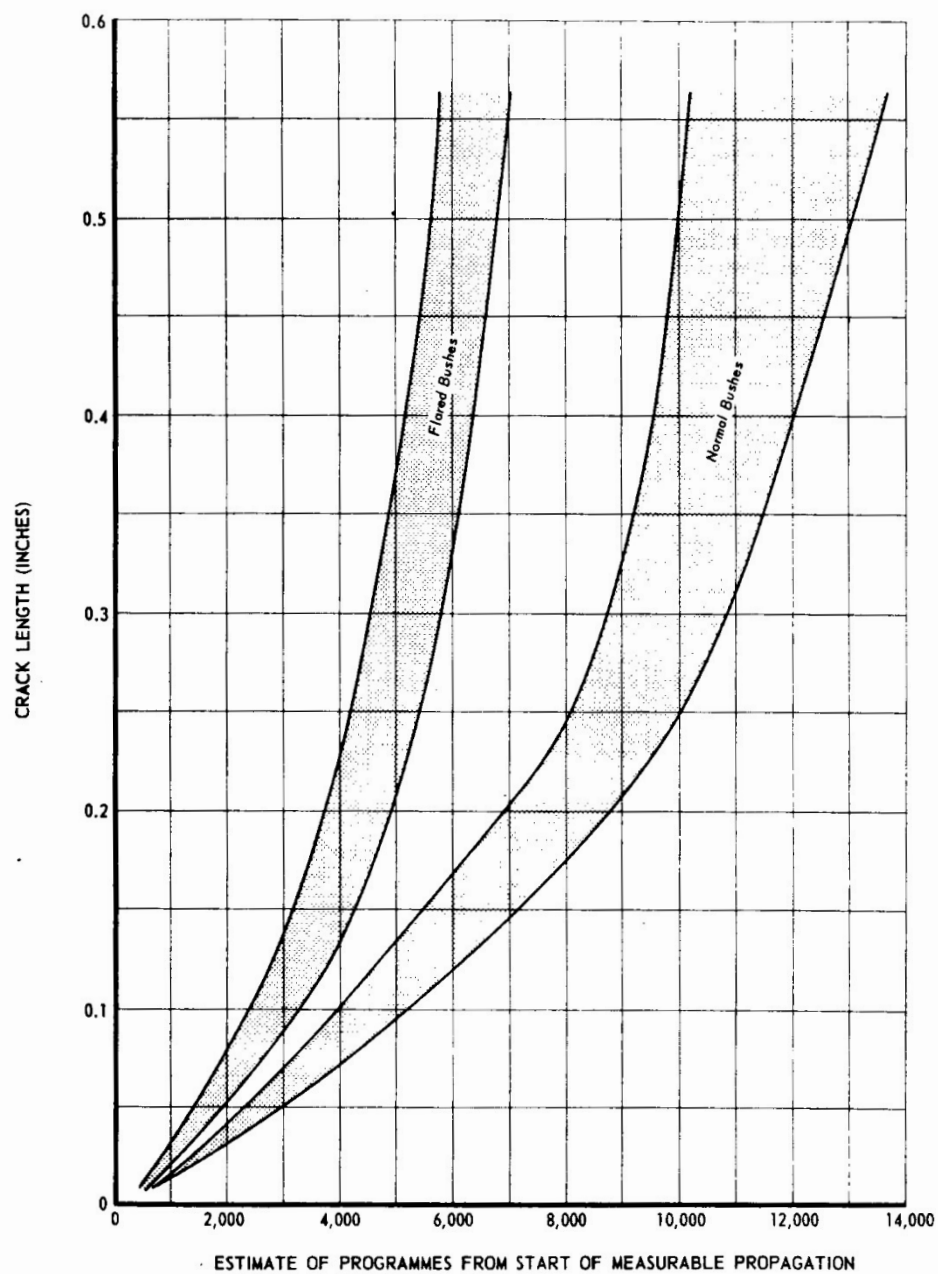
Figure 5-2. Comparison of Crack Propagation Rates -
Flared and Normal Bushes

The manufacturer's report provided, in a number of cases, fatigue crack micro-progression rates in terms of the number of programmes per 0.001 inches progression at known crack lengths. These were integrated and replotted with a common origin in Figure 5-2 and provided a comparative estimate of crack propagation rates between holes with flared bushes and holes with normal bushes. Although there was a degree of estimation in this graph, particularly in respect of the determination of time of actual crack initiation, the results showed under the test conditions used that, up to a crack length of approximately 0.25 inches, the crack propagation rate for a specimen with flared bushes approached twice that of a specimen with normal bushes. It was also estimated from extrapolation of the crack propagation data that, in each case considered, the crack started to propagate measurably at about two-thirds of the life to failure under the test cycle loading. The crack propagation rates were obtained using electron microscope fractographs of the fracture surface in the VH-RMQ boom over a distance one to six millimeters from the crack origin. At similar crack lengths the relative crack propagation rates showed good agreement with the crack propagation rate curve for flared bush specimens.

Fatigue tests carried out by the manufacturer on representative boom sections show that a reduction of approximately 50 per cent in mean life to failure of the boom can be expected as a result of inserting a flared bush of the type found at Station 143 in VH-RMQ.
