AIRCRAFT ACCIDENT REPORT

SOUTHERN AIRWAYS, INC. DC-9, N97S

Tri-State Airport

November 14, 1970

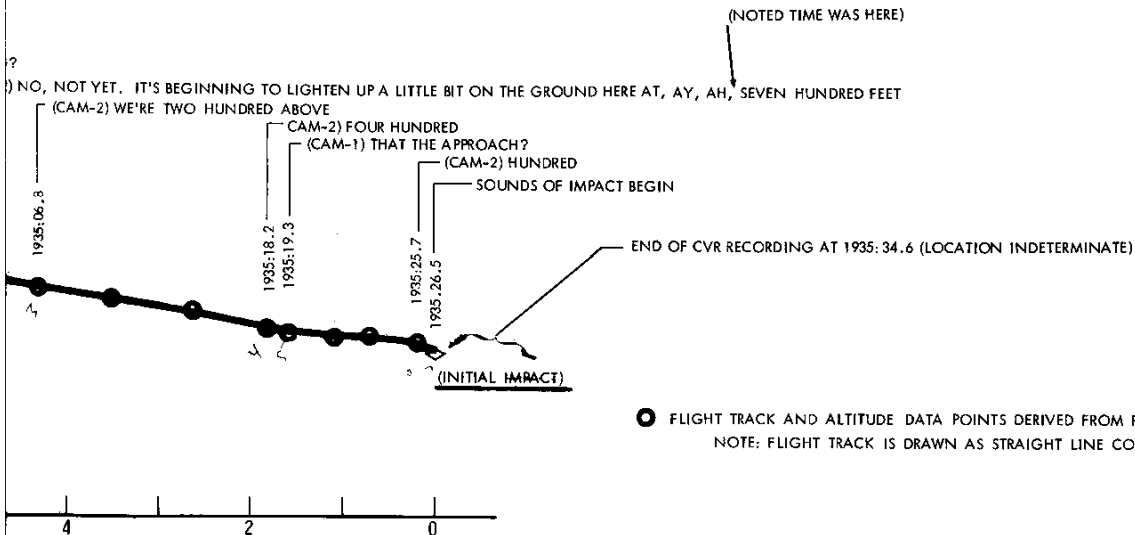
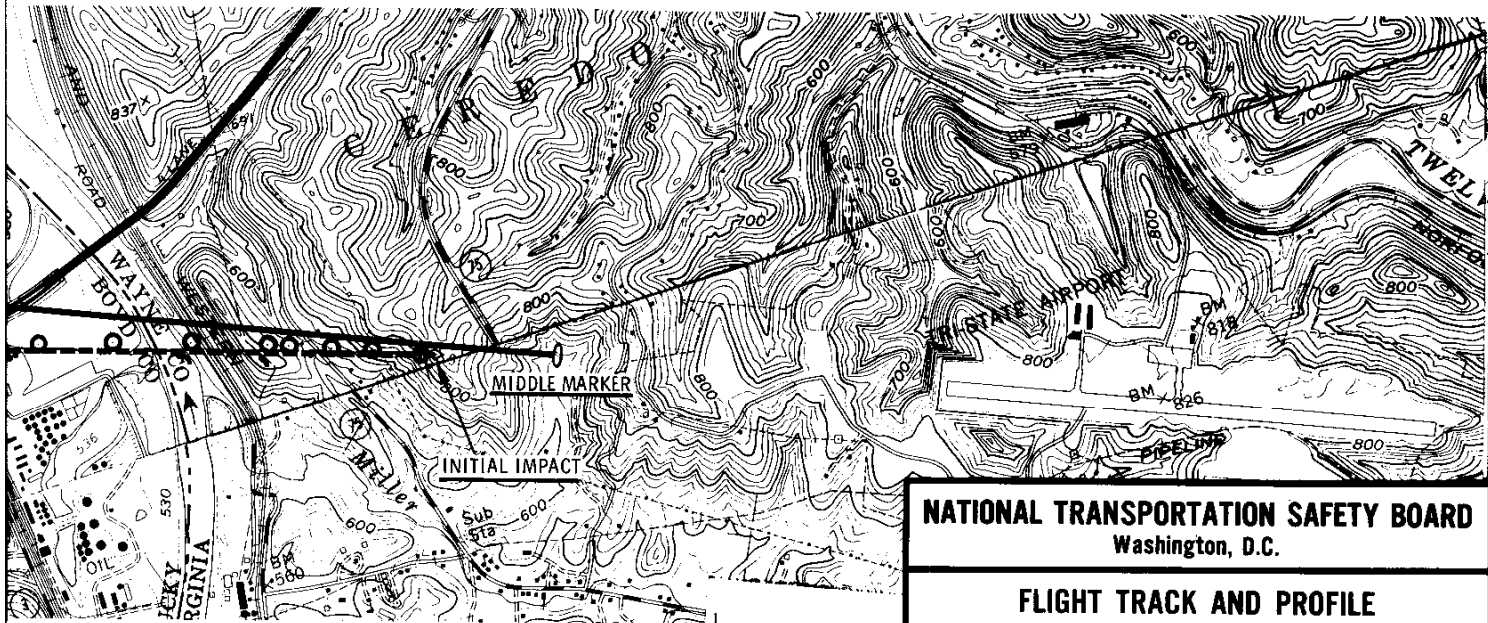
ATTACHMENT 1

FLIGHT TRACK AND PROFILE
SOUTHERN AIRWAYS, INC.
DC-9-31, N97S
HUNTINGTON, WEST VIRGINIA
November 14, 1970

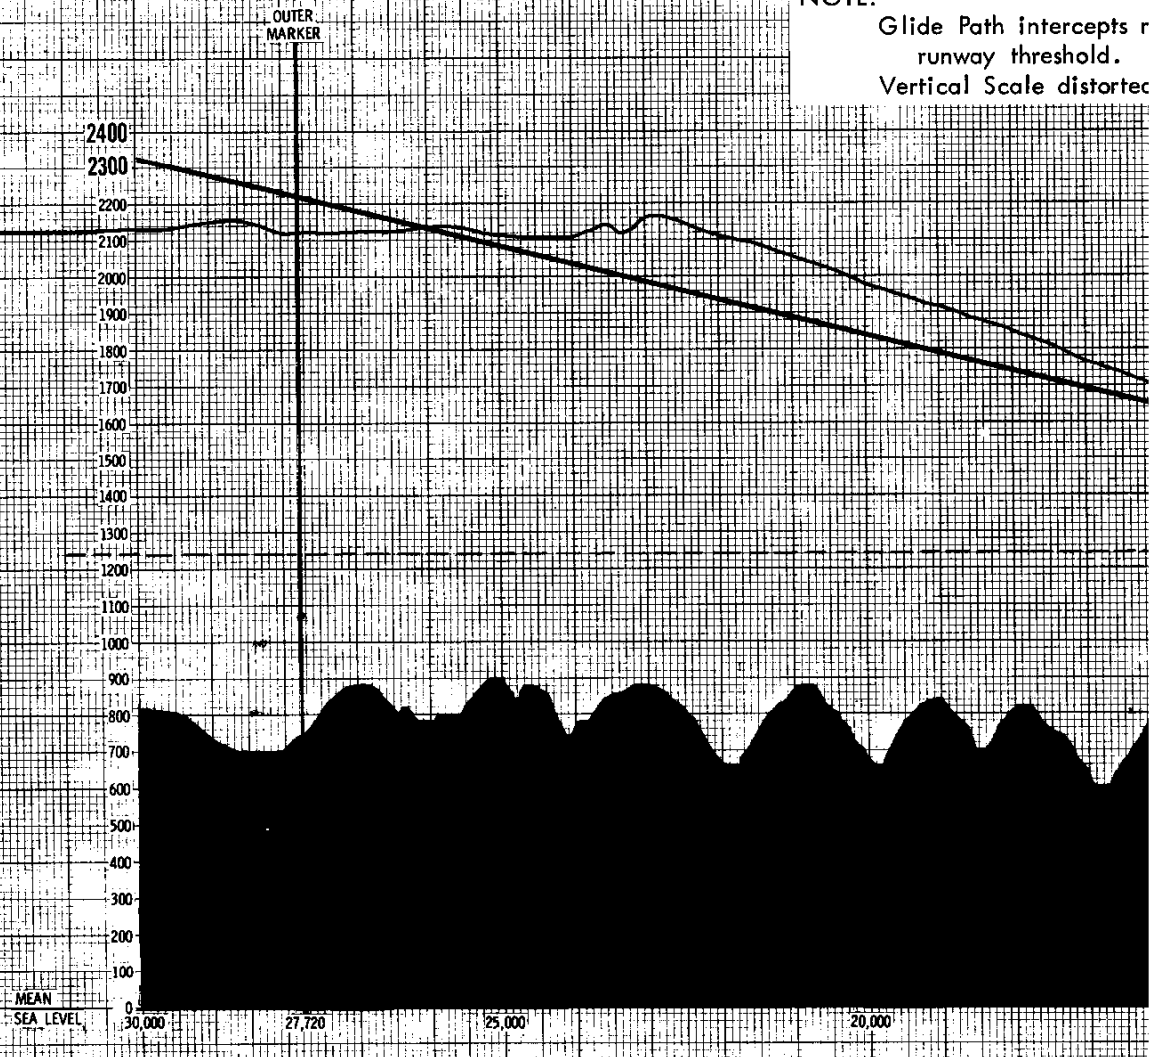
COMPARISON OF DESCENT PROFILE AND 3° GLIDE SLOPE
SOUTHERN AIRWAYS, INC.
DC-9-31, N97S
HUNTINGTON, WEST VIRGINIA
November 14, 1970

--- MINIMUM DESCENT A
— 3° GLIDE PATH
— DESCENT PROFILE

NOTE:
Glide Path intercepts r
runway threshold.
Vertical Scale distortec
