National Transportation Safety Board

Aviation Accident Final Report

Location:	Corinth, MS	Accident Number:	ERA16LA078
Date & Time:	12/24/2015, 0840 CST	Registration:	N891CR
Aircraft:	PIPER AIRCRAFT INC PA-46	Aircraft Damage:	Substantial
Defining Event:	Loss of control in flight	Injuries:	2 Serious, 2 Minor
Flight Conducted Under:	Part 91: General Aviation - Personal

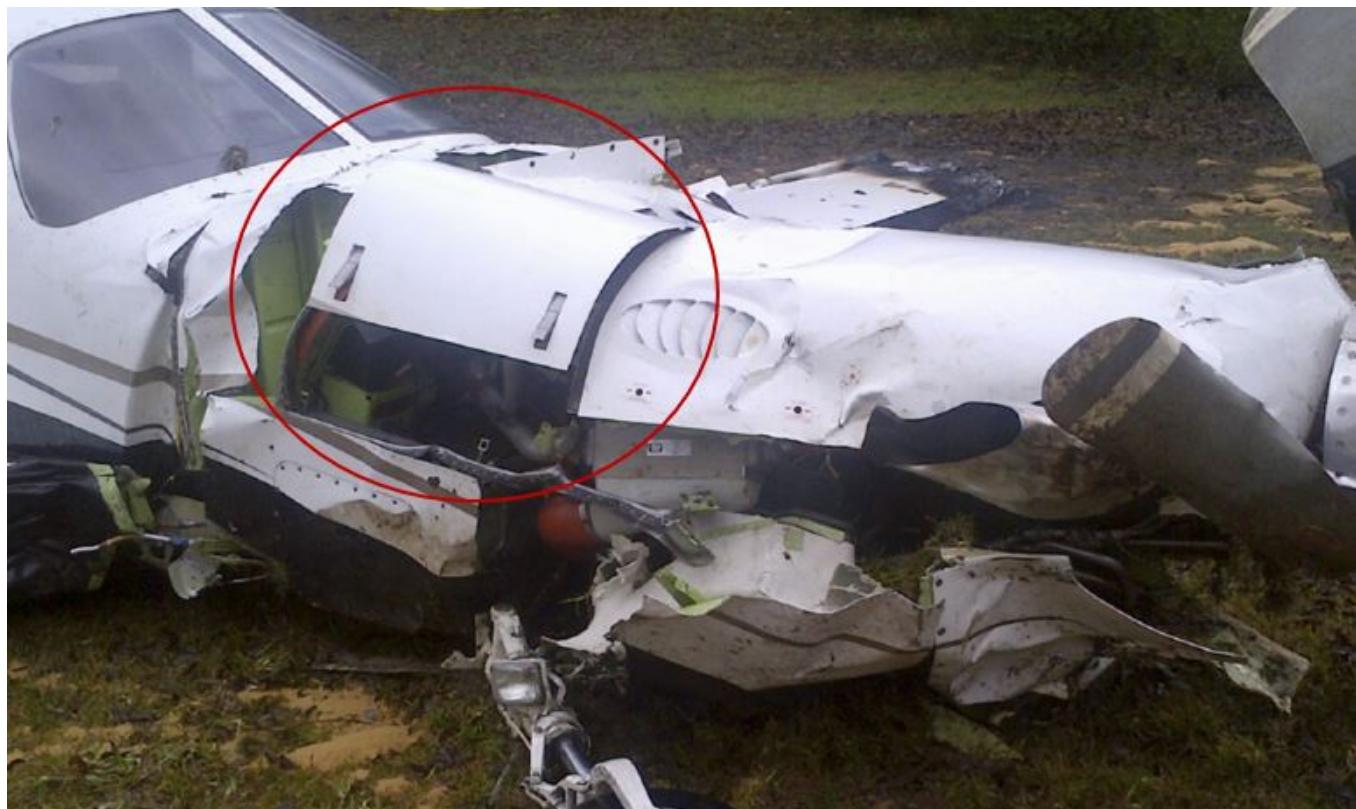
Examination of the wreckage revealed no evidence of any preimpact failures or malfunctions of the airplane or engine that would have precluded normal operation. It was discovered though, that the right access door had not been closed and latched by the pilot before takeoff, as examination of the right access door latches and clevis keepers found them to be functional, with no indication of overstress or deformation which would have been present if the access door had been forced open due to air loads in-flight, or during the impact sequence. Further

examination also revealed that the battery charging port cover which was inside the compartment that the right access door allowed access to, had not been placed and secured over the battery charging port, indicating that the preflight inspection had not been properly completed.

The pilot's inadequate preflight inspection and his subsequent failure to maintain airplane control, which resulted in an access door opening after takeoff, and the airplane exceeding its critical angle of attack and experiencing an aerodynamic stall.

The airplane came to rest about 1,792 ft from the departure end of runway 18 on a 132° magnetic heading on the front lawn of a residence. Examination of photographs of the wreckage taken at the accident site revealed that the right cowl door was open (see Figure 1).

Figure 1 –Right Side Access Door

The right access door was found open and unlatched with minimal damage noted to the door. The right access door support rod was found lying on top of the battery bay, and the battery charging port cover was not installed over the charging port. A functional check of the right access door latches found them to be functional with no indication of overstress or deformation, and there was no deformation or indication of overstress to the clevis keepers.
