Aircraft Accident Investigation Board

Interim Report

State File Number: A961129EPATS
Type of Occurrence: Accident
Date of Occurrence: Feb 18th 2018
Place of Occurrence: Near Yasouj Airport
IRI of IRAN
Aircraft Type: ATR 72-212
Registration: EP-ATS
Operator: Iran Aseman Airlines

Accident Investigation Report
Aircraft ATR72-212 registered EP-ATS
Operated by Iran Aseman Airline
Enroute Tehran to Yasouj
18 Feb, 2018

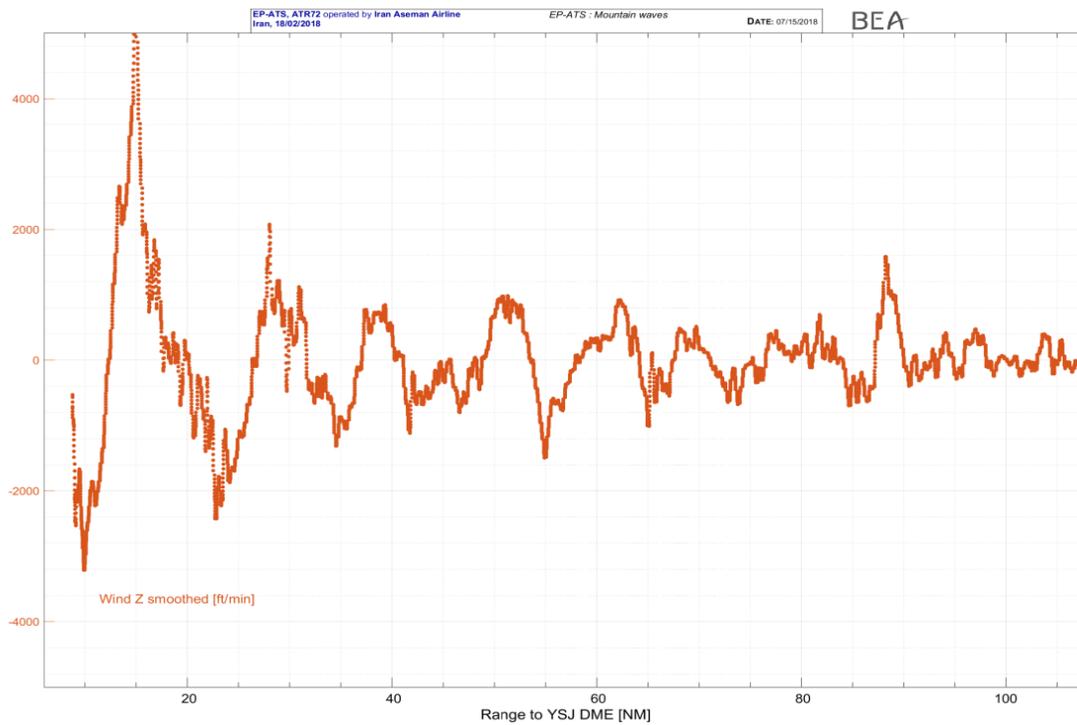
Figure 12: Computed vertical wind during the accident flight.

Drawing the computed vertical wind values versus the range to the DME of Yasouj really shows the oscillations of the vertical wind with a long range change during the accident flight.

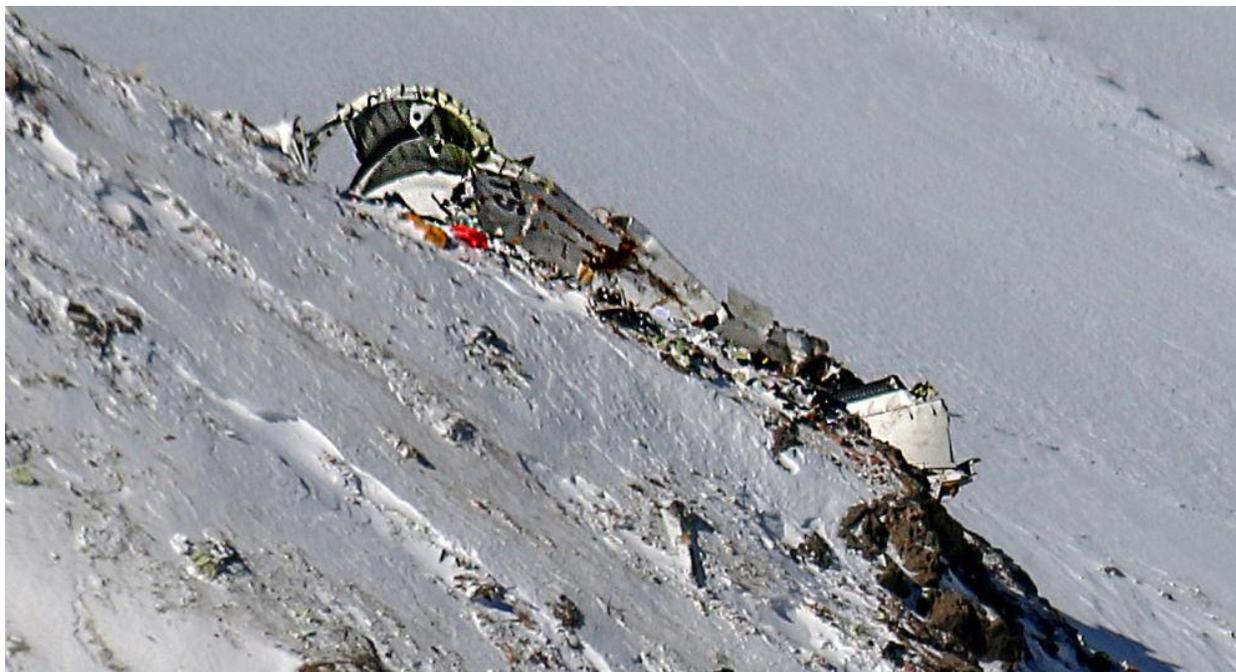
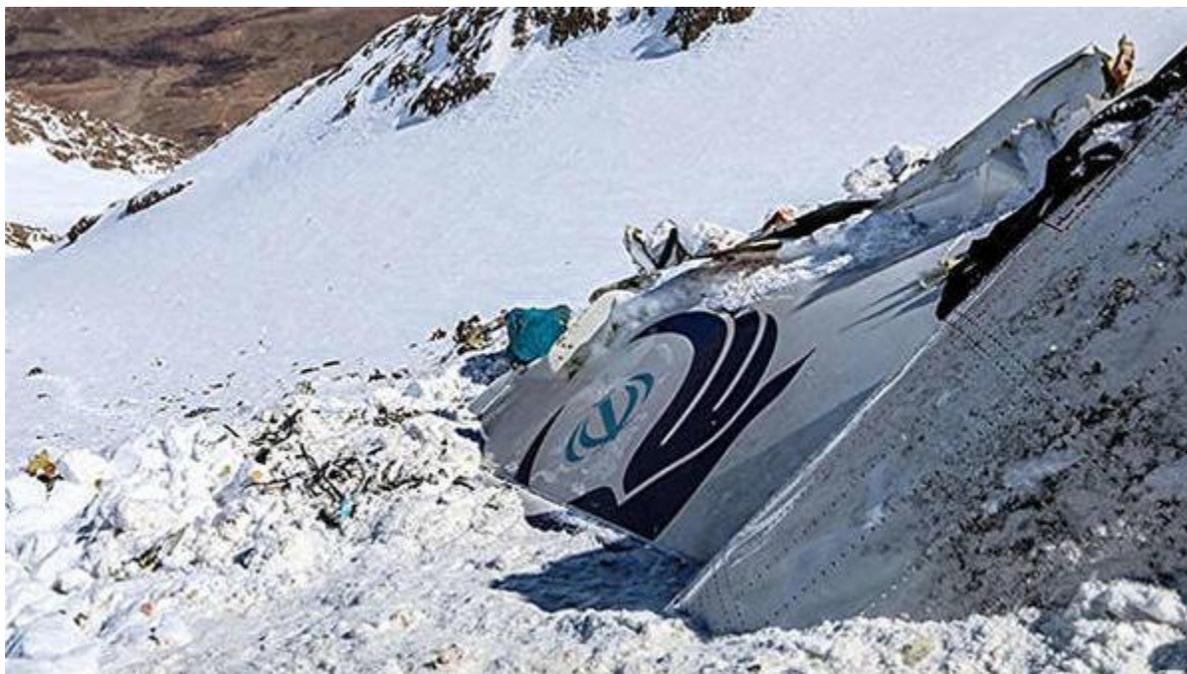
Figure No; 13 Accident Site:

The wreckage was fragmented with a large amount of debris spread over an area in a sloping rocky ravine which was covered by snow. Due to snowfall on the night after accident time, the wreckage was covered with snow completely and it was not possible to find parts of the aircraft and transfer the pieces easily. The technical investigation on wreckage parts was not possible. At the scene of the accident, the Mountain ravine and local winds have been felt to endanger any flight to the accident site to access the site.

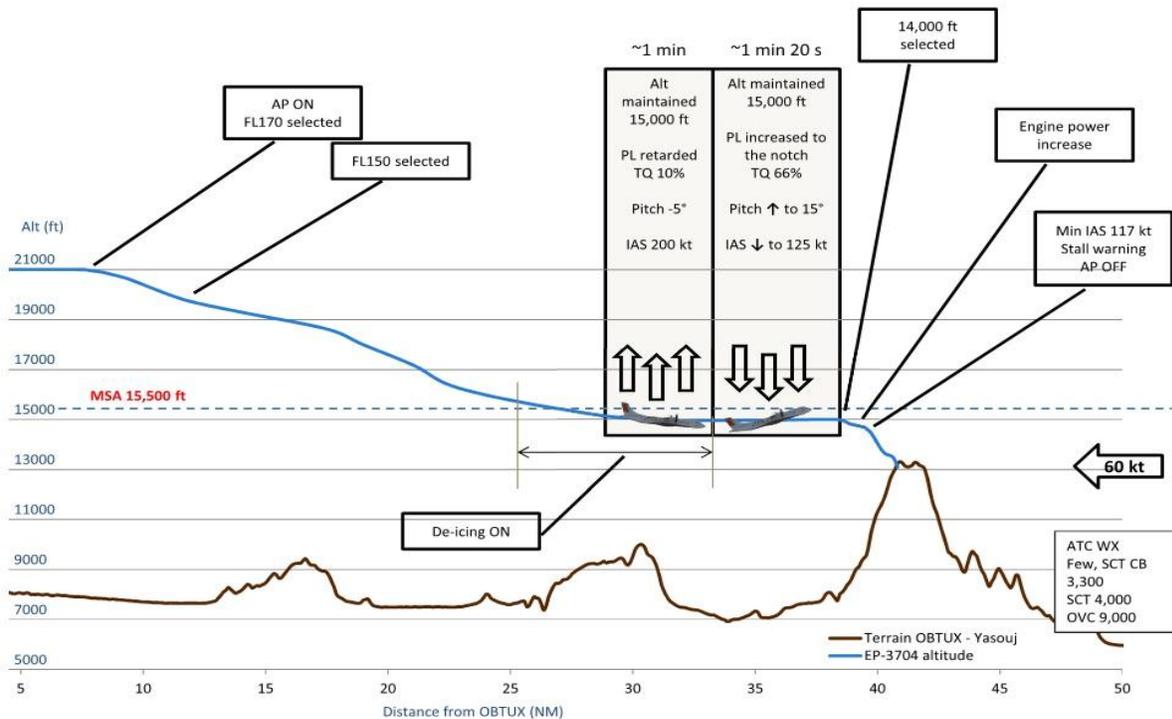
Figure No; 22 Up & Down draft for flight prepared by ATR

From 09:29:28 to 09:30:45, the vertical wind direction changed. It gradually moved from an updraft wind to a downdraft wind. The aircraft pitch started to increase and the IAS decreased, drag increased accordingly. Then power levers were progressively pushed towards the notch, with engine torque increasing. Based on CVR, the pilot told “wow” which might be due to understanding low speed and focused on putting off a system which led to warning prevention. They might refer to AoA after disconnecting LEV II anti-ice system.

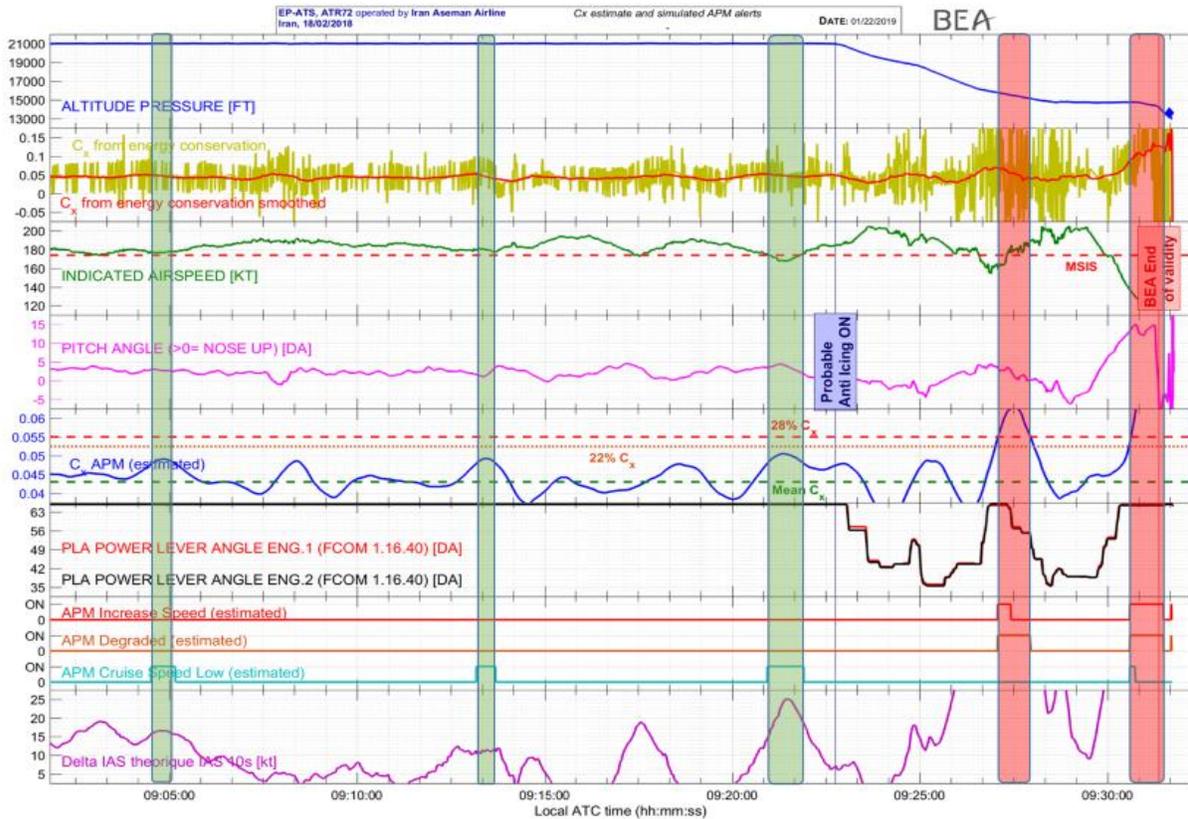
Figure 26, Estimate of C_x and potential APM alerts

The average value of the computed C_x was 0.043 during the level off at FL 210 which is a consistent value for this airplane. Specific periods of interest that are highlighted in the figure:

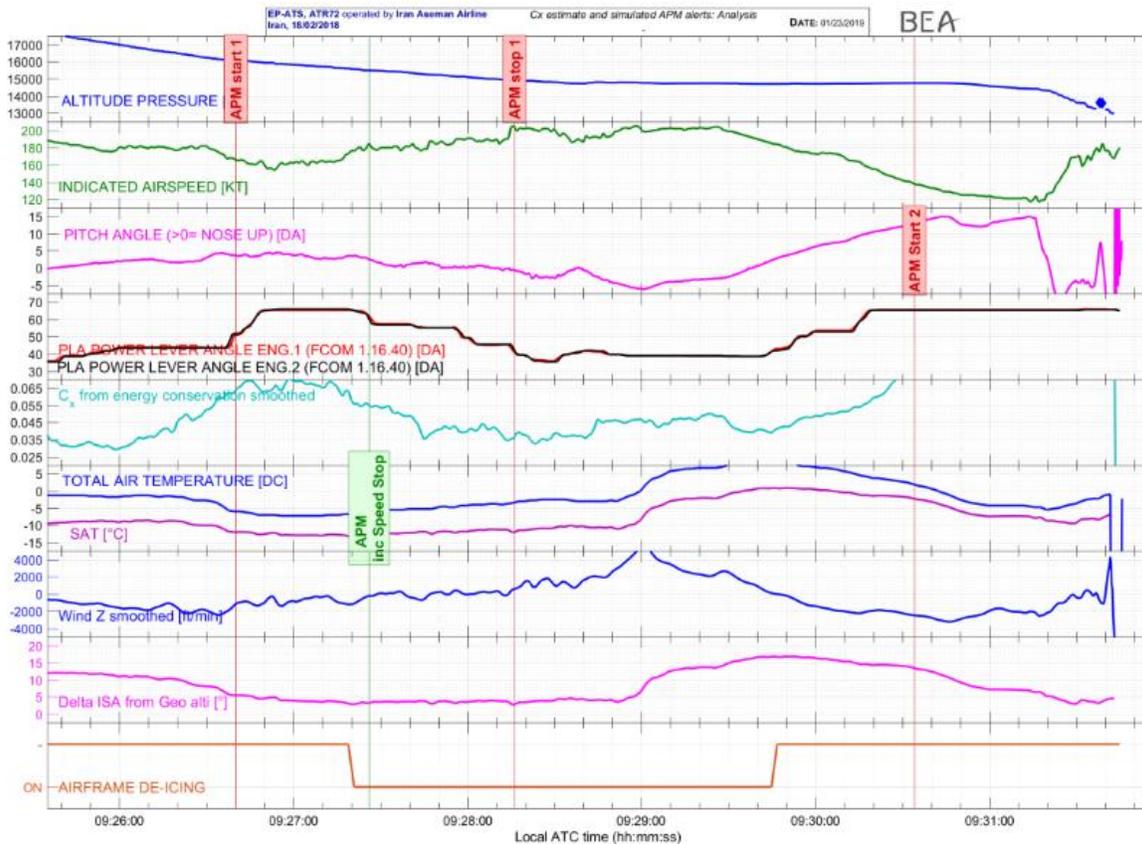
Figure 27, Simulated APM alerts - Analysis

- The first simulated APM alerts (both Degraded Performance and Increase Speed) would have triggered at 9 h 26 min 40 s. The first simulated APM alerts:
 - They triggered more than 30 s before the ice detector caution and the true Cx increasing occurred 70 s before the ice detector caution.
 - The degraded performance alert stopped while the SAT was still lower than -10°C .
- ❖ *Note: when SAT is below -10°C and De-ice system ON, the condition of ice contamination exists, so stopping APM alerts means aircraft performance is normal with no ice contamination.*
