No. 17

Panarctic Explorations, Lockheed L-188, CF-PAB, accident at Rea Point, Melville Island, Canada, on 30 October 1974. Report not dated, released by the Ministry of Transport, Canada.

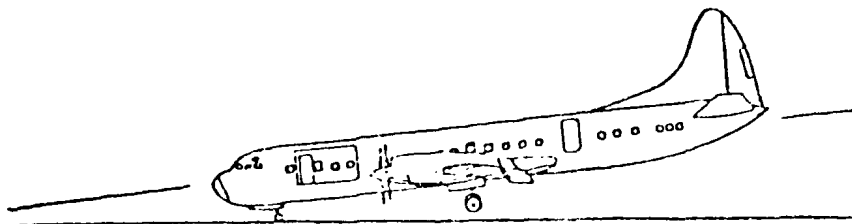
The aircraft struck the 8-in thick sea ice on a heading of about 321° True with about a 2° crab angle to port. The wings were level or slightly left wing low with a nose-down attitude in the order of 7°. The break-up sequence is shown on the following page.

The Electra at impact with nose oleo fully compressed and about to punch through the ice.

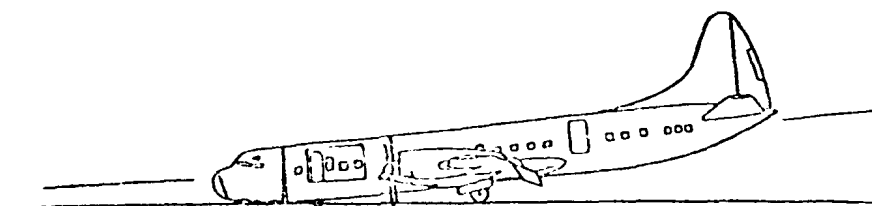
The main gear penetrates the ice, the outboard propellers begin to slash the ice and the nose gear truss girders and shock tube tear out with the fuselage rupturing at FS 200.

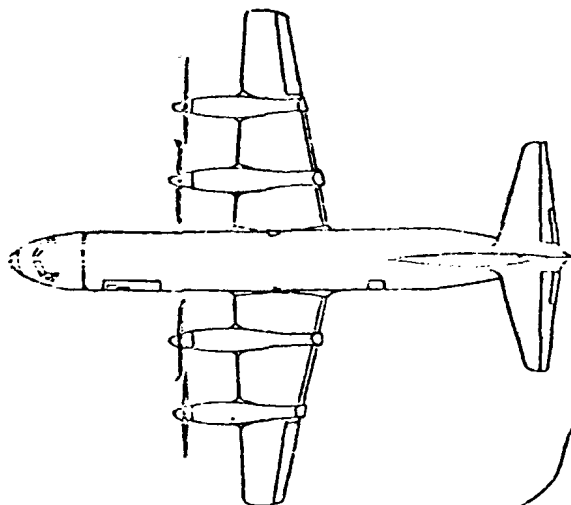
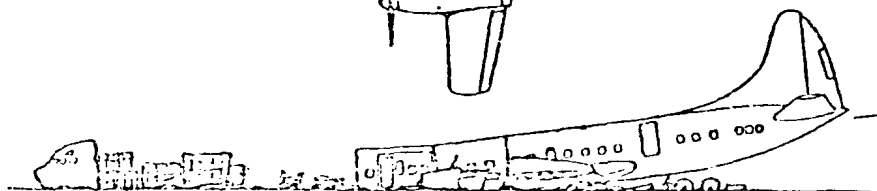
The nacelles and wing centre box contact the ice, the propellers, gearbox and engines separate from the wings, the fuselage ruptured at FS 570, the right wing exploded outboard of WS 170, the left wing separated intact outboard of WS 170 and the centre wing box disintegrated. The cockpit and bulk cargo slid ahead of the decelerating structure, and the passengers, seats and emergency gear cabinet broke free within the aft fuselage.

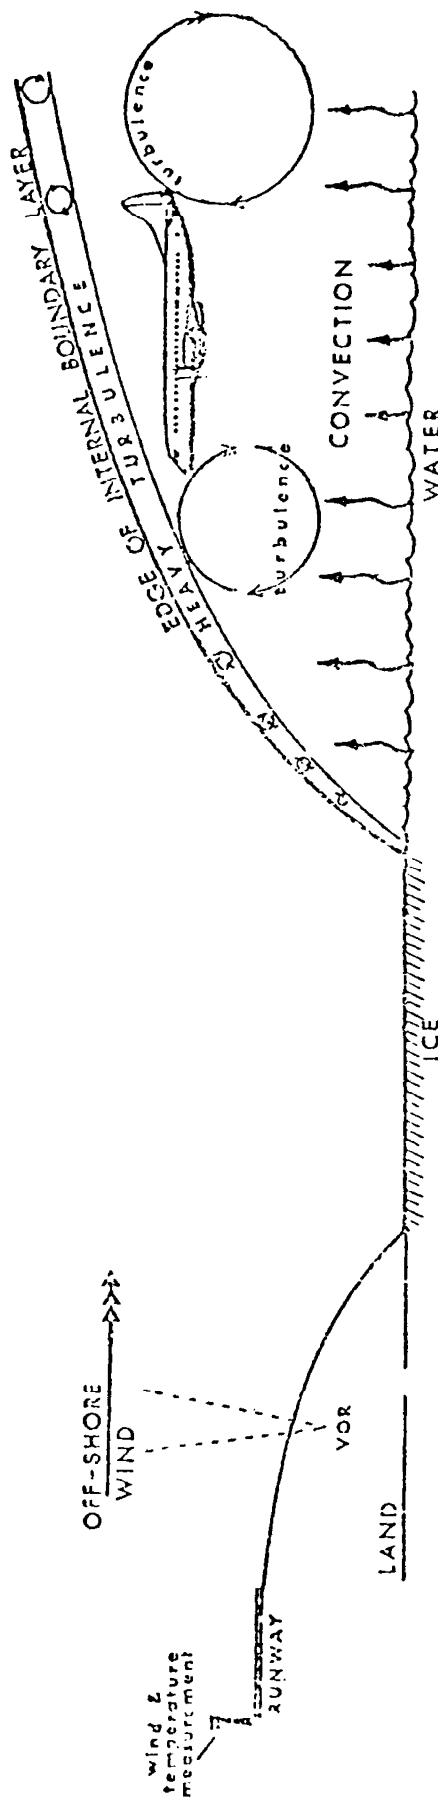
Figure 17-1.- Cross-section of local meteorological situation (or internal boundary layer) associated with cold flow from land over "warm" open lead offshore

There was a strip of open water of at least several miles width over which the aircraft flew immediately prior to the accident. An atmospheric structure analysis based on physical modelling and numerical computation indicates:

- 1) the extreme contrast in temperature as the airflow from the land and sea ice moved over the open water creates an internal boundary layer;
- 2) within the internal layer the flow would have an increased turbulence due to the convection originating from the "hot" open lead;
- 3) development of sea smoke mixed with ice crystals from blowing snow originating several hundreds of metres from the edge of the shore-fast ice and the open water, thickening with distance to dimensions suggested on the diagram; and
- 4) the position of the aircraft at the point where an abrupt descent was initiated corresponds closely to a position where optical shifting of surface images (mirage effect, foreshortening) would have been at a maximum.

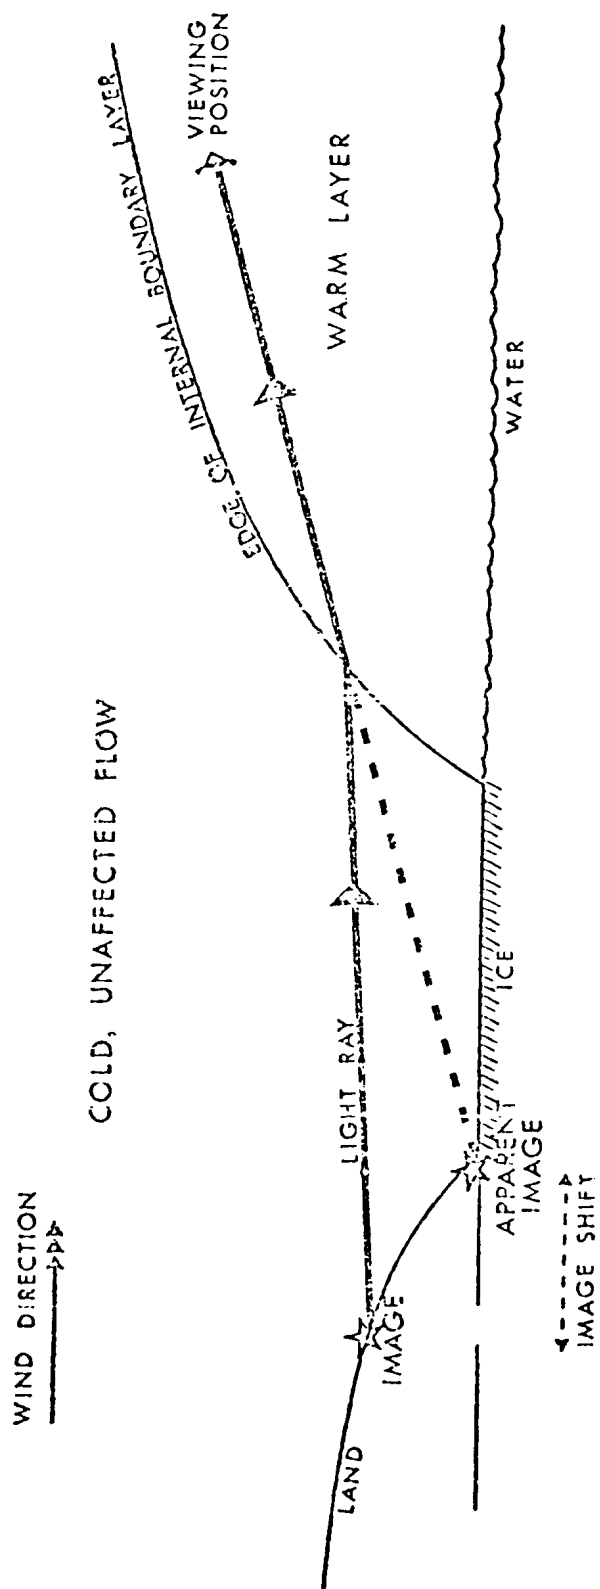
Figure 17-3.- Pictorial demonstration of image shifting due to internal boundary layer  
(Prepared by Dept. of Environment)

In his perceptual state the pilot-in-command interpreted the visual information as requiring an immediate steep descent. Misinterpretations could include: the ice/water line location; pitch-up from the dark/light difference; the ice being a cloud layer; or variations in light intensity and/or image shifting.

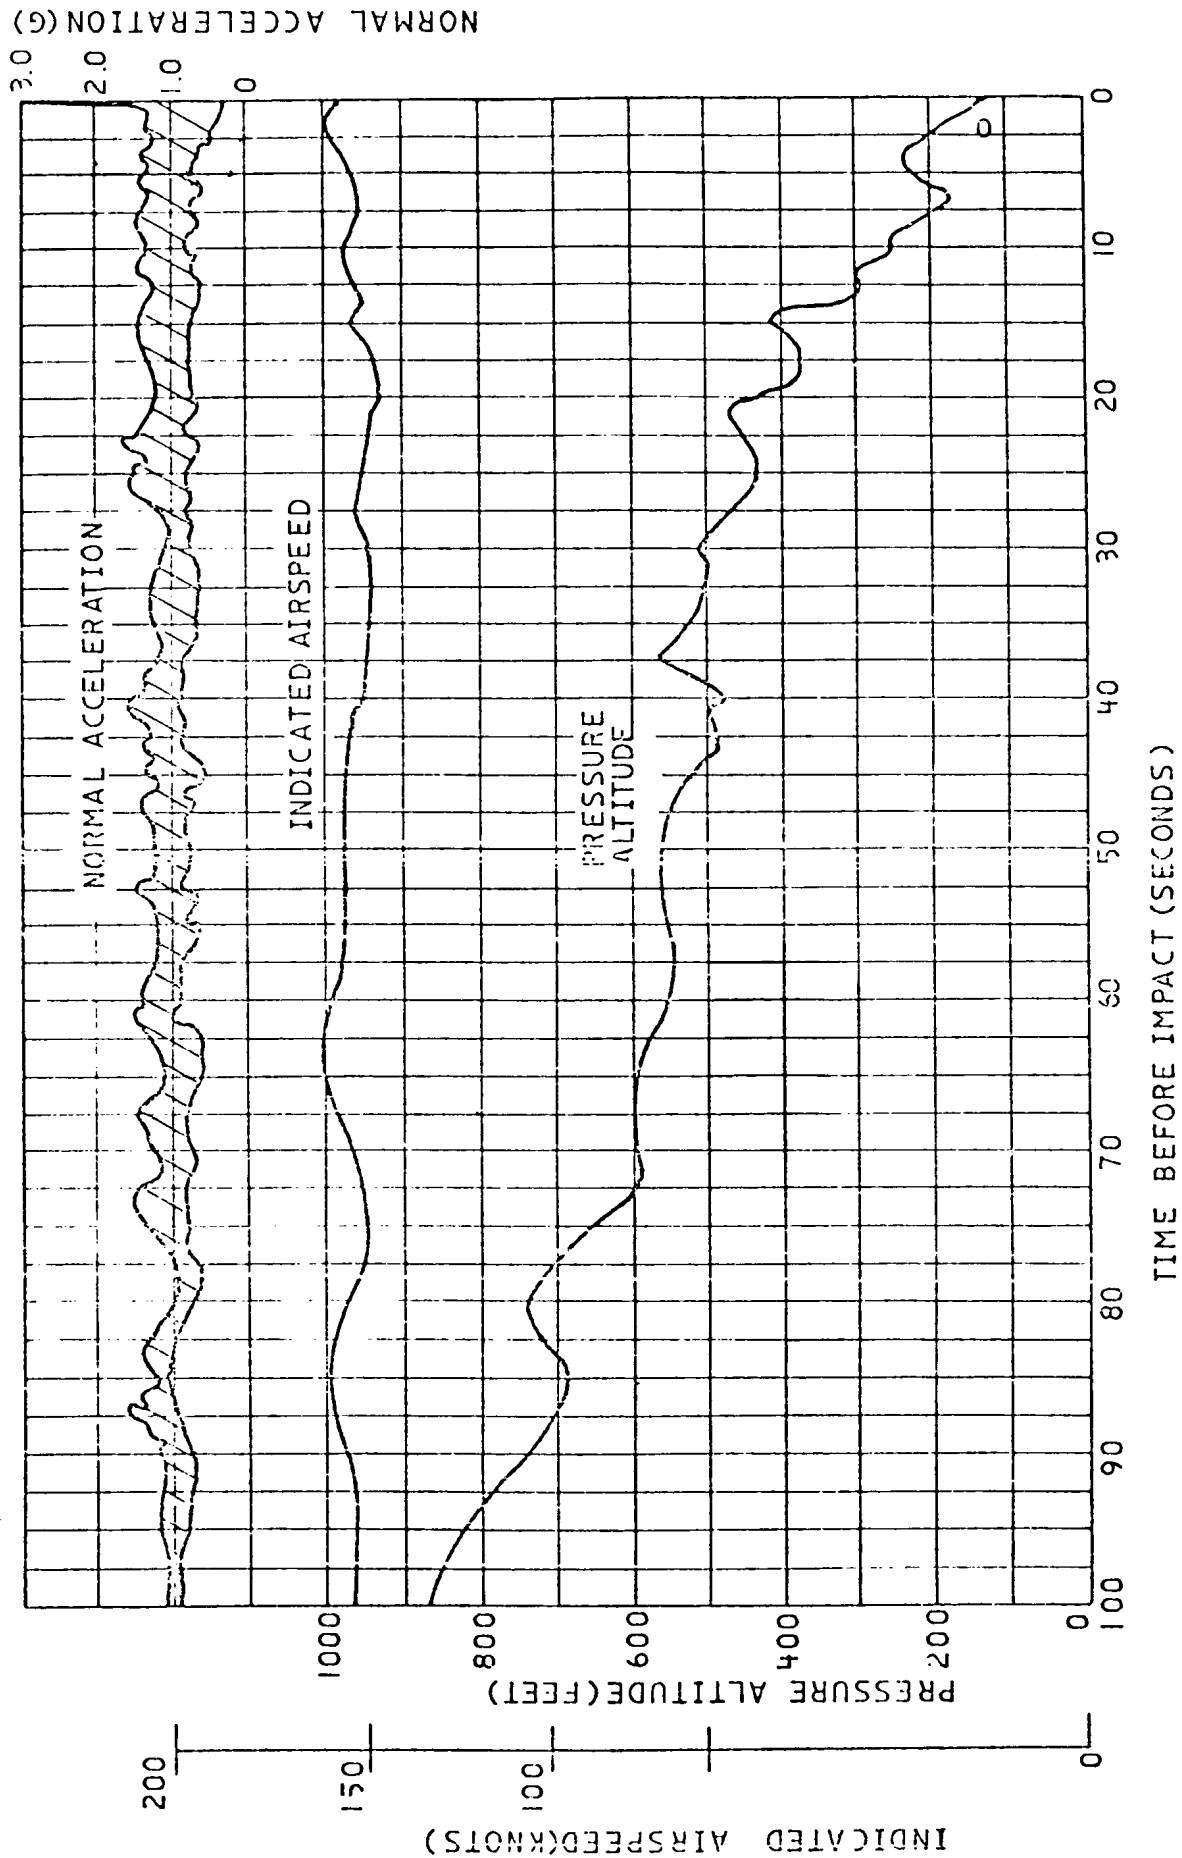
Figure 17-5.- Time histories of flight recorder data over last 100 seconds

The aircraft was equipped with a Fairchild A-100 cockpit voice recorder serial #1698 and a Fairchild 5424-221 flight data recorder serial #1301 although carriage of Flight Recorders is not required of a private operator. The rear section of the aircraft containing both recorders sank to the bottom of Byam Channel in about 100 ft of water. The recorders were subsequently recovered without any damage from the accident or the immersion in sea water. However, the cockpit voice recorder was found to be unserviceable due to a failure of an incorrect tape splice and the data recorder was found to have an inoperative heading stylus and reversed Pitot and static pressure connexions. The company had been advised of the reversed connexions subsequent to a previous accident. Time histories of altitudes and airspeeds were derived but with a reduced accuracy that resulted from the reversed connexions. The accuracy of the acceleration data was poor in the final stages of the approach due to vibration from turbulence. The data derived for the last 10 minutes of flight as well as an expanded version of the last 100 seconds is included.

The fluctuations in the derived pressure altitude over the last 40 seconds of the accident flight were studied in order to try and explain their presence and resolve why the final recorded altitude was at least 110 ft above sea level. It was obvious that the fluctuations were too rapid to represent genuine flight variations. However, there is no obvious explanation for the variations and no satisfactory corrections could be found to reduce them to a more realistic value. Since the altitude had to be derived from a combination of the altitude and air speed stylus positions, there is a combination of measurement errors that degrades the accuracy.
