1. Report No. NTSB-AAR-79-2		2. Government Accession No.		3. Recipient's Catalog No.	
4. Title and Subtitle Aircraft Accident Report - Allegheny Airlines, Inc., BAC 1-11, N1550, Rochester, New York, July 9, 1978				5. Report Date February 8, 1979

AIRCRAFT ACCIDENT REPORT

ALLEGHENY AIRLINES, INC.
BAC 1-11, N1550
ROCHESTER, NEW YORK
JULY 9, 1978

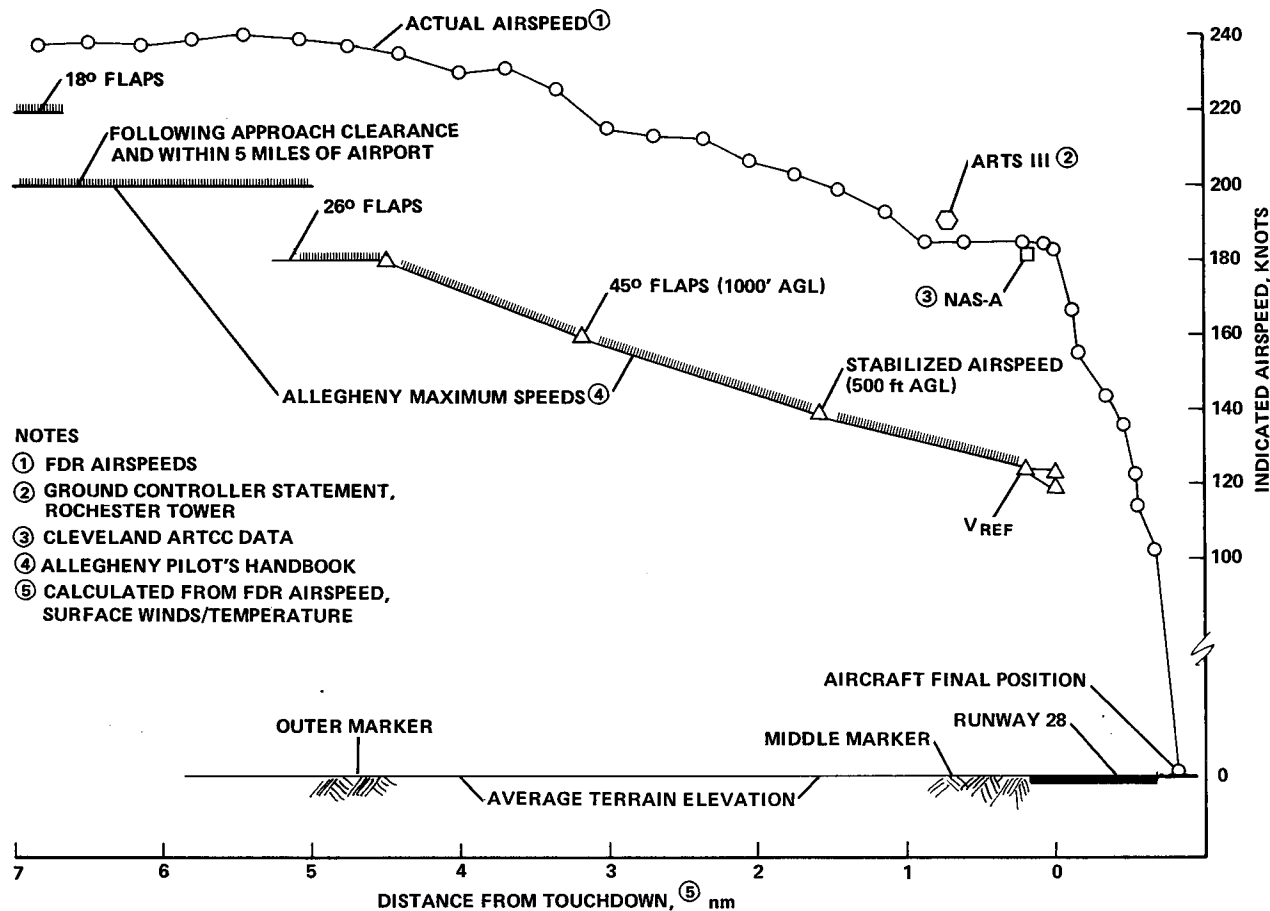
**COMPARISON OF AL-453 AIRSPEEDS WITH
ALLEGHENY MAXIMUM SPEEDS
ALLEGHENY AIRLINES, BAC 1-11, N1550
ROCHESTER, NEW YORK
JULY 9, 1978**

According to flight data recorder (FDR) information, the aircraft crossed the runway threshold at a speed of about 184 kns indicated airspeed (KIAS)--61 kns above V_{ref} . About 1750:08, the aircraft's nose wheel touched down on the runway about 2,540 ft down the runway at 163 kns. This was followed by the touchdown and subsequent failure of the right main landing gear tires at a point about 3,000 ft down the runway at a speed of about 159 kns. This was followed by the touchdown and subsequent failure of the left main landing gear inboard tire about 3,960 ft down the runway at 143 KIAS.

8. The crew failed to comply with recommended approach and landing airspeeds.
9. The approach was not made according to prescribed procedures and was not stabilized.

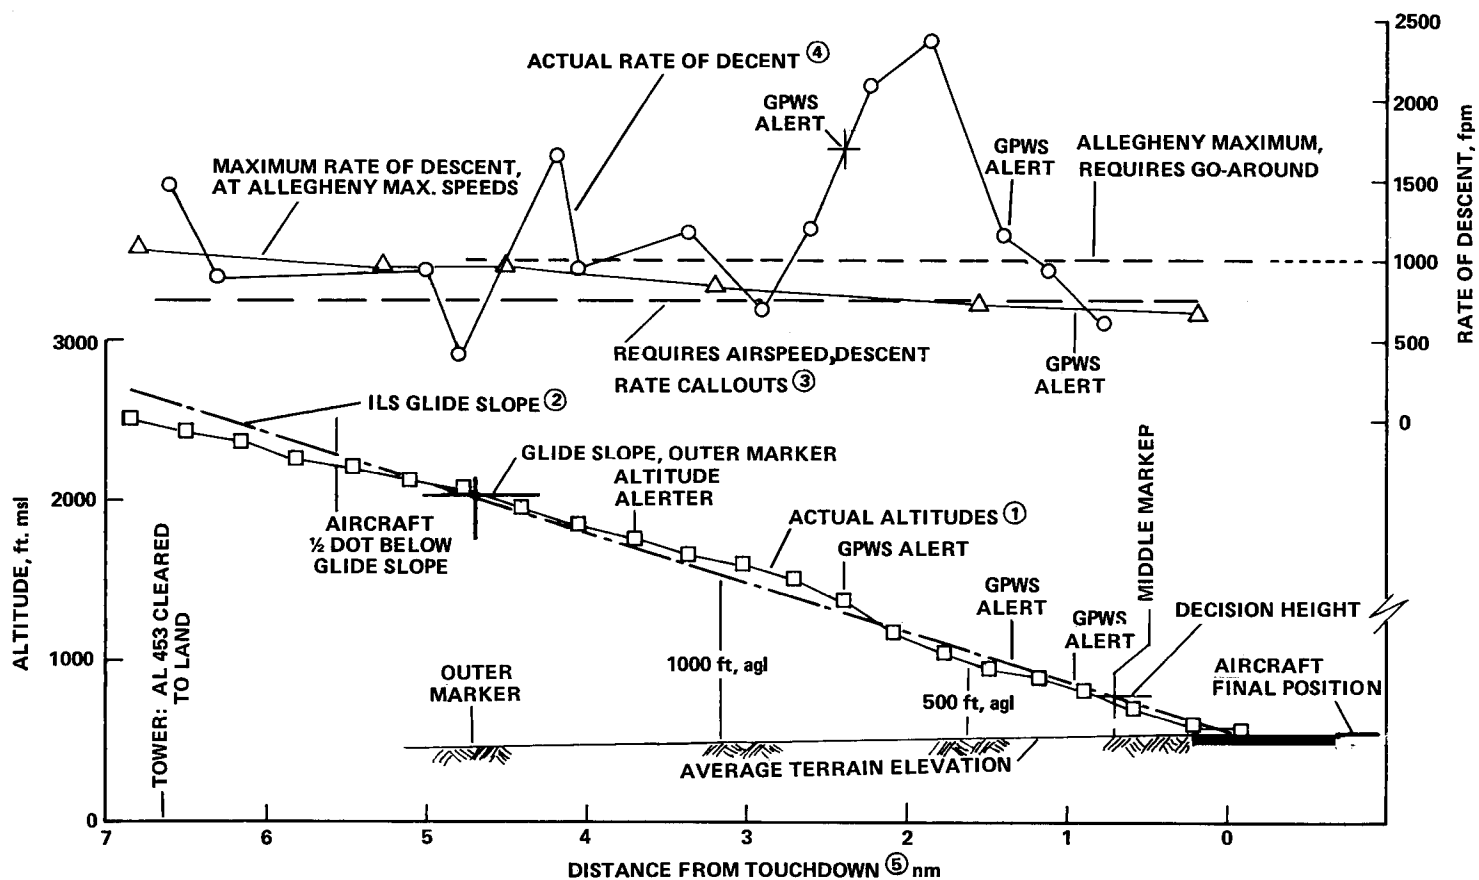
**COMPARISONS OF AL-453 ALTITUDES
AND RATES OF DESCENT WITH
ALLEGHENY AIRLINES, MAXIMUM LIMITS
ALLEGHENY AIRLINES, BAC 1-11, N1550
ROCHESTER, NEW YORK, JULY 9, 1978**

The dangerously high rates of descent of over 2,000 fpm within 2 miles of the threshold and the first GPWS alert should have indicated to the crew that the approach was improper and that a missed approach was necessary. None of the three GPWS alerts caused the crew to take the necessary corrective action even though company procedures dictated otherwise.

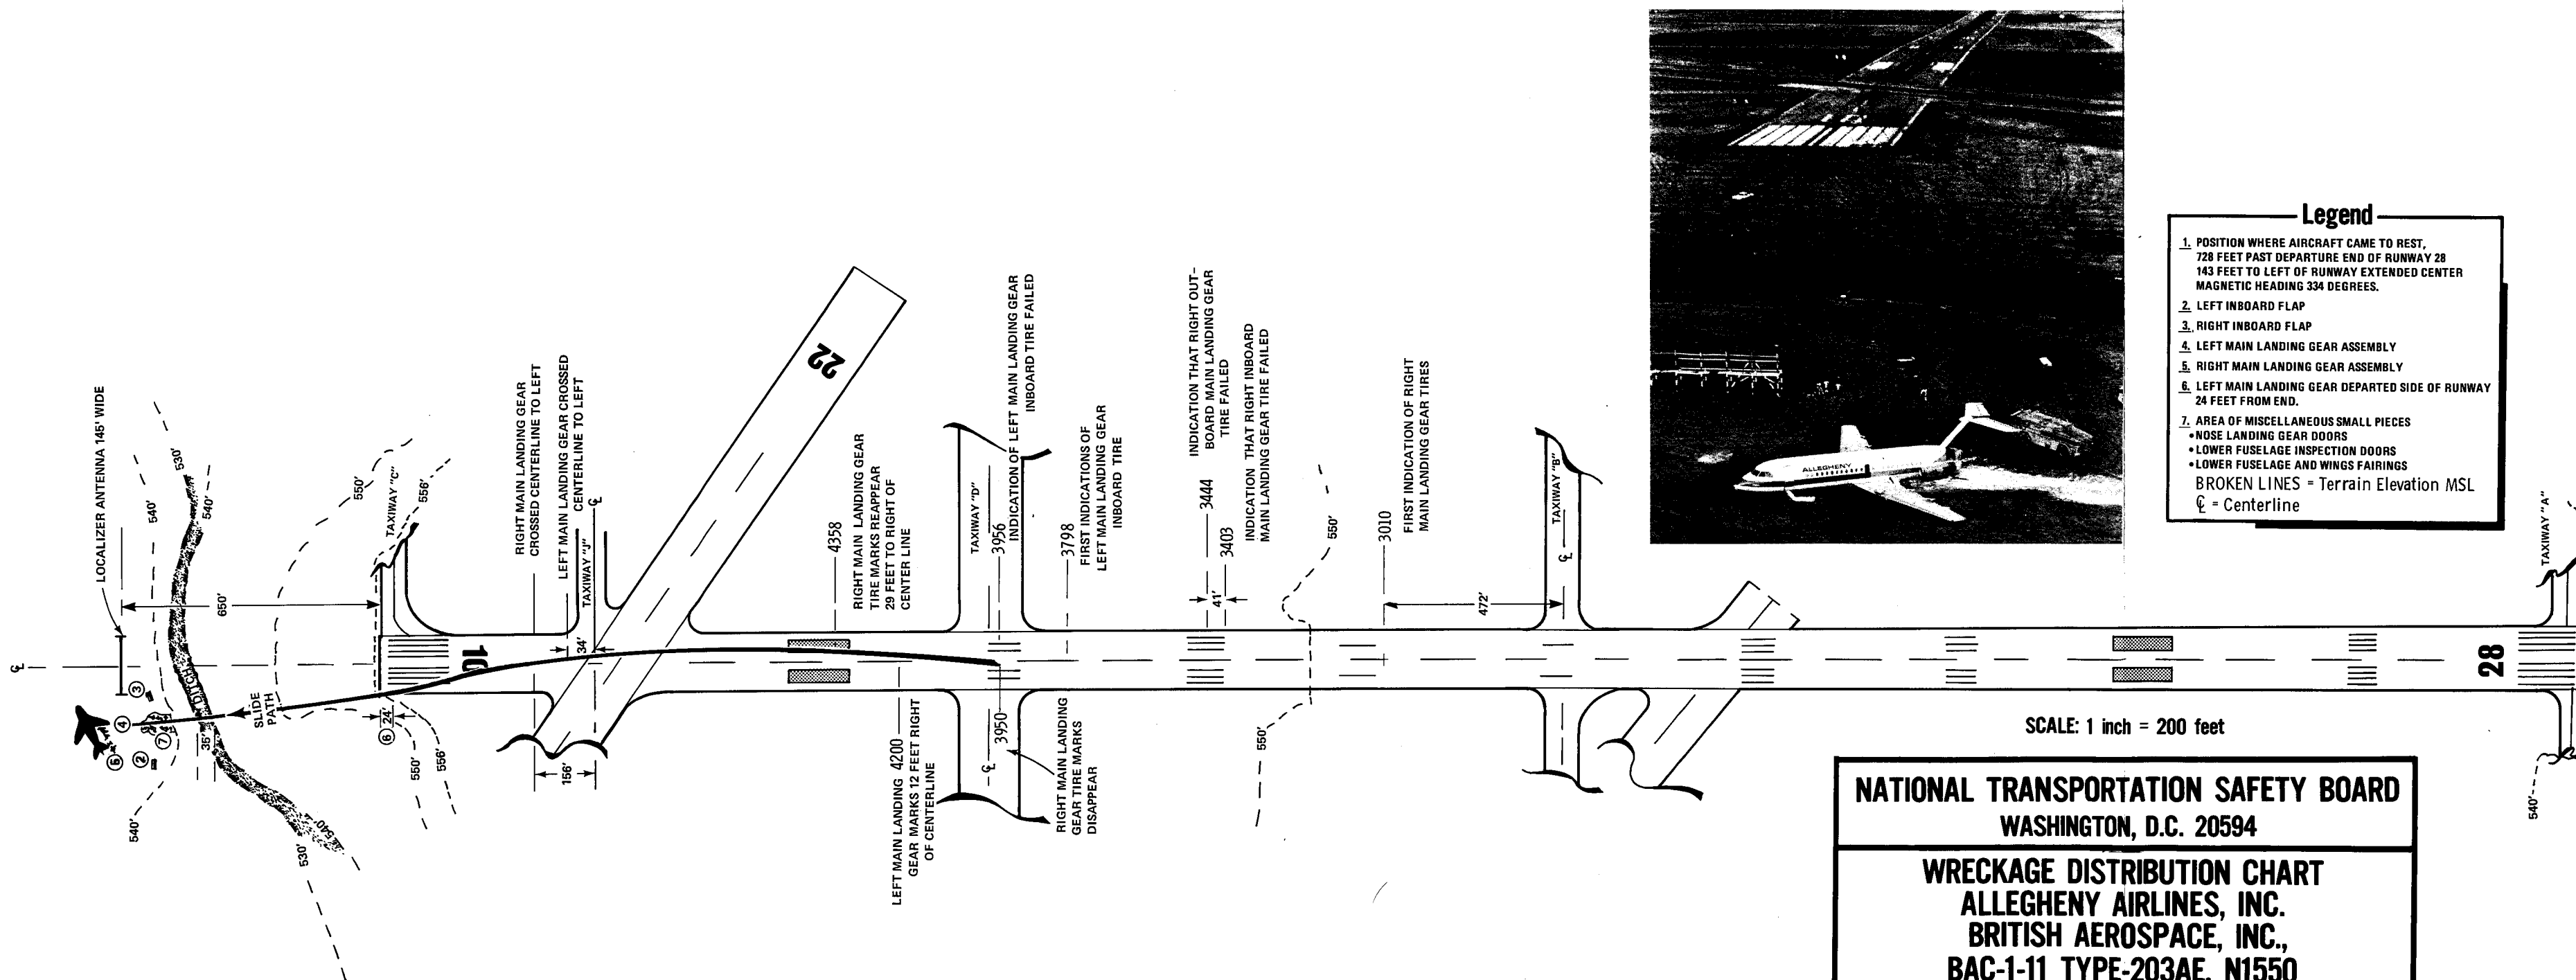
**WRECKAGE DISTRIBUTION CHART
ALLEGHENY AIRLINES, INC.
BRITISH AEROSPACE, INC.,
BAC-1-11 TYPE-203AE, N1550
ROCHESTER-MONROE COUNTY AIRPORT, NEW YORK
July 9, 1978**

About 7 sec after the inboard tire of the left main landing gear failed, the aircraft departed the end of the runway at a speed of about 102 kns. Following its departure from the end of the runway, the aircraft traveled about 425 ft down a gradual slope and then traversed a 35-ft-wide, 10-ft-deep drainage ditch. Impact with the drainage ditch caused the nose landing gear to collapse rearward and both main landing gear to separate from the aircraft. The aircraft continued on and came to a rest about 728 ft past the departure end of the runway, 143 ft to the left of the extended runway centerline, on a heading of 334° magnetic.

Before the aircraft came to rest, the left main landing gear was propelled over the fuselage. It impacted the top fuselage skin and came to rest adjacent to the left side of the aircraft. (See Appendix I.) The fuselage was creased and buckled in several areas. However, the empennage was not damaged.
