AVIATION INVESTIGATION REPORT

A16A0032

Collision with terrain

Mitsubishi MU-2B-60, N246W

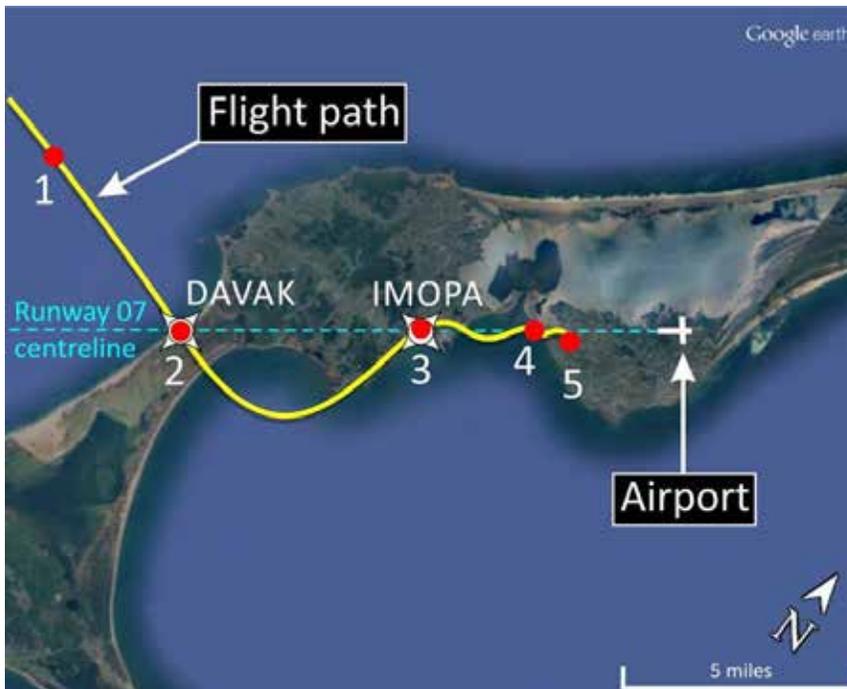
Figure 1. Flight path (Source: Google Earth, with TSB annotations)

At 1227:14, the aircraft crossed DAVAK on a heading of 114°M at 4500 feet ASL—1500 feet higher than the published procedure crossing altitude. The aircraft was descending at 1600 fpm and at an airspeed of 238 knots—about 100 knots above the recommended approach speed of 140 KIAS.¹² This resulted in the aircraft deviating significantly from the inbound course of 072° and subsequently proceeding on a meandering flight path.

Almost immediately afterwards, the aircraft crossed IMOPA—the final approach waypoint, 4.2 nm from the runway—at 2200 feet ASL, which is 790 feet above the published crossing altitude of 1410 feet ASL. The aircraft was descending at 1900 fpm, the speed was 188 knots—about 50 knots above the recommended approach speed of 140 KIAS—and the power levers remained at idle.

Immediately following the power application, the aircraft experienced an upset, yawed, and quickly rolled to the right, exceeding a 70° angle of bank, and then rapidly descended. The pilot was caught by surprise and reacted by trying to counteract these conditions. At approximately 150 feet AGL, the aircraft regained a wings-level attitude. However, the aircraft was still descending at a high rate and had not regained the loss of altitude resulting from the upset. During this time, the aircraft’s rate of descent increased from 1350 fpm, reaching a maximum of 4600 fpm. There was insufficient altitude to recover the aircraft.

1. 4.7 nm from DAVAK, 6800 feet ASL, 240 knots, 2500 fpm descent
2. At DAVAK, 4500 feet ASL, 238 knots, 1600 fpm descent (1500 feet above the published crossing altitude, about 100 knots above the recommended approach speed)
3. At IMOPA, 2200 feet ASL, 188 knots, 1900 fpm descent (790 feet above the published crossing altitude, about 50 knots above the recommended approach speed; gear and flaps should be set)
4. 2.7 nm from the runway, 1440 feet ASL, 1200 fpm descent, 175 knots, gear and flaps selected (the aircraft should be levelling at 620 feet ASL and slowing to 125 KIAS)
5. Impact: 1.4 nm from the runway and about 1000 feet south of the centreline

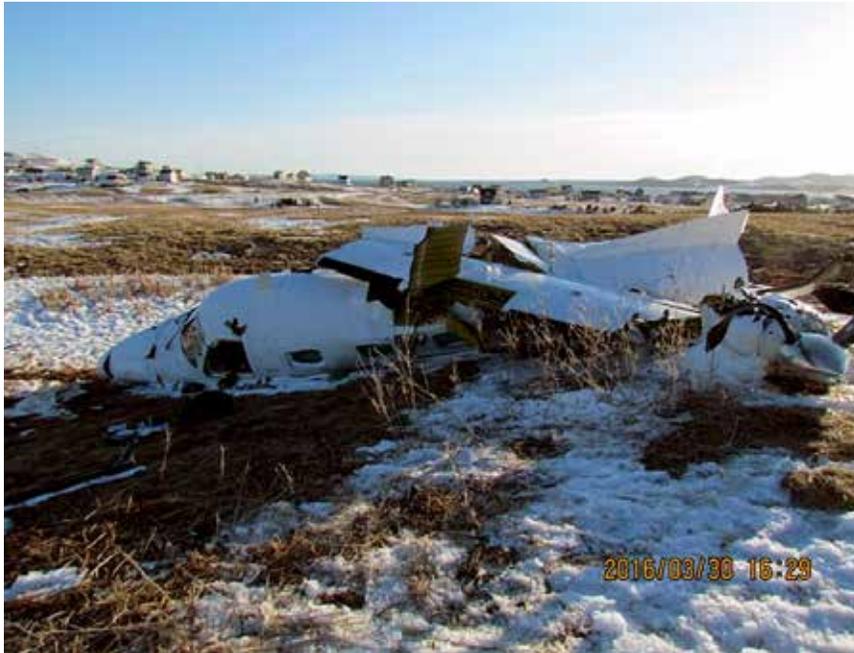
Figure 2. Accident site

During the impact sequence, the pilot's seat separated from its floor tracks. The passenger-pilot's seat remained connected to the cockpit floor. The bottom frame of both seats was deformed, and portions of the seats' structure failed. Both rows of aft-facing passenger seats separated from their supporting structure (floor and wall). The aft-facing passenger seat on the forward left side was not occupied during the occurrence flight. The 2 forward-facing passenger seats remained connected to the wall structure but separated from the floor structure.

The centre section of the wing remained on top of the fuselage, but was displaced to the left and rotated, indicating that its connections to the fuselage had failed. The upper fuselage section underneath the wing was visibly crushed by the weight of the wing. The cabin section was crushed and had an opening that extended across the top of the fuselage, terminating near the forward, lower corner of the main entrance door. As a result of the crushed cabin, only the occupant in the forward right seat had sufficient occupiable volume. The nose landing gear and the left main landing gear had separated, as had the empennage.

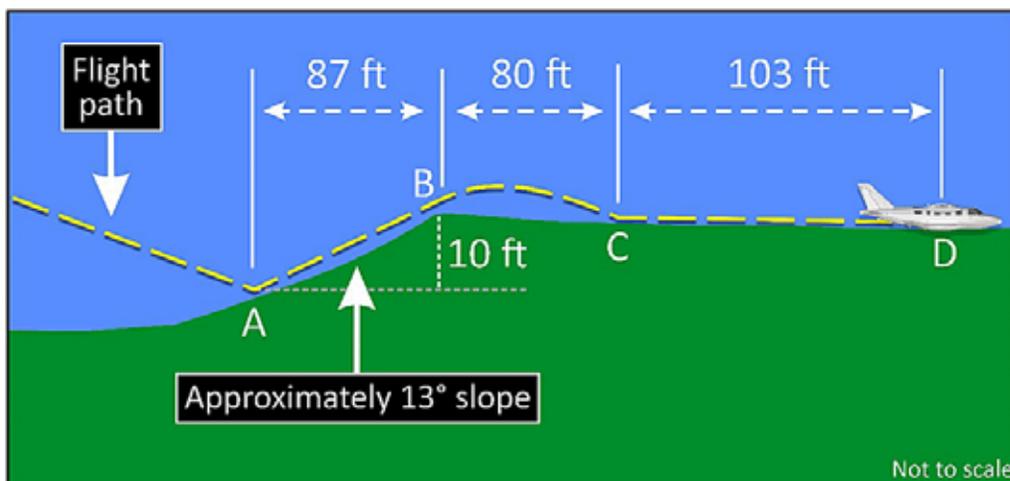
Figure 4. Impact sequence

During the approach to Runway 07, the aircraft struck the base of a hill in a left-wing-low, nose-high attitude, 1.4 nm west and 1000 feet south of the runway centreline (Figure 4). The aircraft momentarily became airborne again, then struck the ground and slid for about 100 feet before coming to rest.

- A First point of impact
 B Top of slope and end point of initial ground scars (aircraft airborne)
 C Second point of impact
 D Final resting position of main aircraft wreckage

Propeller strikes were found in the ground on both sides of the initial impact site: 3 strikes on the left side and 2 on the right side. Measurements of these strikes indicated that the engines were driving both propellers and producing power at impact. Based on the analysis of the propeller strikes and the flight data, the investigation determined that the aircraft struck the ground at a ground speed of about 100 knots and a descent rate of approximately 4000 fpm.
