NATIONAL TRANSPORTATION SAFETY BOARD

AIRCRAFT ACCIDENT REPORT

SWIFT AIR LINES, INC.
NORD 262, N418SA
MARINA DEL REY, CALIFORNIA
MARCH 10, 1979

NTSB-AAR-79-13

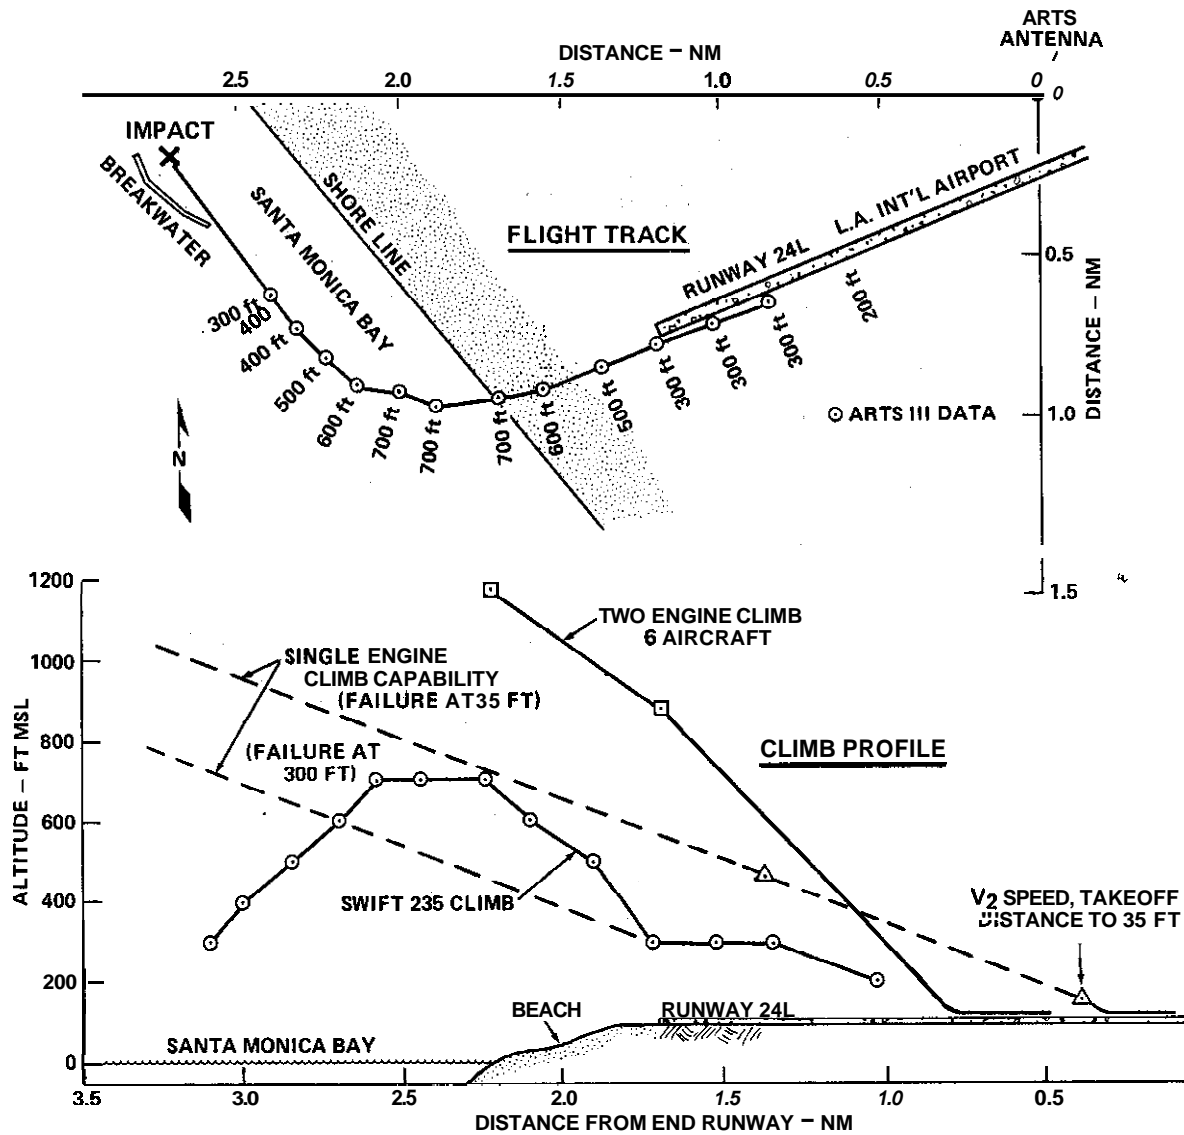
After the accident, the two-engine climb performance was recorded for six similarly loaded Nord 262 flights. (See figure 2.) These aircraft gained about 800 ft of altitude at the end of the runway and 1,200 ft at the shoreline. The expected single-engine climb performance data were extracted from the Nord 262 performance manual. (See figure 2). For Flight 235's takeoff conditions, the calculated single-engine climb gradient was 310 ft per nautical mile. This would mean that the aircraft should have crossed the departure end of the runway at an altitude of about 550 ft, or 250 ft higher than its actual crossing altitude.

Figure 2. Flight track and climb profile Swift Aire Lines, Inc., N418SA, Los Angeles, California, March 10, 1978.
