Final Report on aircraft accident

Case no: **2015-075-F-021**

Date: **9. August 2015**

Description: **Aircraft crashed in a narrow valley with a low cloud base, while attempting to turn around**

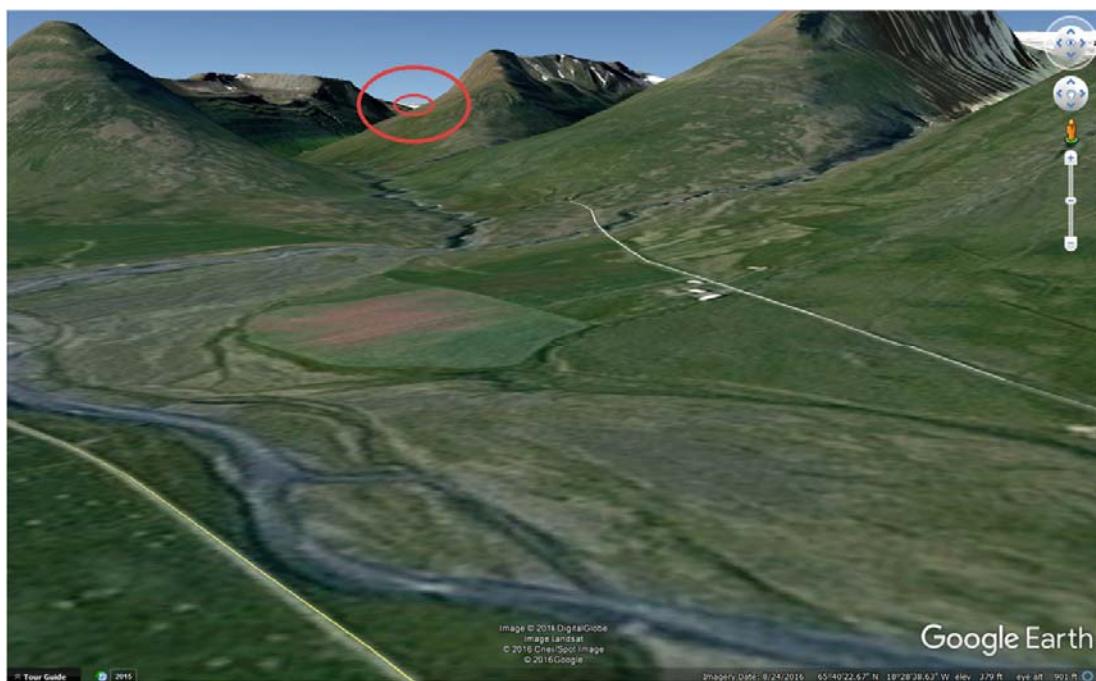
Figure 4: Red circles indicates area of suspected break in clouds in Barkárdalur

The airplane was then flown towards the heath/ridge of Hörgárdalsheiði at the head of the valley of Hörgárdalur [Item 7 on Figure 1]. According to the PF the cloud base was blocking off the heath/ridge of Hörgárdalsheiði, so they turned around again. According to the PF they had the option of flying around the whole mountainous peninsula of Tröllaskagi¹², but that would result in an hour being added to the flight time. When they reached the ridge of Staðartunguháls again, the pilots noticed what looked like a break in the cloud cover above the head of the valley of Barkárdalur out the left window (Figure 4). They therefore decided to make the 3rd attempt to fly across the peninsula of Tröllaskagi, now via the valley of Barkárdalur. Various landmarks and locations being mentioned in this chapter are shown in Figure 5 and Figure 6.

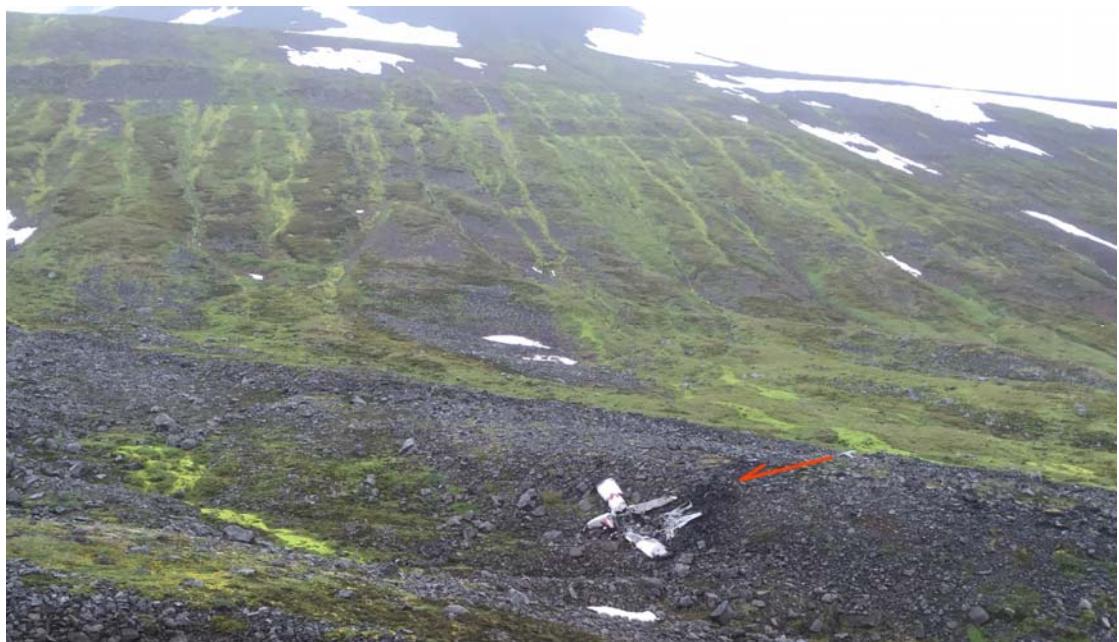
Figure 7: The accident site (the arrow showing the direction of the crash)

The airplane skidded across a rock covered ridge, see arrow in Figure 7. Parts broke off the airplane and the wing tips hit the ridge, tearing up the wing tip fuel tanks, causing fires. The floats broke from underneath the airplane fuselage, causing the fuselage bottom to tear up and fire to start when the airplane skidded off the ridge and then came to rest on the other side of the rocky ridge.

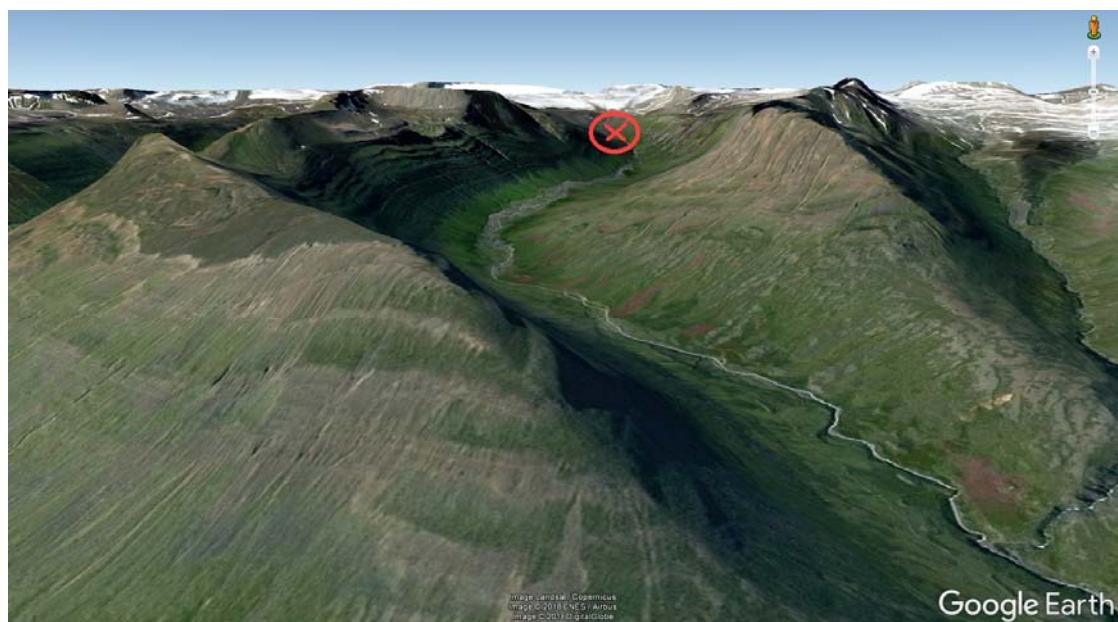
Figure 14: The valley of Barkárdalur (Accident site marked with X inside red circle)

The valley of Barkárdalur (see Figure 14) is a long narrow valley with 3000 – 4500 feet high mountain ranges extending on either side. In the aft third of the valley the valley floor rises rapidly. Along the track of the last 2 miles before the accident site, the valley floor rises from 1320 ft up to 2260 ft, or by 940 ft. The accident site was located at an elevation of 2260 ft, at $65^{\circ} 39' 46.2''$ N, $018^{\circ} 46' 40.9''$ W. The elevation of the mountain passage at the head of the the valley of Barkárdalur is approximately 3900 ft.

The ITSB determined that the pilots failed to take note of the geometry of the valley of Barkárdalur, namely its narrow width and fast rising floor towards its head. This fact along with limited performance of the airplane would have indicated that clearing the passage at the head of the valley of Barkárdalur or turning around would have been almost impossible for this particular airplane in its overweight condition.

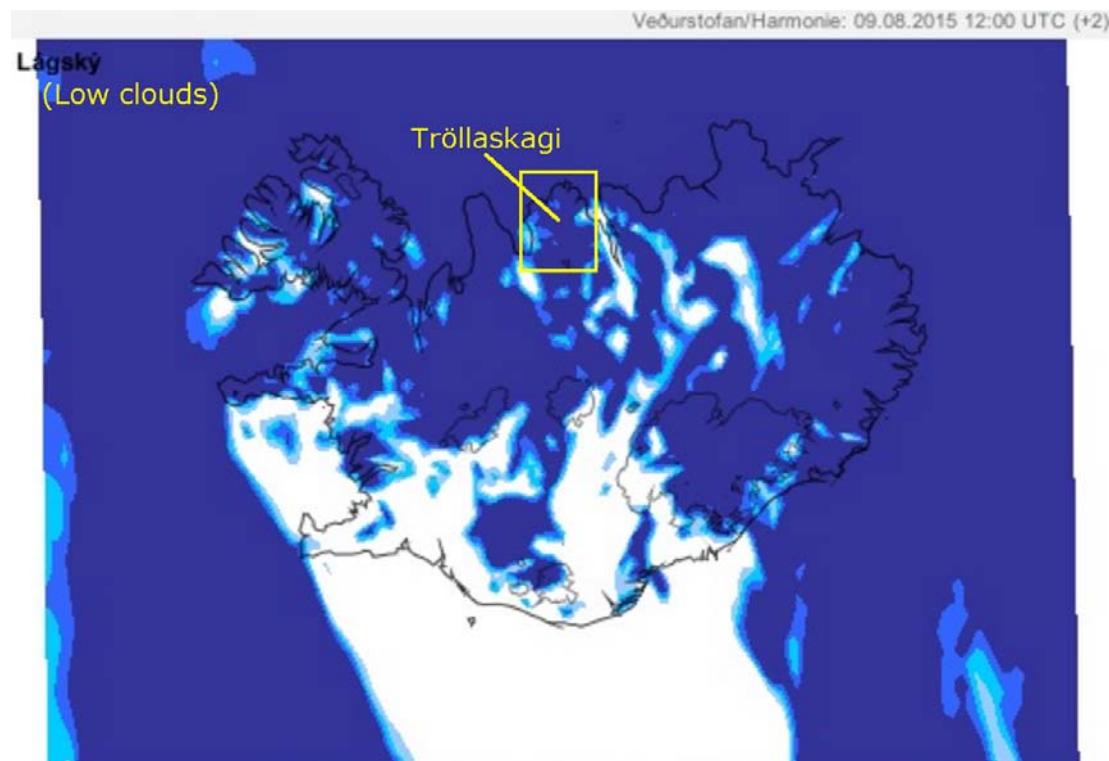
Figure 15 Low clouds (shown in blue) forecasted over Iceland at 14:00 on the day of the accident

The ITSB collected the weather data that was available on the IMO website, before the flight. Figure 15 shows the low cloud cover forecasted over Iceland at 14:00²⁰ on the day of the accident. The low cloud ceiling forecast issued at 12:00 on the day of the accident for the time period around 14:00 which is shown in Figure 15 is based on the “HARMONIE” high resolution weather model from the IMO. According to the model, the weather conditions did not support VFR flight from Akureyri to Keflavik, across the peninsula of Tröllaskagi.

The ITSB collected the weather data that was available on the IMO website, before the flight. As can be seen in Figure 15, a low cloud cover was forecasted over Iceland at 14:00²⁷ on the day of the accident. According to the IMO forecast for flight conditions over Iceland, valid 12:00 to 17:00 at the day of the accident, the cloud ceiling was BKN/OVC between 800 and 2500 ft in northern Iceland and poor visibility in rain or drizzle. Furthermore the IMO forecast stated for visual flight conditions between parts of Iceland, that VMC did not exist in the northern part of Iceland. According to Figure 17 the weather forecast, prior to the departure at the day of the accident (August 9th), VFR conditions would not exist over the highlands on the route between Akureyri Airport and Keflavik Airport, until August 11th.

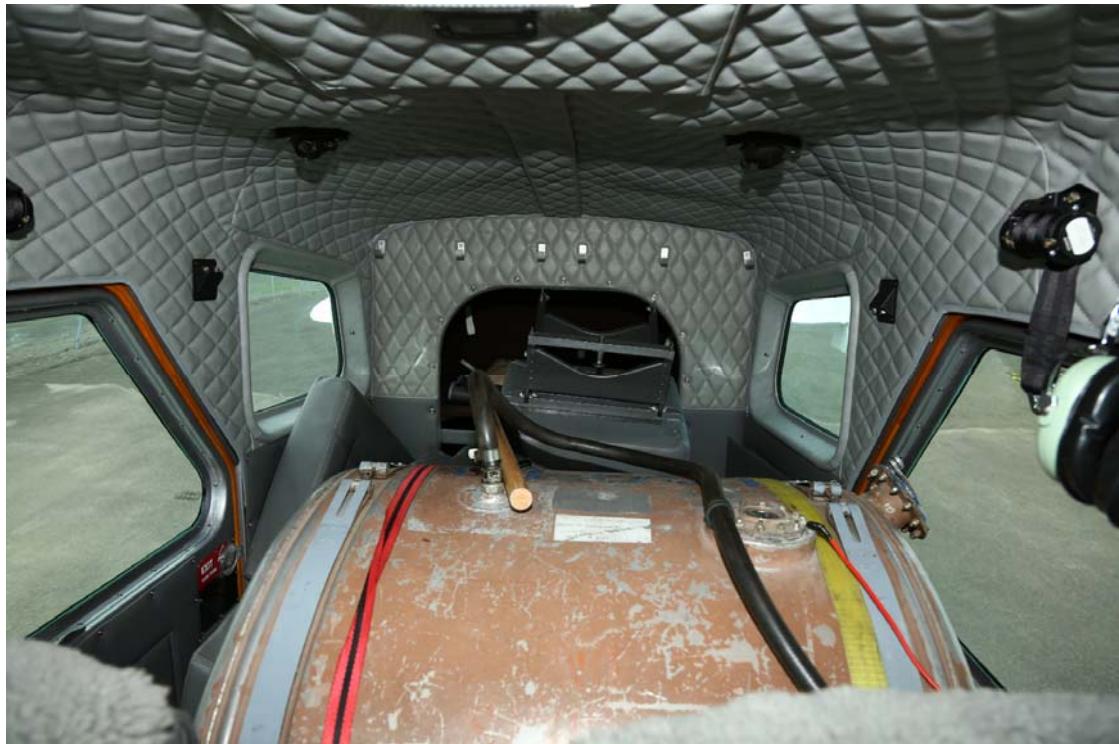
Figure 20: Picture showing the installed ferry fuel tank and the 2nd seat row in the aft part of the cabin

As mentioned in the chapter 2.1.2. Fueling, the investigation revealed that the ferry fuel tank contained 118 – 219 liters of fuel before takeoff. The investigation also revealed that a fuel line was connected to the ferry fuel tank on the tank side (see

Figure 20). The ITSB could however not verify whether this fuel line was connected to the airplane's fuel system due to the severe damage from the fire. The ITSB investigation also revealed that prior to the accident flight, the co-pilot's seat remained installed and the seats that had been removed to fit the ferry fuel tank in the 2nd seat row were stored in the aft most section of the cabin, behind the ferry fuel tank and on top of the third seat row. See Figure 20, taken during the preparation of the flight on August 8th, 2015.

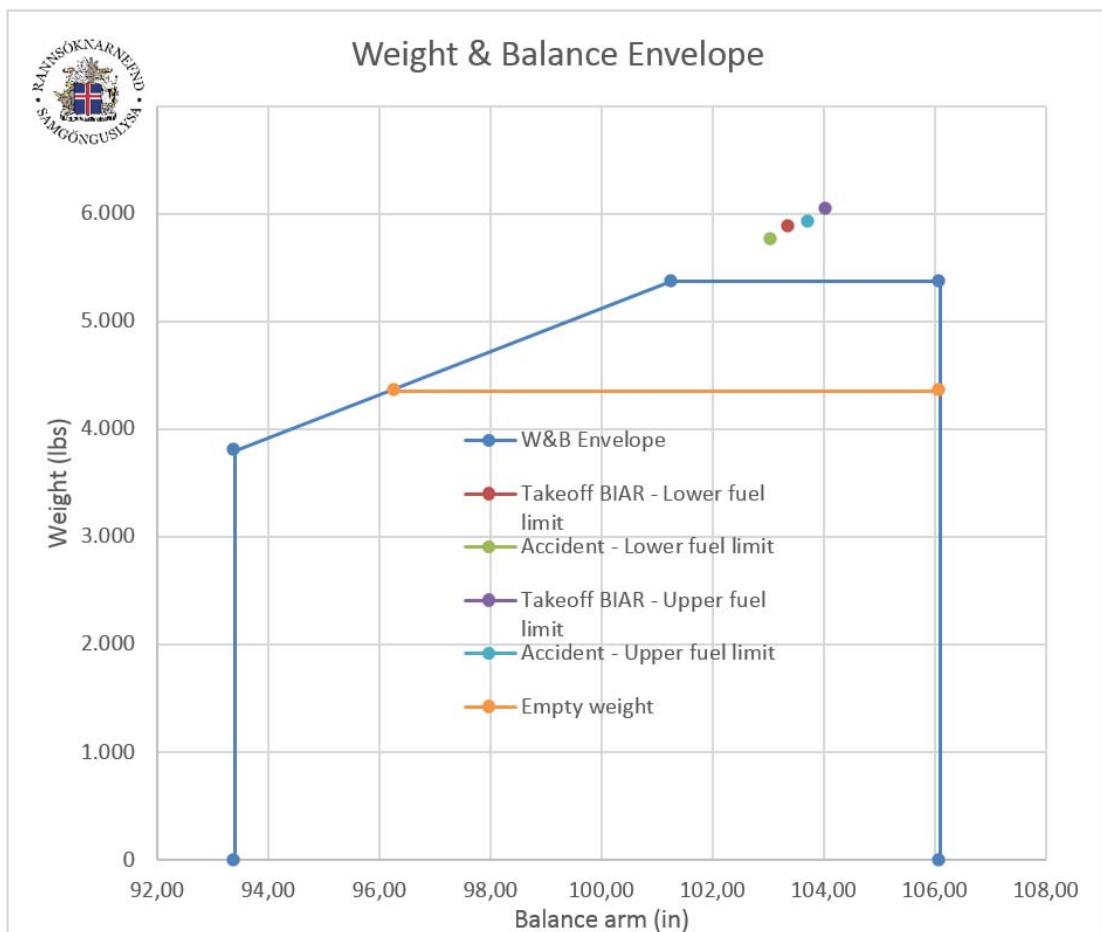
Figure 21: Calculated Weight & Balance for airplane N610LC at the time of the accident

At the time of the accident, the airplane had been flown for about 45 minutes. The calculations revealed that at the time of the accident the weight of the airplane was between 5760 lbs. and 5919 lbs. This was between 390 lbs and 549 lbs over the airplane's maximum gross weight. The airplane was therefore found to be outside its allowable weight limits when the accident occurred.

The weight of the airplane, in relation to its weight and balance envelope can be seen in Figure 21. Details on the weight & balance calculations can be seen in Appendix B.

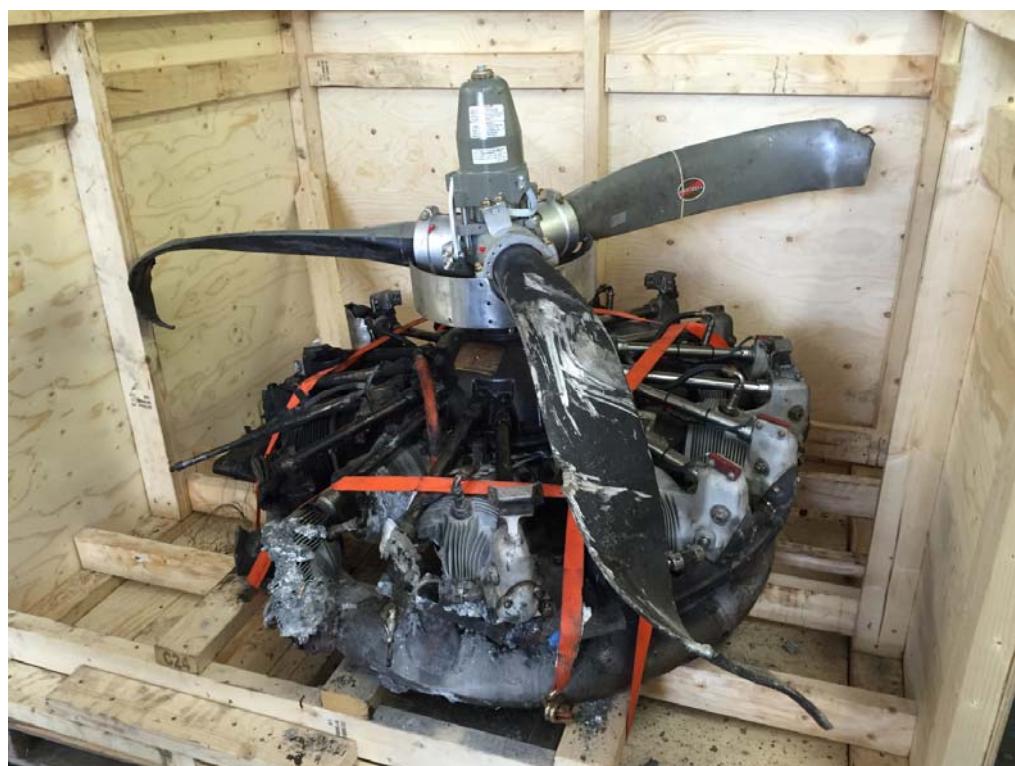
Figure 22: The engine and propeller from airplane N610LC shipped for teardown inspection

The engine and the propeller were sent for a teardown inspection (see Figure 22) at a facility in the United States of America, specializing in overhauling and rebuilding Pratt & Whitney R985 series engines. Present for the teardown inspection, in addition to the facility's specialists performing the inspection, was the IIC²³ from the ITSB, the ACCREP²⁴ from the NTSB, two representatives from the FAA and a propeller specialist from the propeller manufacturer.

The overall condition of the engine at the time of flight could not be determined, due to the absence of the engine's rear accessory case, blower assembly and critical accessories such as the magnetos and carburetor. These parts in the aft section of the engine were manufactured out of magnesium and had burned away during the post accident fire. The teardown inspection of the engine parts that had survived the fire did however conclude that no internal mode of failures had occurred to those parts prior to the accident and no possible cause of the lack of engine performance was found.

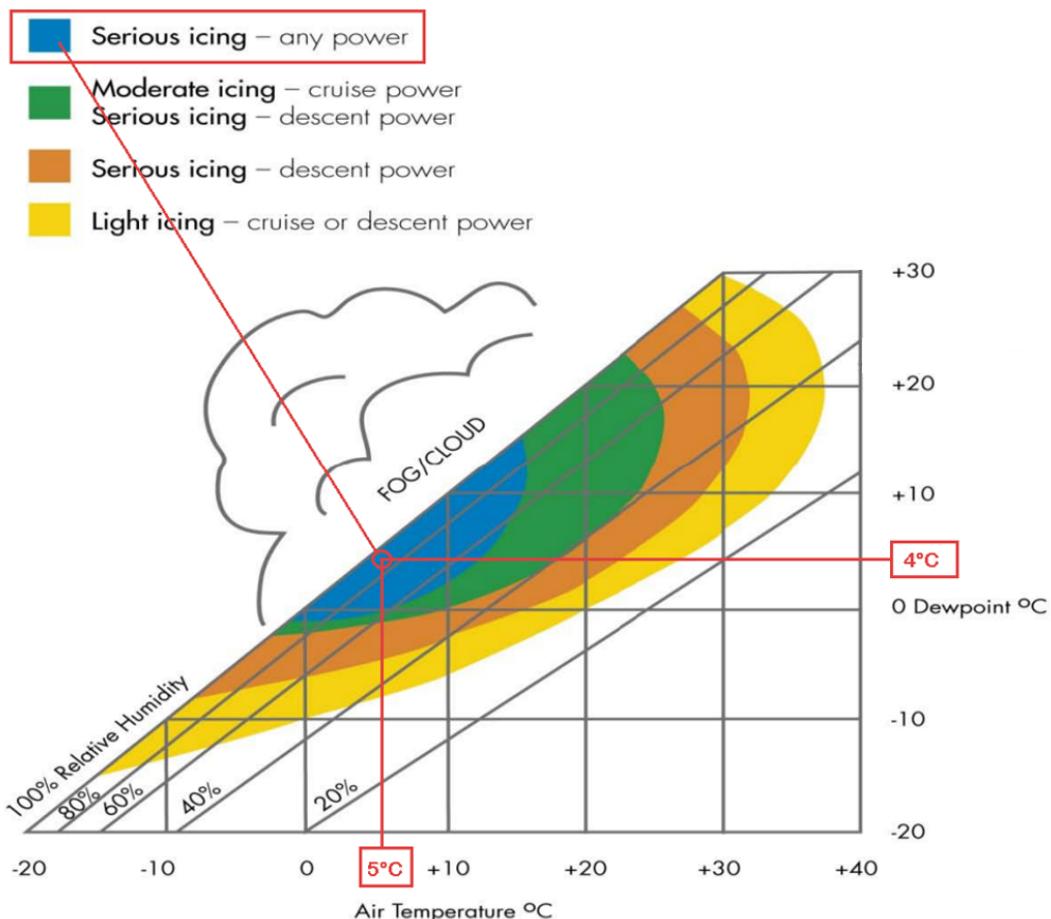
Figure 23: Carburetor icing conditions at the accident site at the time of the accident²⁵

The ITSB analyzed the weather in the valley of Barkárdalur at the time of the accident with regards to possible carburetor icing. According to the analysis, as shown in Figure 23, it is highly likely that carburetor icing occurred before the accident.

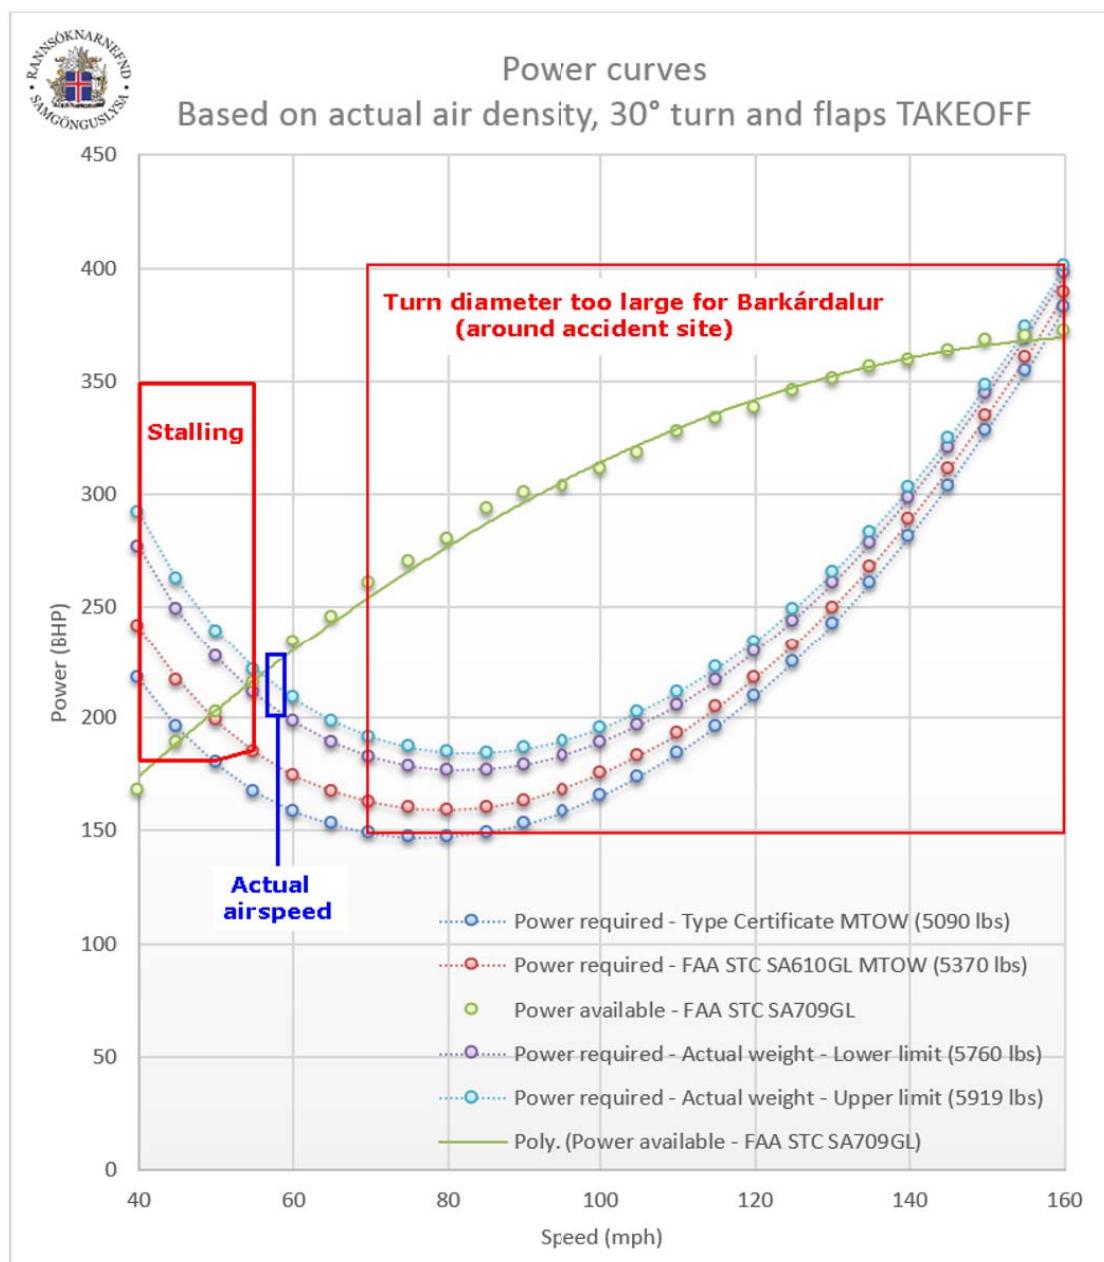
Figure 24: Power curves for 30° turn – Power available barely meets power required

As can be seen in Figure 24, performing a 30° turn at an airspeed just below 60 mph (the airspeed at which the turn was attempted) would have been fine with regards to the airplane's type certificate MTOW of 5090 lbs or its STC SA610GL MTOW of 5370 lbs. However, when taking into consideration the upper and lower limits for the airplane's actual weight, a 30° turn at an airspeed just below 60 mph resulted in the power available just barely exceeding the power required.

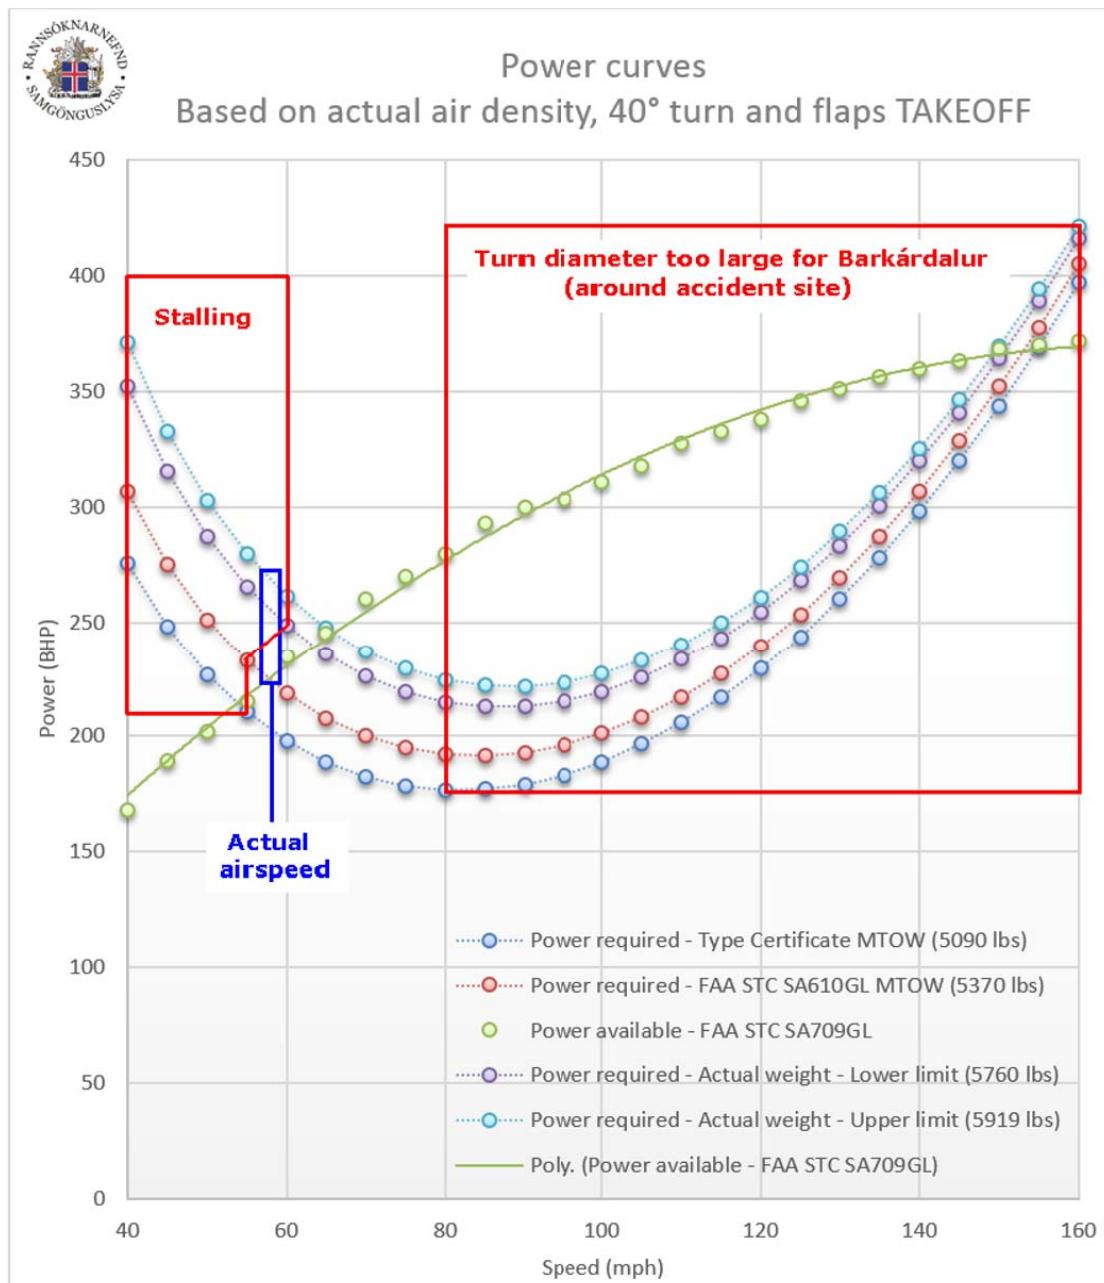
Figure 25: Power curves for 40° turn – Airspeed too low, stalling and power required exceeds power available

When the bank angle was then increased to 40°, the performance became insufficient. As can be seen in Figure 25, a 40° turn at an airspeed just below 60 mph resulted in the power required exceeding the power available, while at the same time the airplane was about to stall due to its overweight condition. The PF states that the airplane did not reach this stall condition during the turn. The ITSB believes he reason why the airplane lost altitude when the turn was executed can be explained by the fact that the power required exceeded the power available.

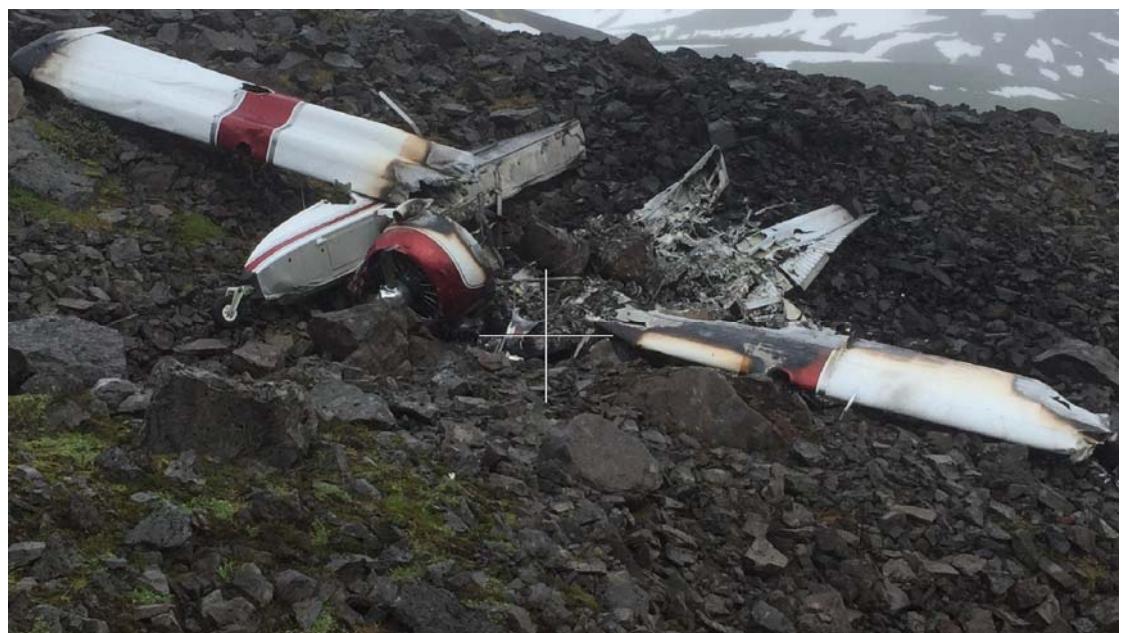
Figure 26: The wreckage of N610LC after the accident

The wing tips hit the ground as the aircraft skidded across a ridge. The fuel tanks in the wing tips ruptured and several fires started on the ridge that the airplane skidded across. The main fuel tanks in the airplane fuselage also ruptured and fuselage fire started when the airplane came to rest on the other side of the ridge. The complete fuselage section of the airplane was on fire within 2-3 minutes after the crash and there were indications of explosions of the fuel tanks.

The fire reached such a temperature that the aluminum in the fuselage and tail section of the airplane, as well as the complete interior, burned to such an extent that molten aluminum¹⁷ was found on the rock under the wreckage. There were mostly steel¹⁸ parts such as control cables and components that remained. From this the ITSB estimates the fuselage cabin fire temperature to have been between 700°C and 1500°C. The fuselage cabin fire self-extinguished within 25 minutes.

Fire also started in the aft section of the engine casing which was made out of magnesium. The magnesium fire was to the extent that the complete aft portion of the engine casing was burnt away. This engine fire lasted approximately 2-3 hours.
