NATIONAL TRANSPORTATION SAFETY BOARD

AIRCRAFT ACCIDENT REPORT

REDCOAT AIR CARGO, LTD.
BRISTOL BRITANNIA 253F, REGISTRATION G-BRAC
BILLERICA, MASSACHUSETTS
FEBRUARY 16, 1980

NTSB-AAR-81-3

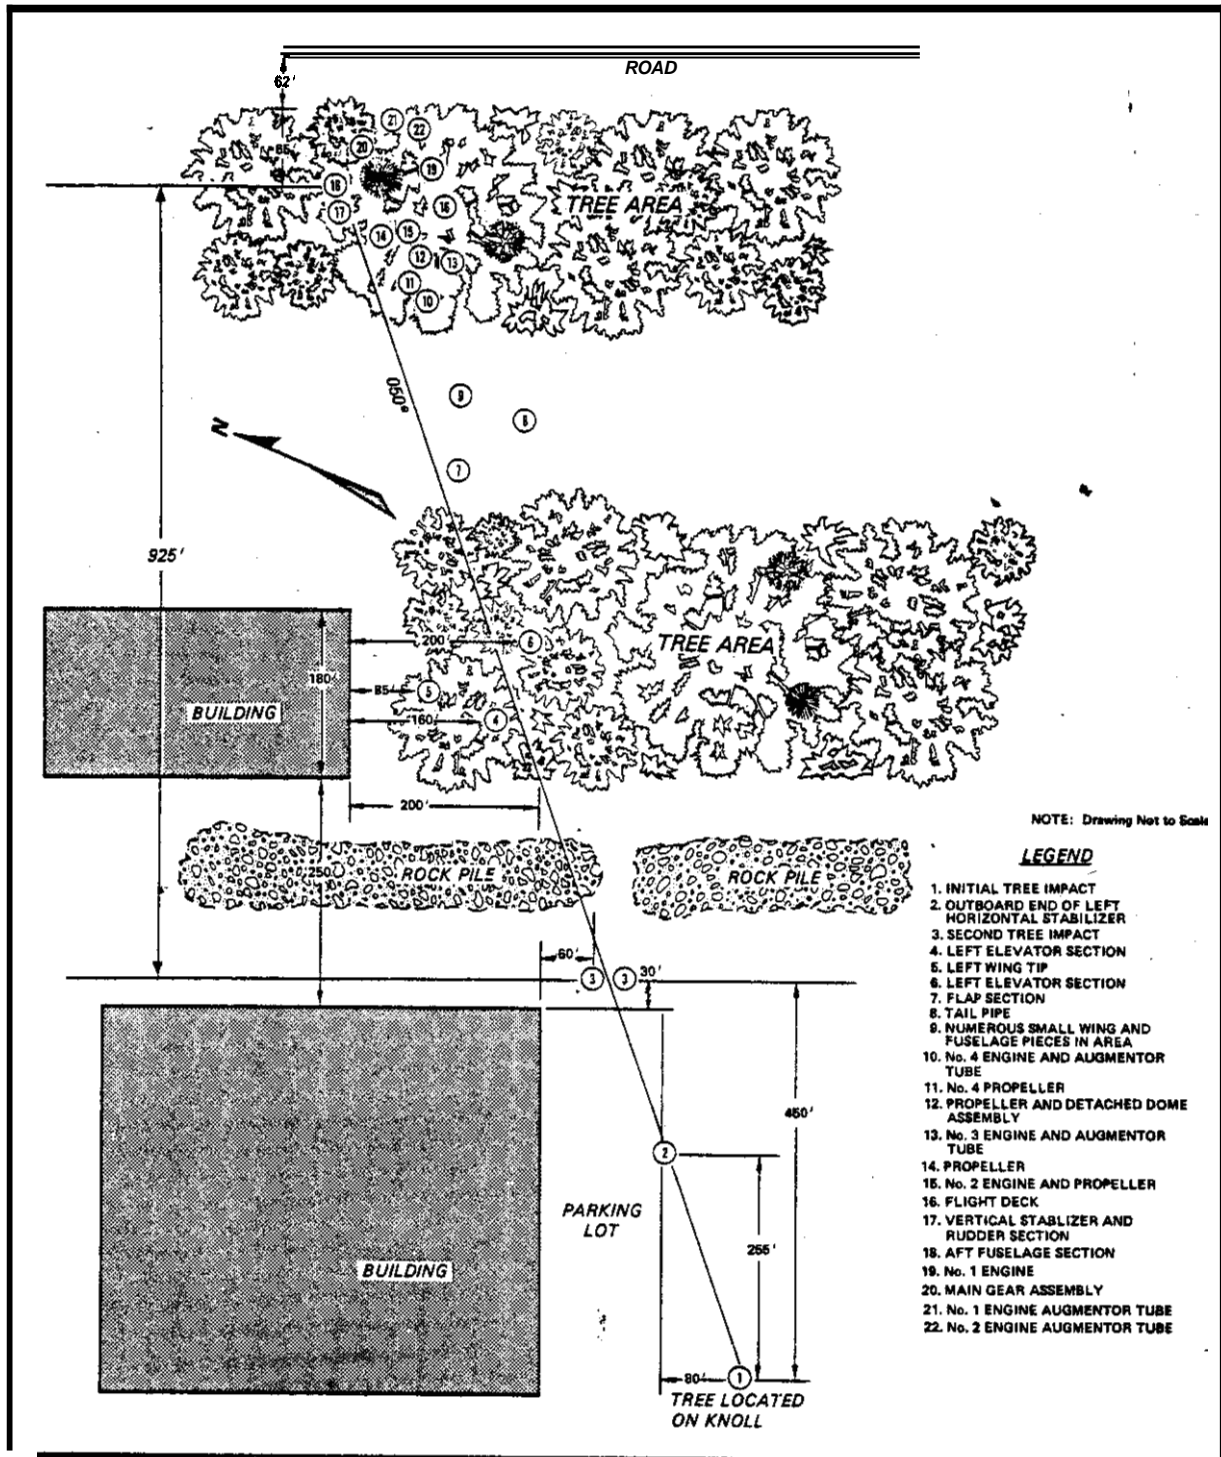
APPENDIX E WRECKAGE DISTRIBUTION CHART

The aircraft passed through trees and struck the ground on a magnetic heading of 050°. (See appendix E) It initially struck a tree about 60 ft above the ground adjacent to a parking lot. A portion of the left horizontal stabilizer was found about 255 ft beyond initial tree contact. There was no evidence of other tree contact for about 450 ft, where several tree tops were broken. The aircraft, continued over a relatively clear area with no ground contact. About 700 ft beyond the initial impact area, the aircraft passed through a thick stand of trees for about 250 to 300 ft. The swath through these trees was immediately adjacent to a building north-northwest of the trees. The swath indicated that the aircraft was in a right bank of about 30° to 45° as it cut through the trees. The proximity of the adjacent building was such that the left wingtip had passed just above the top of the building, which was about 40 ft high. Portions of the left elevator, left horizontal stabilizer, and left wingtip were found among the trees under the swath.

The aircraft struck the ground about 200 ft beyond the last stand of trees, slid across an open area, and entered another stand of trees where it came to rest. The wreckage path was about 1,502 ft from initial tree impact to where the farthest portion of the fuselage came to rest. The width of the swath and wreckage scatter was about 200 ft. The aircraft slid into the last stand of trees; with its nose to the right. The remains of the cockpit structure and nose section, including the nose landing gear, were found along the right side of the crash path. The aircraft broke up considerably during the crash sequence, especially in the forward fuselage and wing areas. The engines and propellers were damaged severely and disrupted during the impact.
