AIRCRAFT ACCIDENT REPORT

MCDONNELL DOUGLAS CORPORATION,
DC-9-80, N1002G,
YUMA, ARIZONA,
JUNE 19, 1980.

NTSB-AAR-81-16

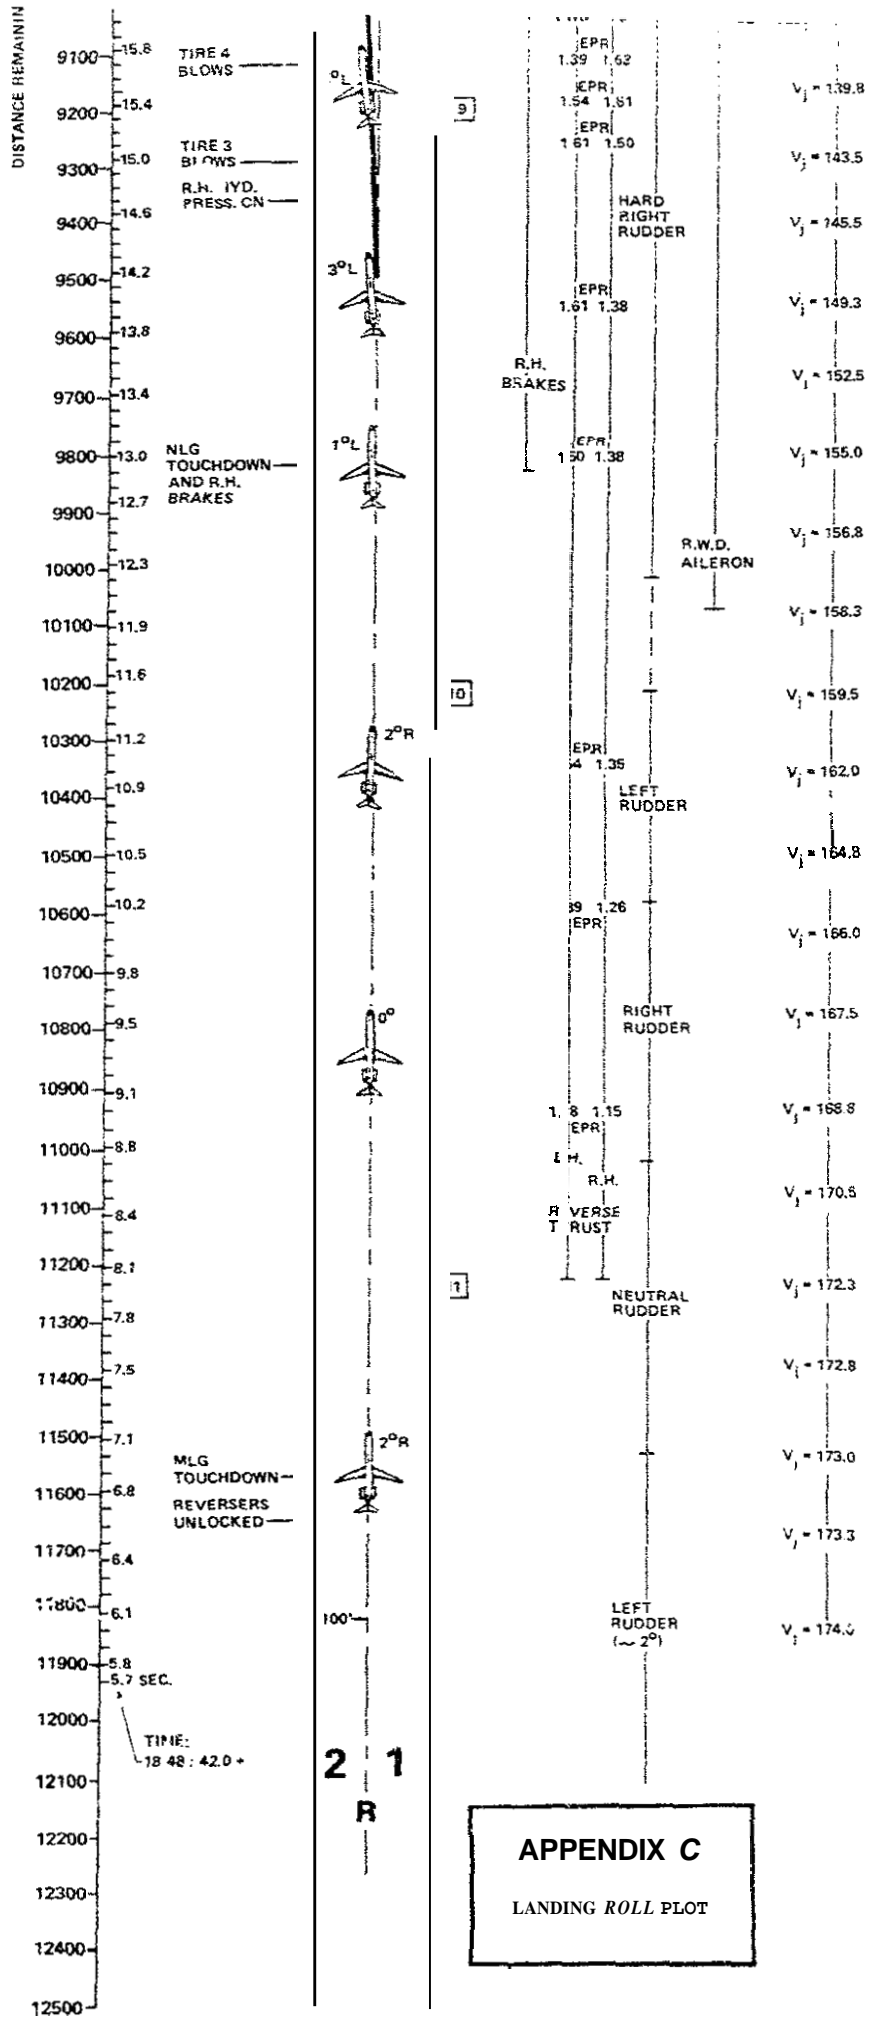
APPENDIX C
LANDING ROLL PLOT

The first tire marks attributable to the accident aircraft were located about 1,900 feet beyond the landing threshold of runway 21R. (All distances herein are expressed in feet beyond the landing threshold of runway 21R.) Starting at 4,000 feet, the first pieces of tire rubber and carcasses were found along the right side of the runway, and at 5,500 feet, pieces of tire rubber and carcass were found along the left side of the runway. About 3,500 feet, the rubber and wheel markings showed that the aircraft began to drift left of the runway centerline. At 5,500 feet, the centerline of the aircraft's fuselage was displaced about 10 feet left of the runway centerline. Thereafter, the aircraft began to track toward the right side of the runway and its rate of movement to the right increased as the landing roll continued. During this movement, the aircraft began rotating to the right and it entered a left skid.
