INTERSTATE AVIATION COMMITTEE
AIR ACCIDENT INVESTIGATION COMMISSION
FINAL REPORT

Type of occurrence	Accident
Aircraft type	Airplane, Boeing 737-200
Registration	EX-009
Registered owner	"Itek Air" Airline
Operator	"Itek Air" Airline
Regional Aviation Authority	Department for Civil Aviation, Kyrgyz Republic
Place of Occurrence	Manas Aerodrome (distance 9.7 km, bearing 273° M from the ARP)
Date and Time	24.08.08, 14 hours 45 min UTC, (local time 20 hours 45 min)

On August 24, 2008 at 1445 hrs UTC (2045 local time, hereinafter local time will be given) at Manas Aerodrome a Boeing 737-200 aircraft registered EX- 009 operated by Itek Air crashed while conducting a scheduled passenger flight IRC 6895 from Bishkek to Teheran at night in visual meteorological conditions.

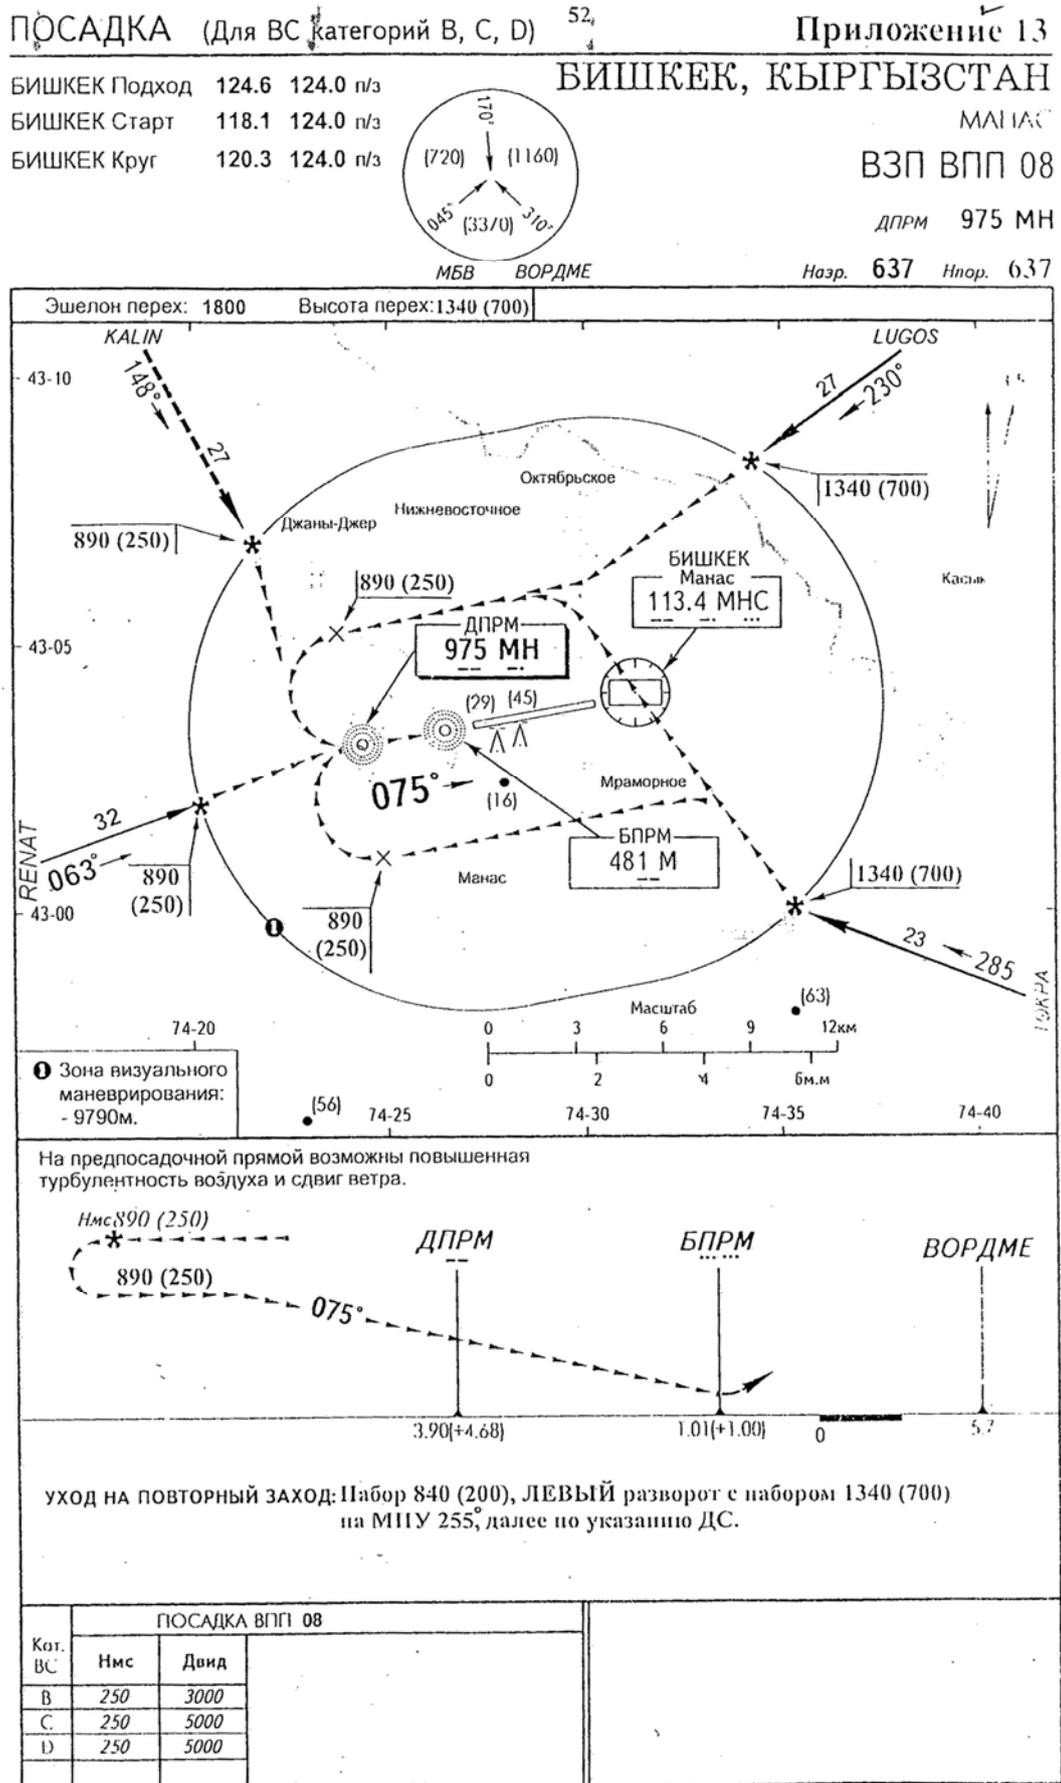
Fig. 1. Visual approach pattern at Manas Airport.

The visual approach pattern for RWY-08 is shown on Figure 1.

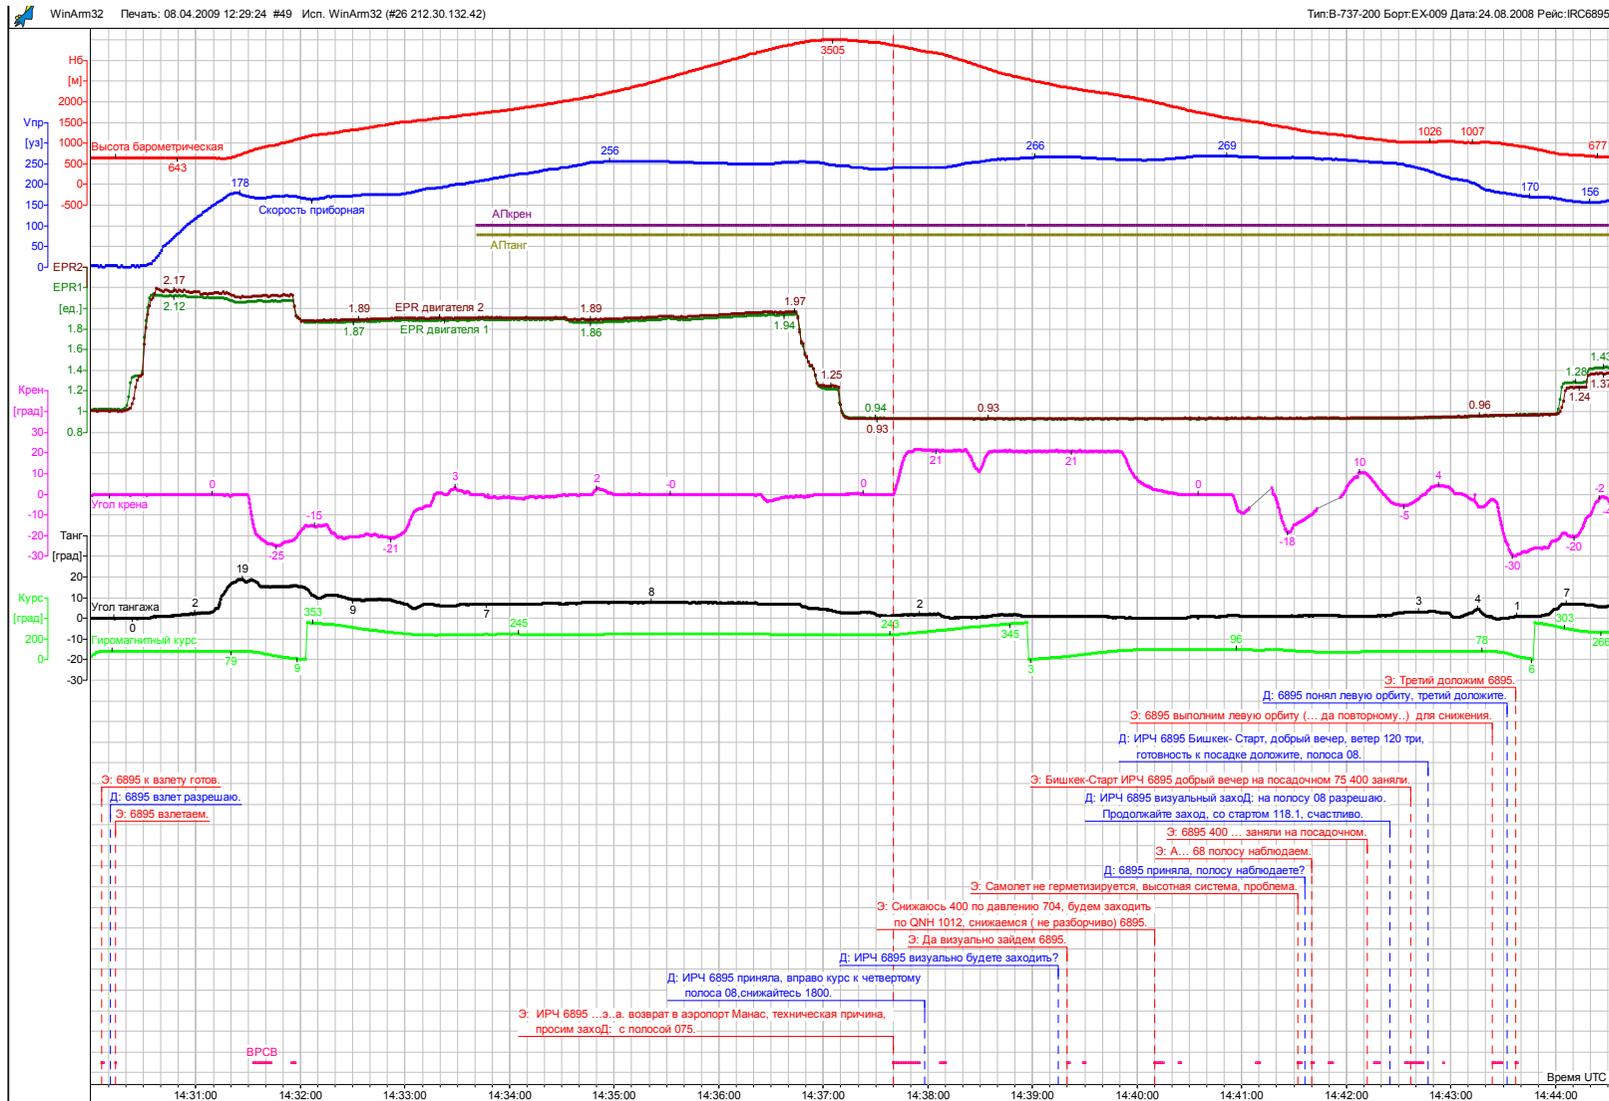
Fig. 2. The B737-200 EX-009 flight data for 24 August, 2008 on the basis of the FDR data.

The synchronization of FDR 980-4100 GQUS data and the radar data was done using the pressure altitude readings recorded by the FDR and radar. The difference between FDR time and radar time was 9 seconds.

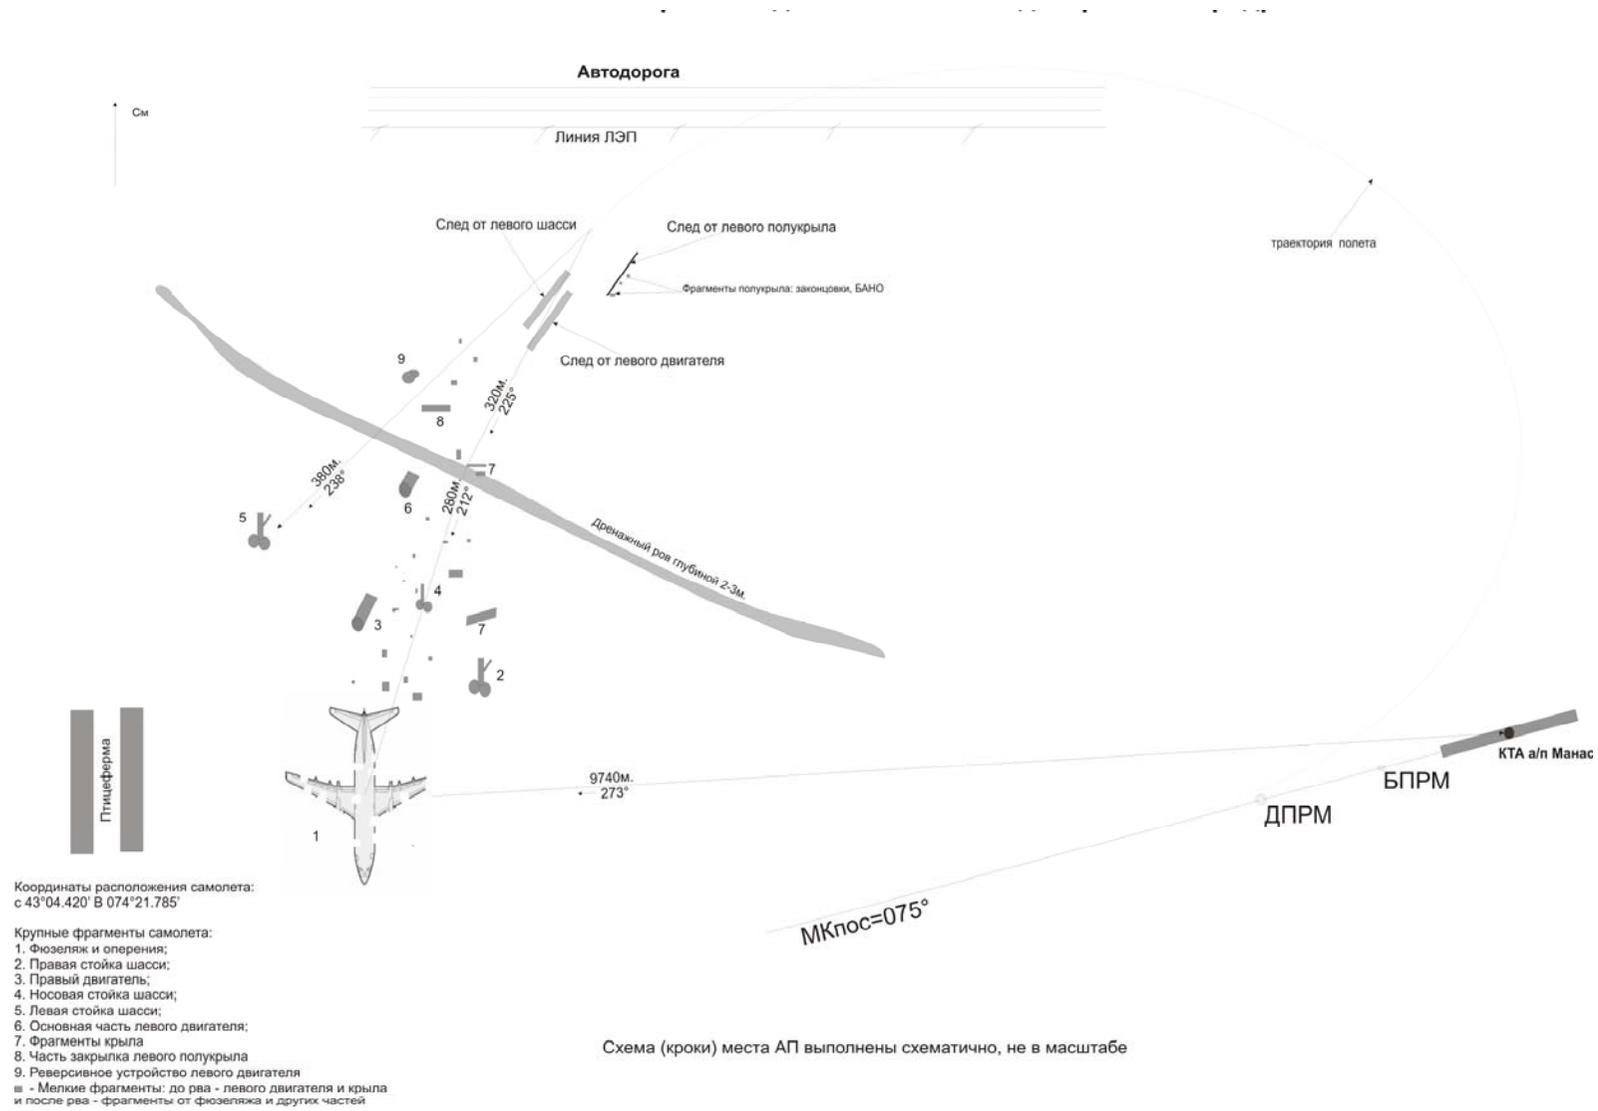
Fig. 6. Wreckage plot (no scale).

The aircraft touched the ground left wing first at a distance of 620 m and bearing of 039° M from the place of its final stop. The left wingtip was partly crushed on the impact. Small fragments of the wing were found at the following distances from the place of the first impact: first fragment – 27 m, second fragment – 42 m, third fragment (a piece of the navigation light glass) – 46 m.

The plot on Fig. 6 shows the positions of the largest fragments.

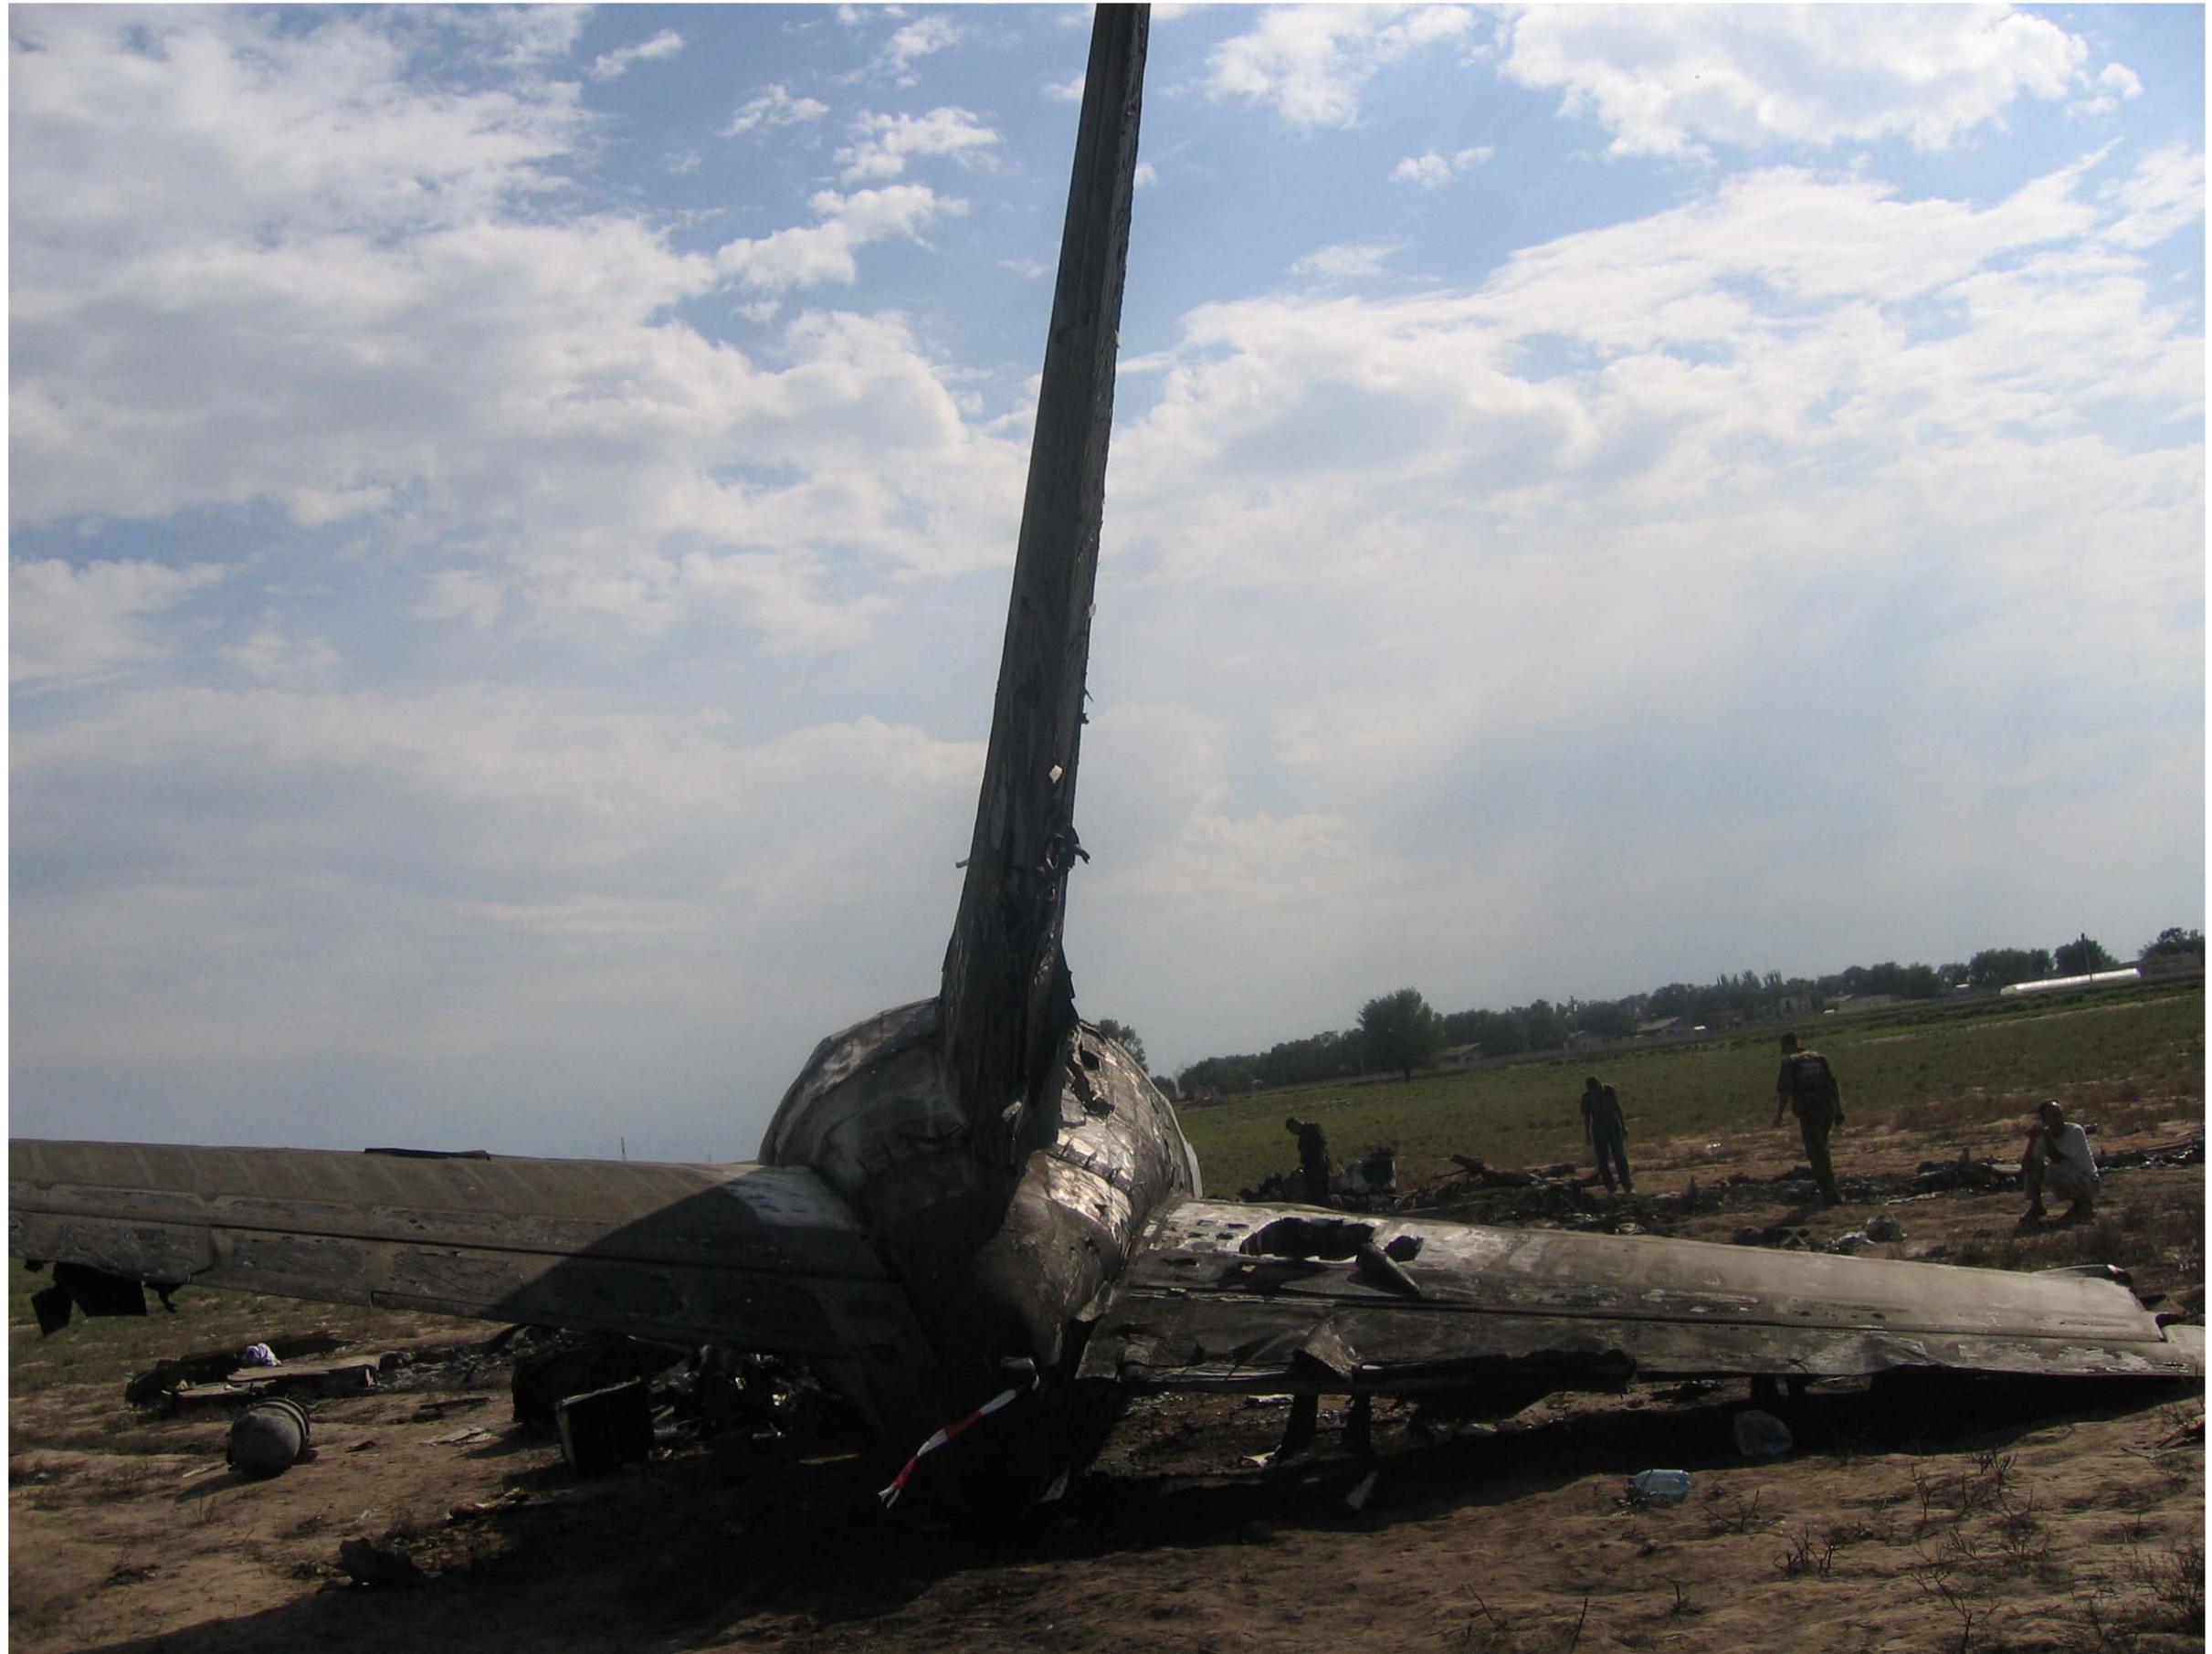
The aircraft was almost totally burned out in the ground fire, excepting the tail part.

Fig.7 Wreckage of the aircraft structures. Backward view.

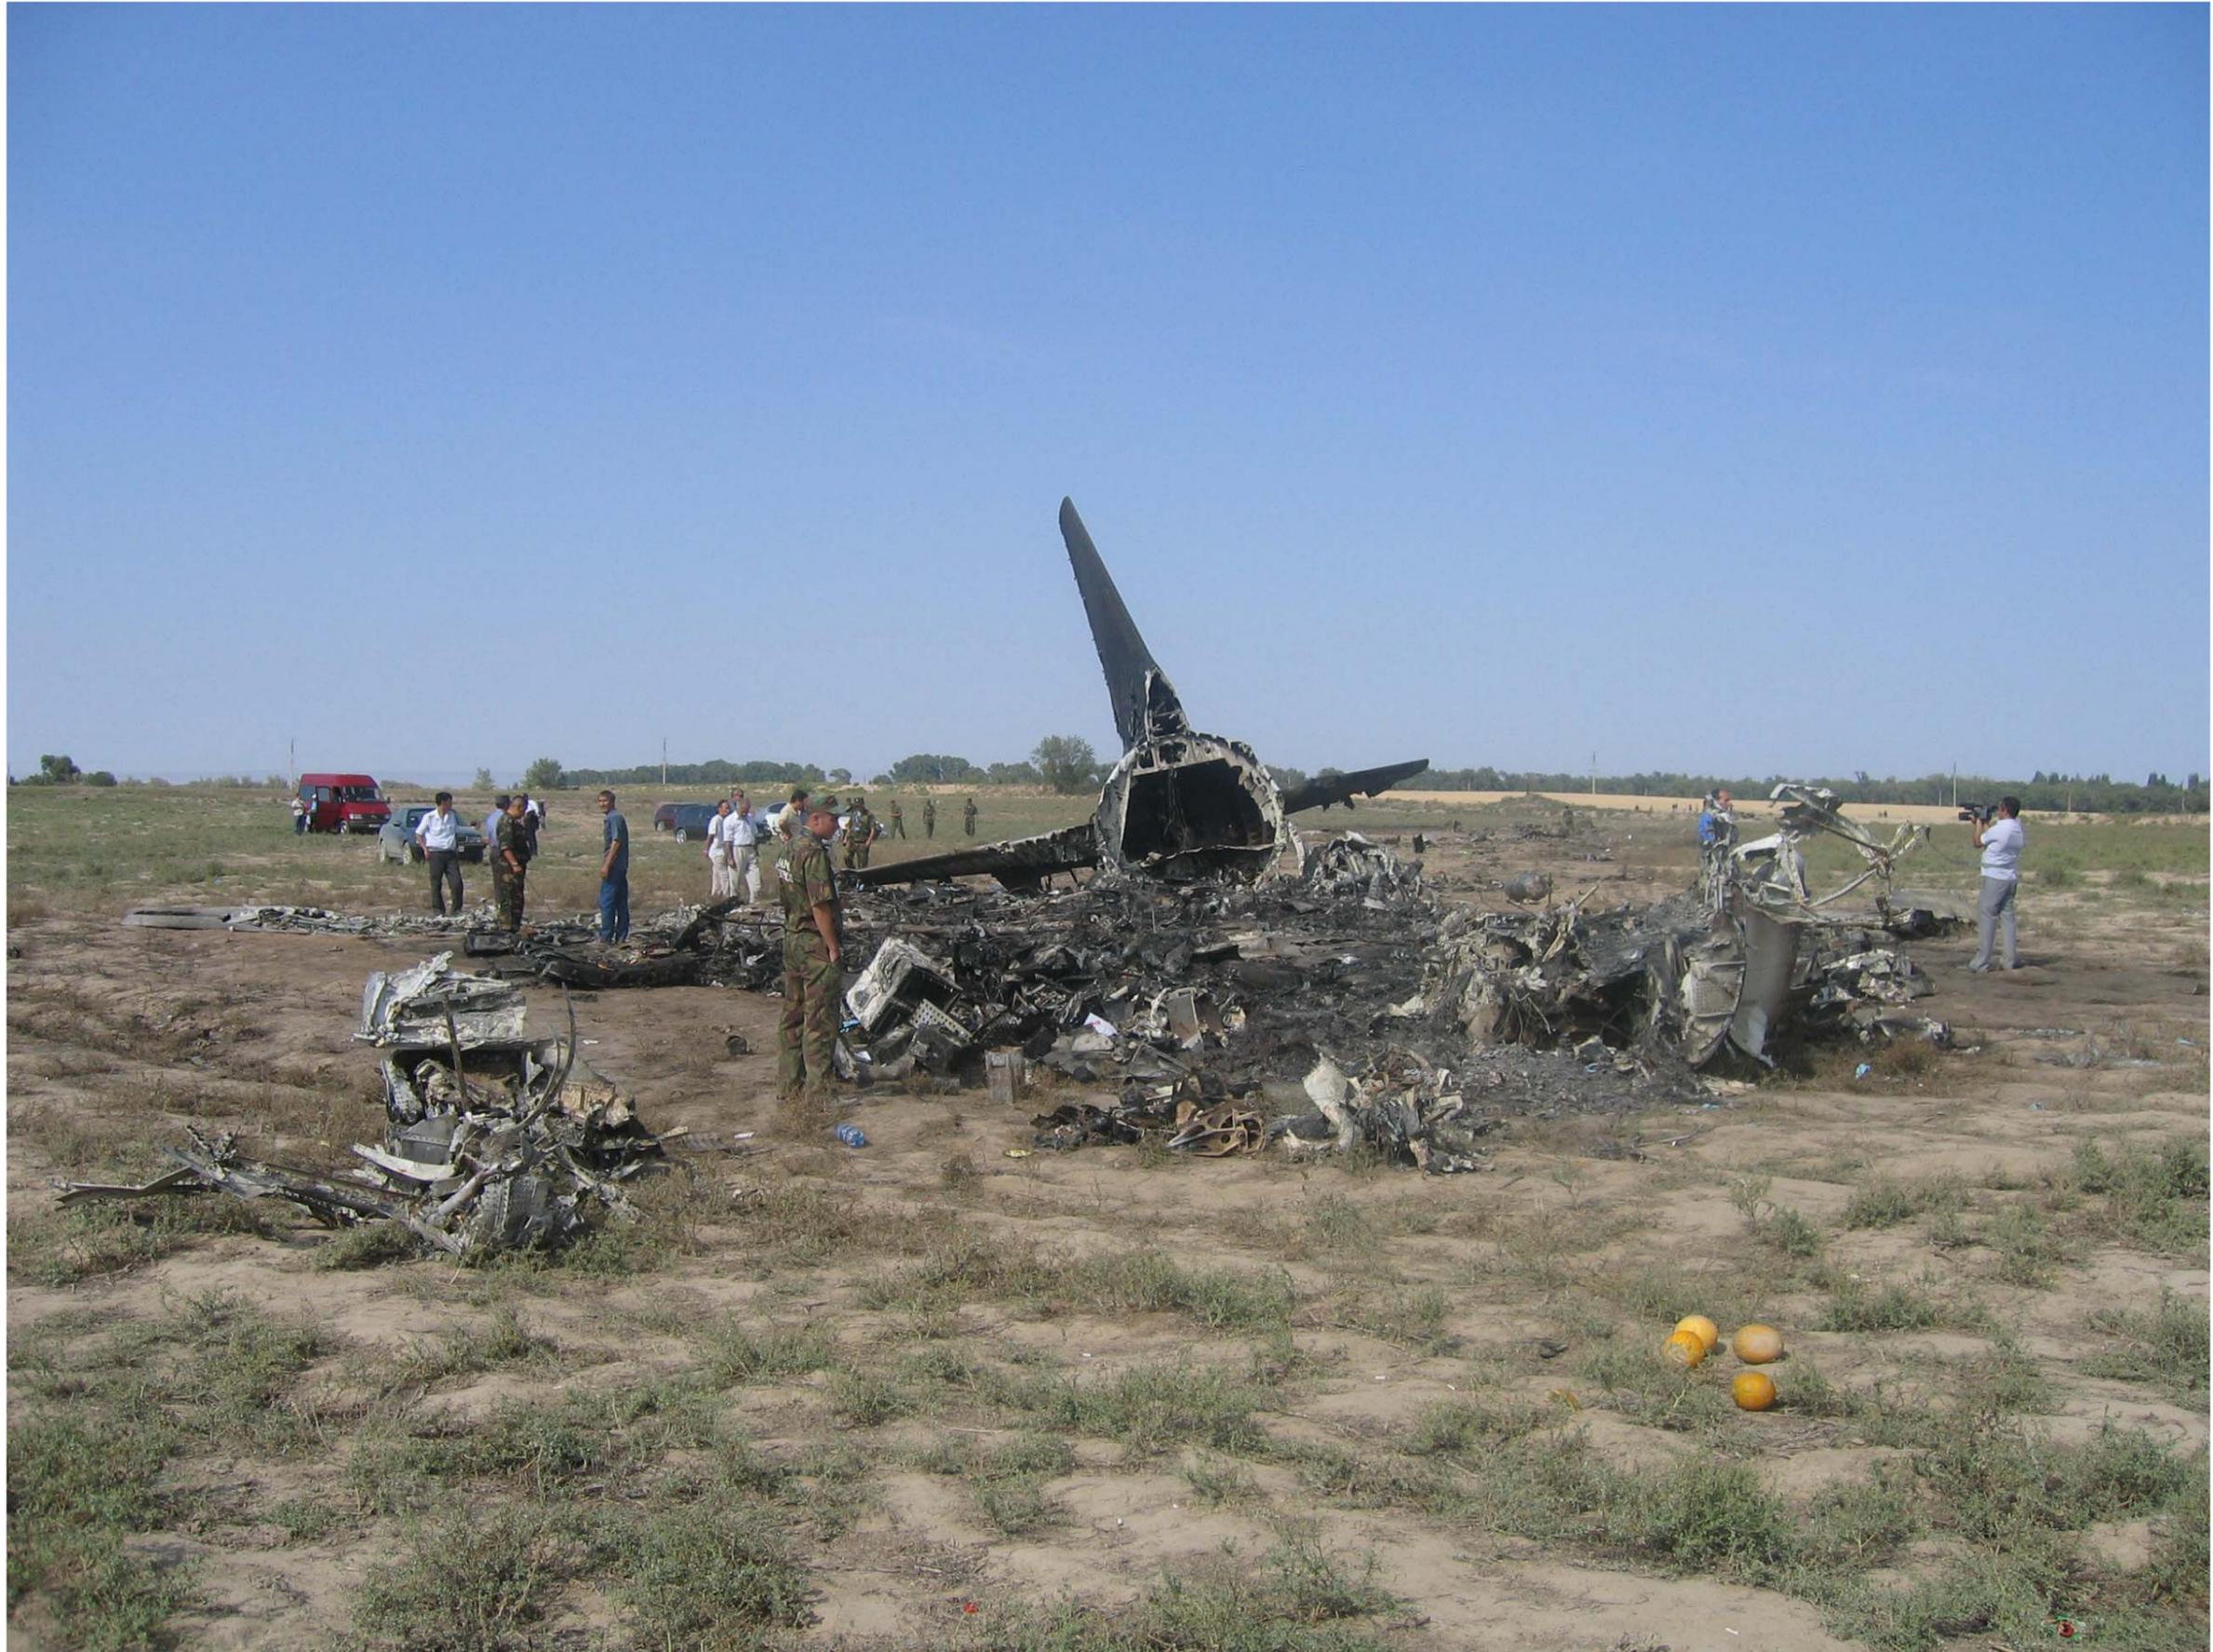
Fig. 8. Wreckage of the aircraft structures. Forward view.
