NATIONAL TRANSPORTATION SAFETY BOARD

AIRCRAFT ACCIDENT REPORT

**GEORGIA-PACIFIC CORPORATION
CESSNA 500 CITATION, N501GP
MERCER COUNTY AIRPORT
BLUEFIELD, WEST VIRGINIA
JANUARY 21, 1981**

NTSB-AAR-81-9

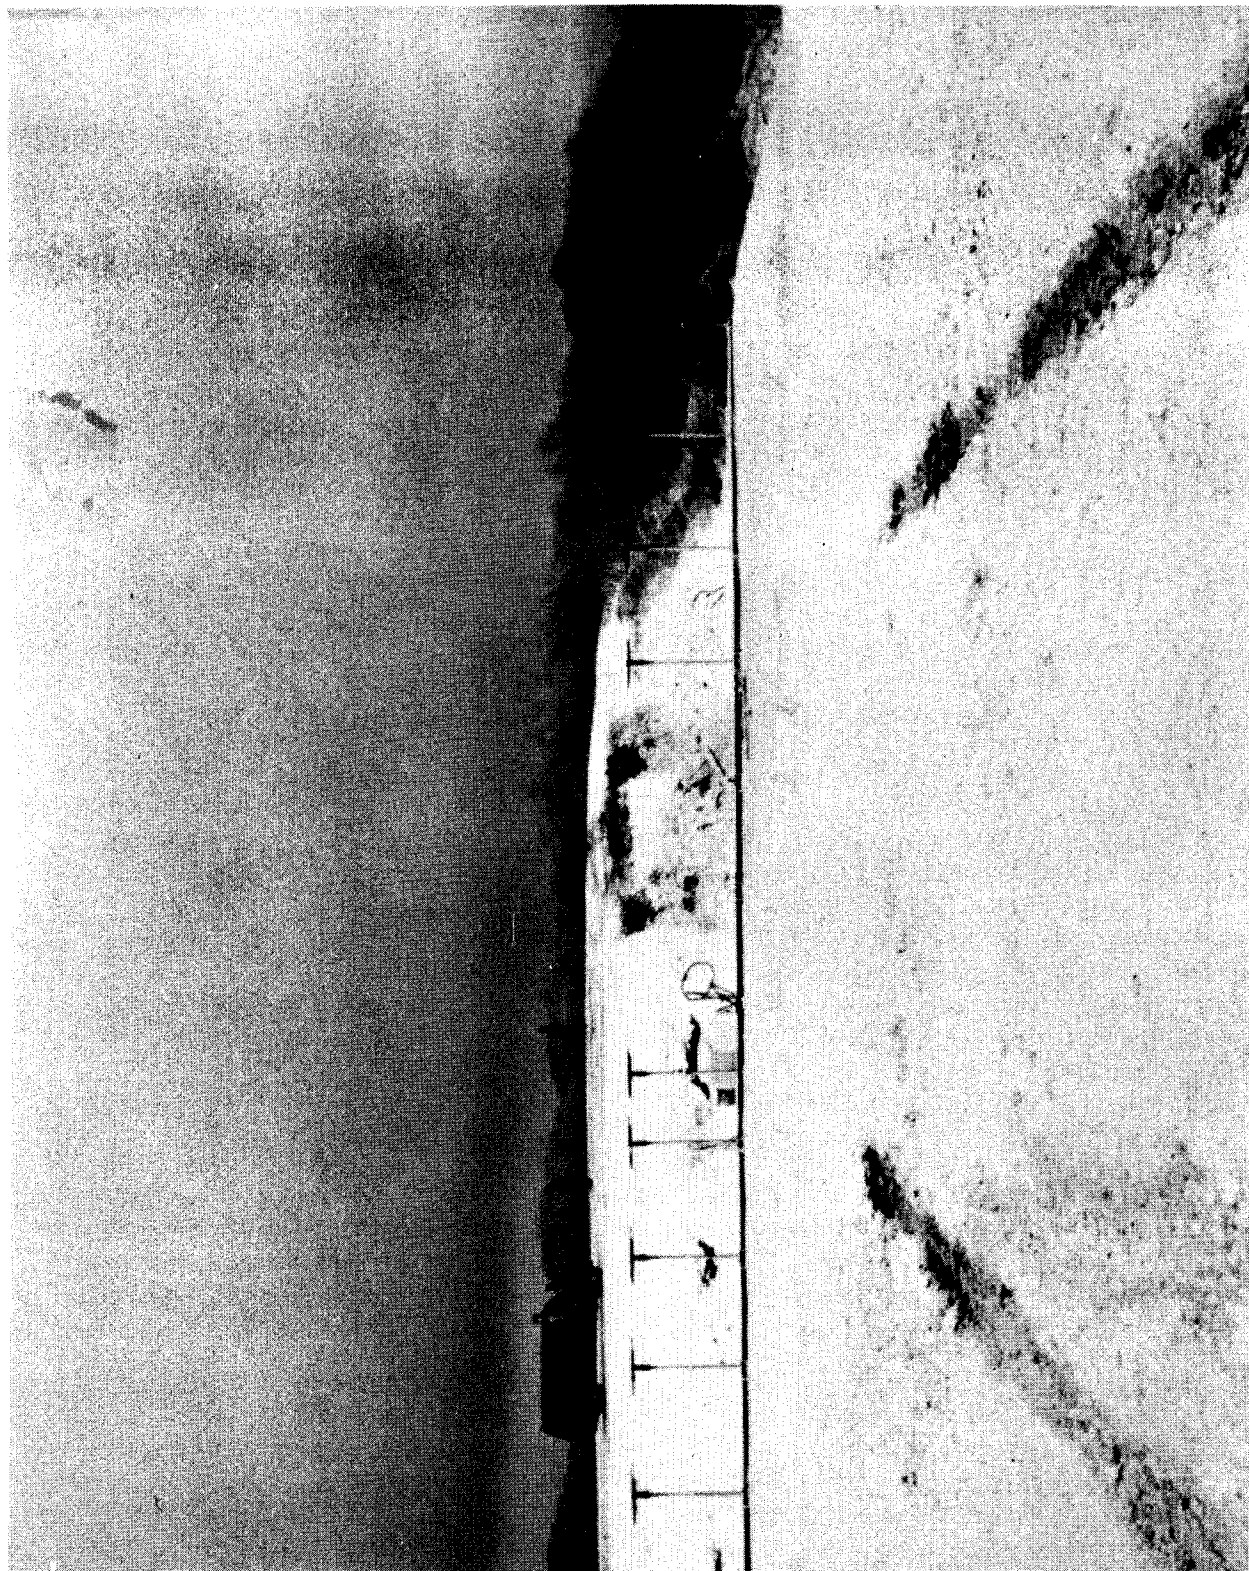
Figure 1.—Departure end of runway 23 showing main landing gear wheel tracks and impact damage to the localizer antennas and embankment.

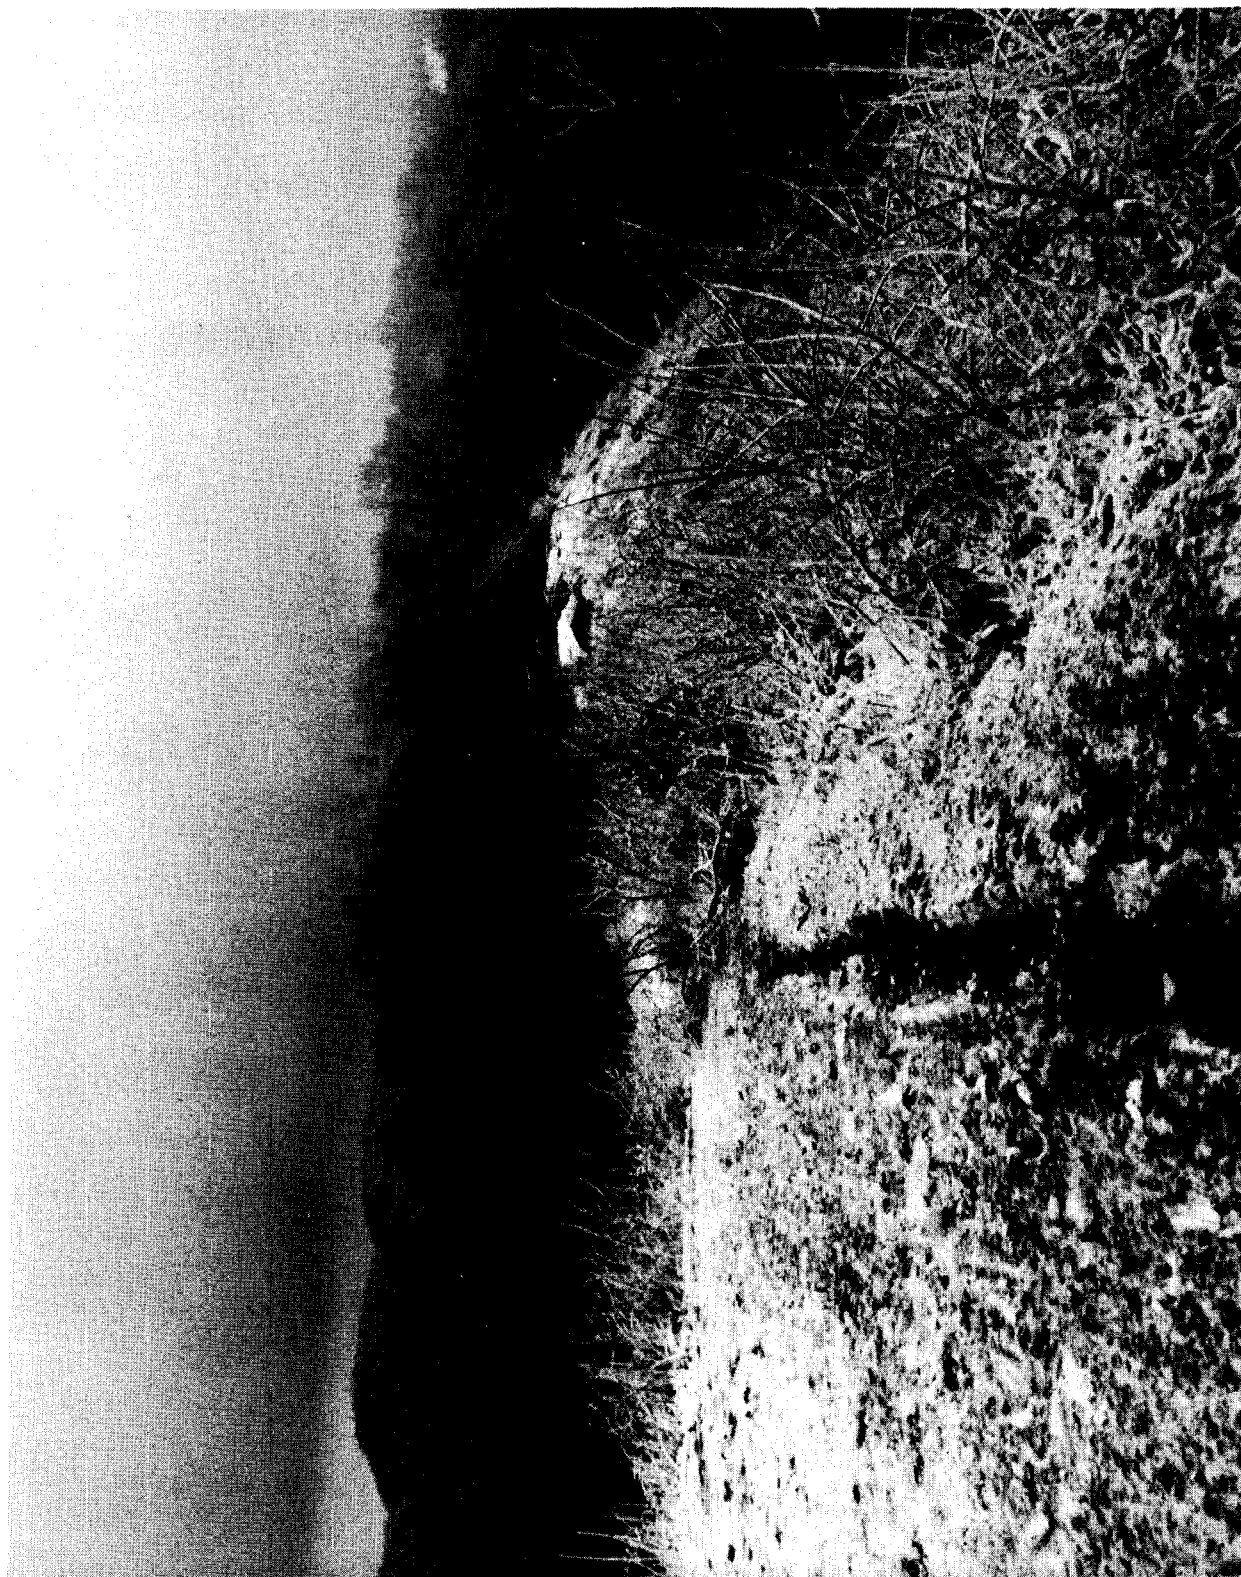
Figure 2.—View of terrain beyond the embankment. The track in the foreground was made by the right main landing gear wheel and is headed in the direction of the accident site as shown by the fire-damaged trees.
