NATIONAL TRANSPORTATION SAFETY BOARD

AIRCRAFT ACCIDENT REPORT

SKY TRAIN AIR, INC.
GATES LEARJET 24, N44CJ
FELT, OKLAHOMA
OCTOBER 1, 1981

NTSB-AAR-82-4

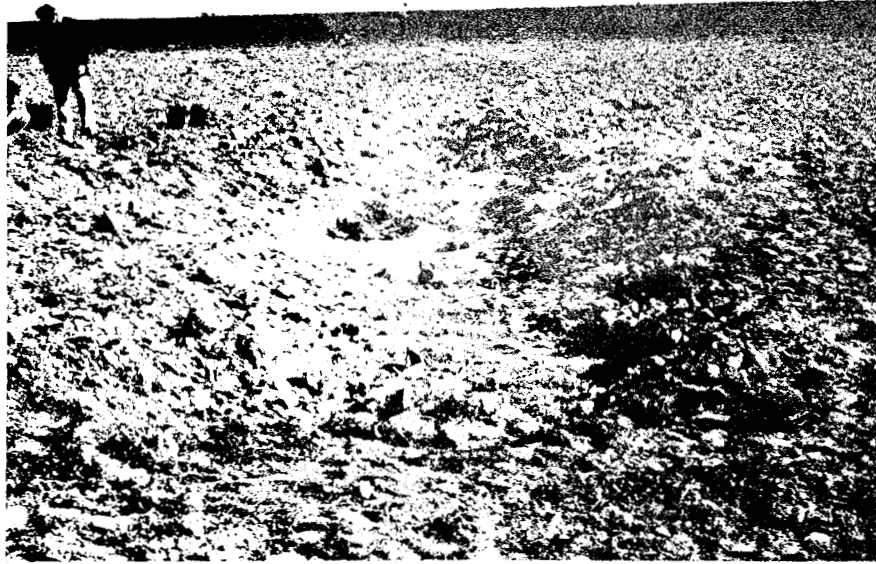
The aircraft struck a level plowed field in an approximate 45° nosedown, left wing down attitude at high speed (figure 1.) The ground was composed of a layer of loose dirt and a sublayer of rock about 3 feet below the surface. The aircraft disintegrated from extreme forces when it struck the layer of bedrock and formed an impact crater 48 feet long 17 feet wide and 2 to 3 feet deep. Wreckage was scattered in a fan shaped pattern about 900 feet long and 850 feet wide. The crater was oriented along a magnetic heading of 135°. (See appendix F.) Several relatively heavy items, such as the engines and landing gear trunnions were scattered between magnetic bearings of 105° and 155° from the impact crater. There was evidence of soot deposits and fire damage to small, random portions of the wreckage as a result of the impact and explosion. There was no evidence of an inflight fire.

Figure 1.--View looking southeast at impact crater.
Wreckage debris scattered beyond crater.

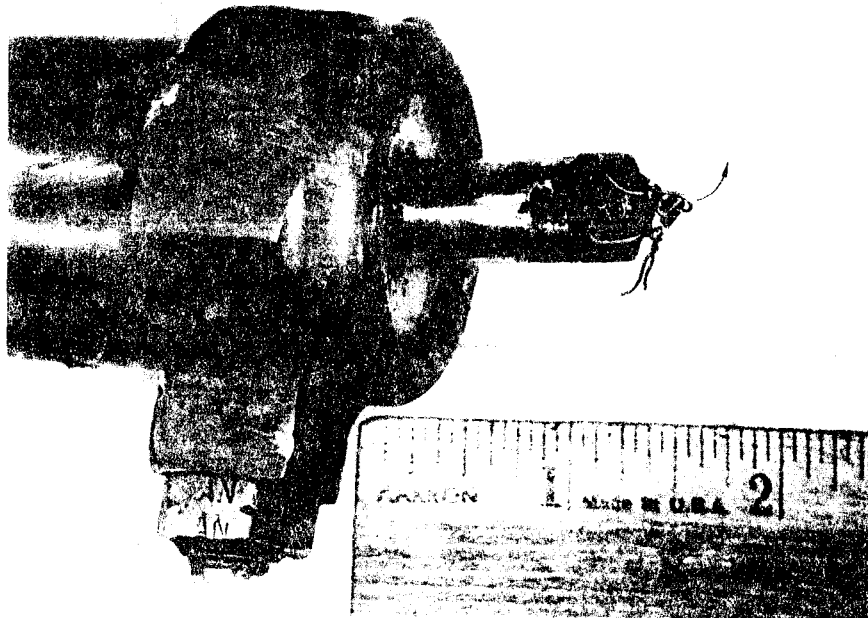
Examination of the wing spoiler actuator by the Safety Board's metallurgical laboratory disclosed that the piston rod-end broke from overload bending forces (figure 2). The actuator gland was driven sufficiently into the cylinder to shear the setscrew. Impact marks on the exterior of the actuator barrel (see figure 3) had deformed the inside wall of the barrel (see figure 4). The piston (see figure 5) was jammed within the distorted area 0.65 inch from its fully retracted position which indicates that the actuator piston had been moved by impact forces into the spoiler retract direction when the piston became jammed. The position in which it was jammed correlated with an extended spoiler deflection angle of 20.5° . The deflection angle, in turn, corresponded to the position the spoiler would seek due to opposing air loads at an airspeed of 369 knots. This speed is 69 knots above the maximum airspeed (V_{mo}) for the aircraft. However, it was not possible to determine what portion of the distance that the piston had moved from the progressive forces associated with the impact breakup sequence.

Figure 2.—Closeup view of the piston rod end in position in the actuator.
Arrow indicates direction of bending of piston rod.

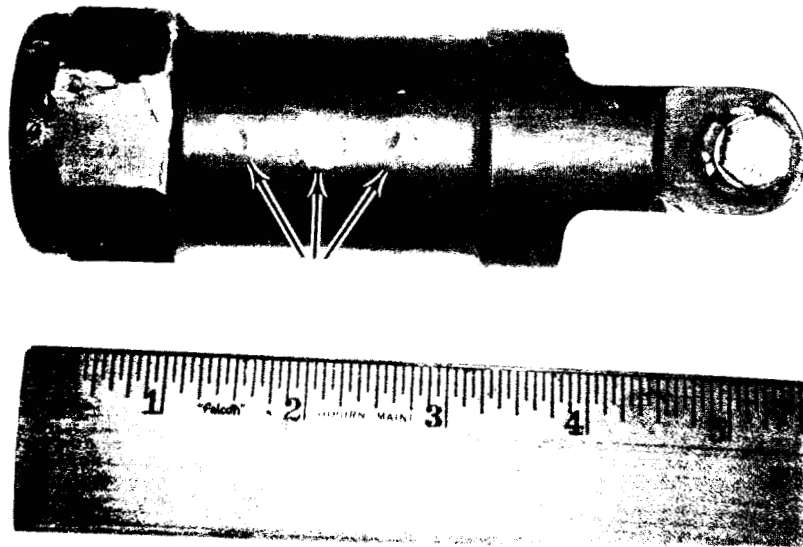
Figure 3.--Arrows indicate impact damage on the barrel.

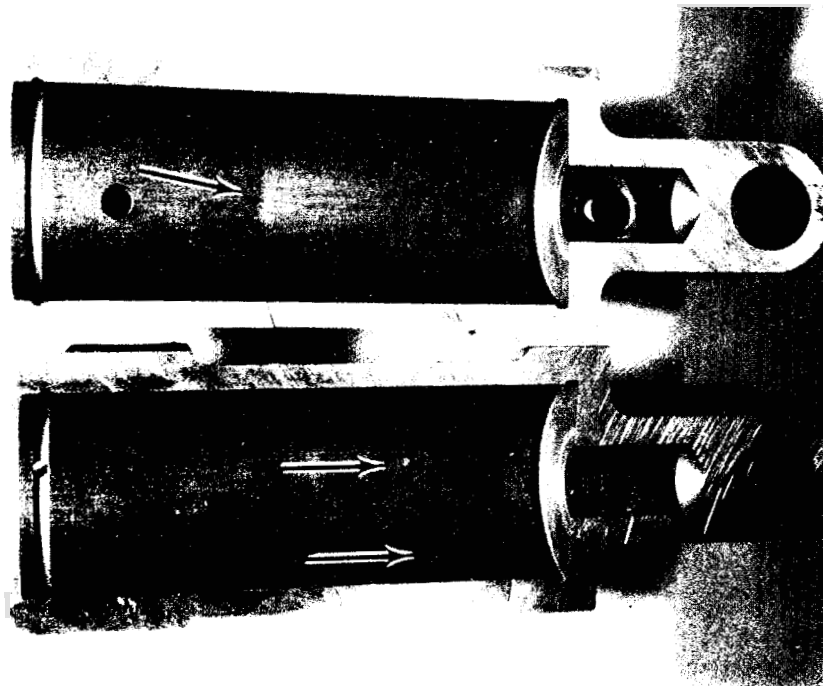
Figure 4.—View of the inside wall of the barrel. The top two arrows indicate the impact deformations.

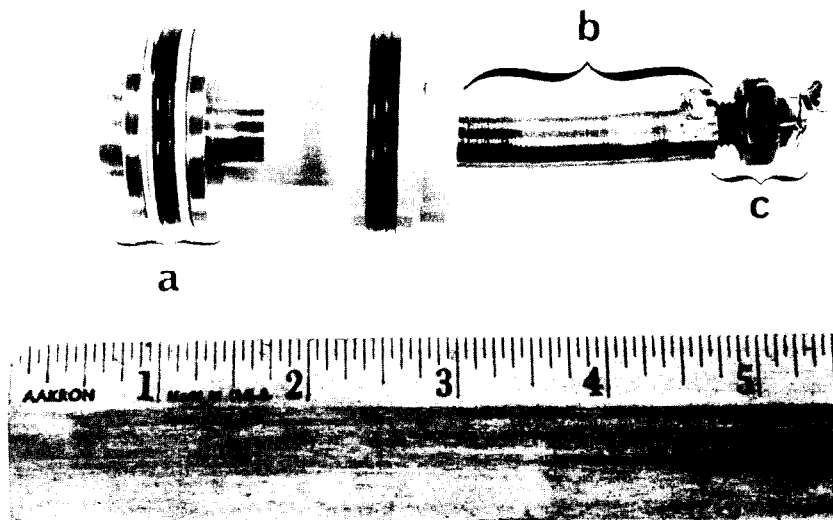
Figure 5.--View of (a) piston, (b) rod, and (c) rod end, after disassembly.
