Air Accident Investigation Unit Ireland

FORMAL REPORT

**Cessna 208B, G-KNYS
Near Clonbullogue, Co. Offaly**

13 May 2018

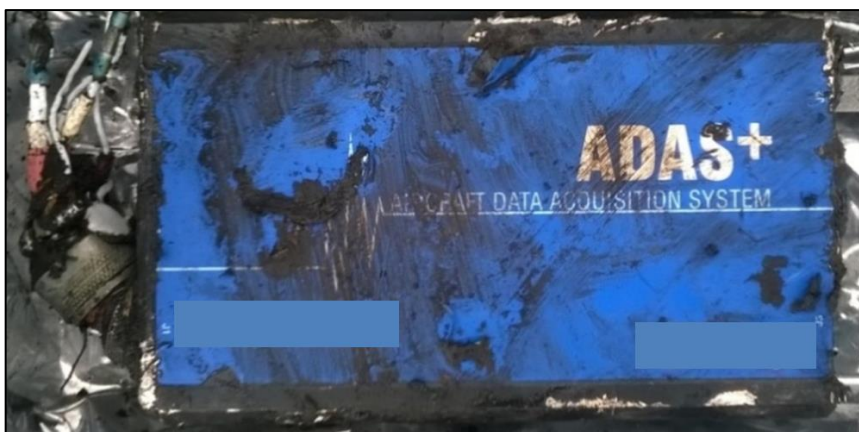
Photo No. 2: ADAS unit recovered from the wreckage

The ADAS unit from the accident aircraft was found at the site when the front section of the aircraft was lifted from the bog. It was damaged, but intact (**Photo No. 2**), and was shipped to the Engine Manufacturer's Norwood facility in the USA on 15 May 2018 with the assistance of the National Transportation Safety Board (NTSB). It was examined in the presence of a Federal Aviation Administration (FAA) representative, acting on behalf of the NTSB.

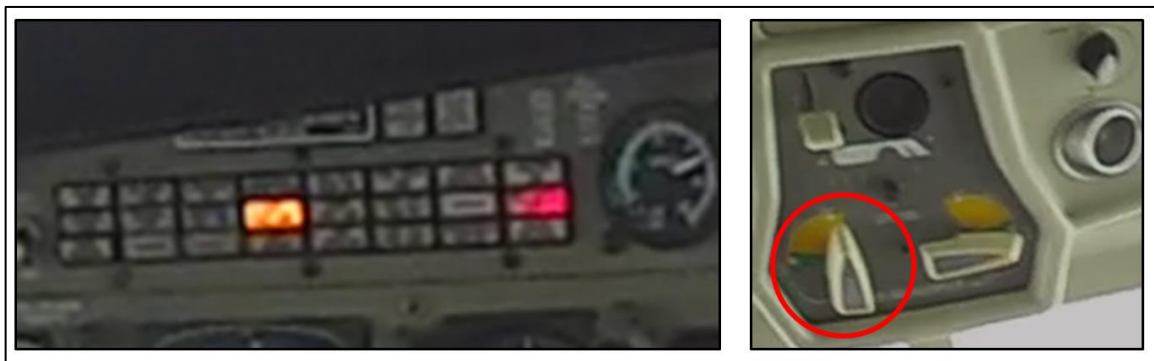
One of the skydivers' videos from the day before the accident showed the cockpit-mounted annunciator panel with what was established to be the red *FUEL SELECT OFF* warning light illuminated and the amber *LEFT FUEL LOW* caution light illuminating briefly (left image in **Figure No. 11**). The video also shows the overhead fuel tank selector panel with the left-hand fuel tank selected to the *OFF* position (right image in **Figure No. 11**). Neither the annunciator panel nor the fuel selector panel were visible in the videos from the accident flight.

Figure No. 11: Annunciator panel and fuel selector panel in flight on the day before the accident. Left tank selector OFF (circled)

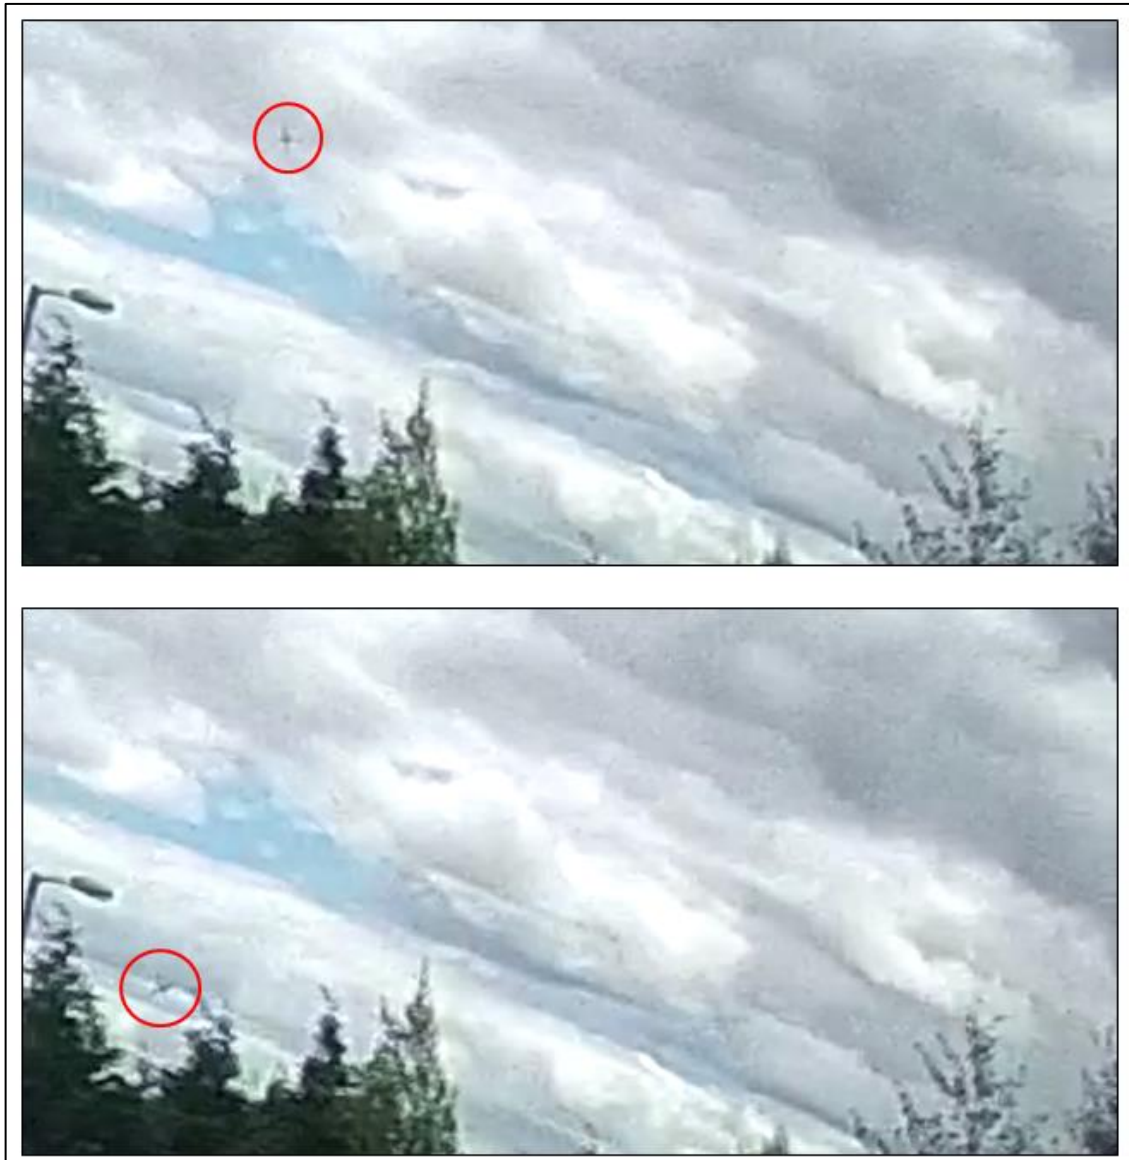
The upper image in **Figure No. 14** was also extracted from the CCTV recording and shows the aircraft (circled in red) just before it rapidly lost altitude. The lower image in the figure shows the aircraft before it disappeared below the line of trees in what appeared to be a near-vertical (nose-down) attitude. However, at this stage, there appears to be some degree of motion back in the direction from where the aircraft had been travelling in the earlier part of the recording. Also at this stage, one of the aircraft's wings appears to be lower than the other. This CCTV recording was subsequently analysed with the assistance of the NTSB (**Section 1.16**).

Figure No. 14: Aircraft (circled in red) just before it rapidly lost altitude (upper image). The lower image shows the aircraft in what appeared to be a near-vertical descent

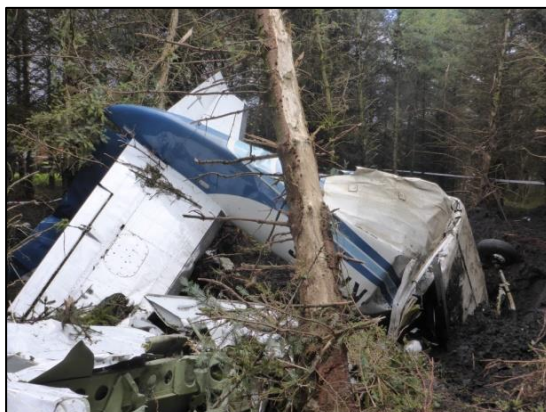
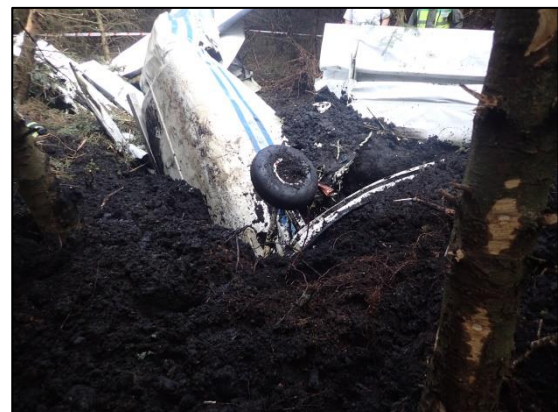
Photo No. 3 and Photo No. 4: Aircraft as found at accident site

The impact was such that the entire front section of the aircraft, forward of the main wheels, was submerged below the surface of the bog (**Photo No. 3** and **Photo No. 4**). On the aircraft type, this section is approximately 4.8 m in length. The aft fuselage, wings and tail section were above ground. The wreckage above ground was lying towards its left-hand side and generally angled back towards the north-east. The lower (underside) surface of the fuselage, on which the fixed main landing gear was mounted, was pointing towards the north-west (310° magnetic approximately). This was towards the CCTV camera located at the wind farm security hut (**Section 1.11.8**).

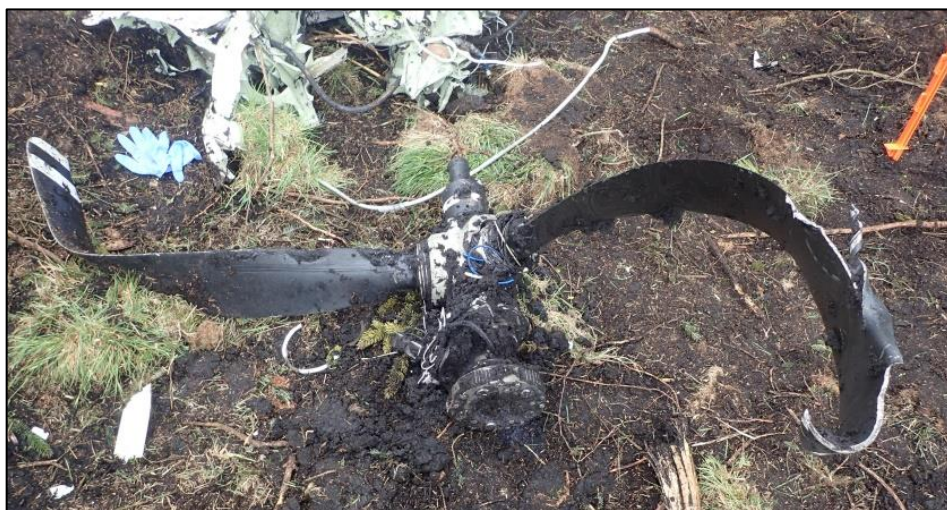
Photo No. 5: Propeller as initially recovered (third blade subsequently recovered)

The engine and the propeller were also recovered from the excavated area. Part of the propeller's reduction gearbox had fractured from the engine and remained attached to the propeller hub. There were two blades attached to the hub. One of these blades was bent forwards; the other was torn, twisted and bent rearwards (**Photo No. 5**).

The third propeller blade was not located immediately; however, following further significant excavation of the site after the aircraft had been extracted, the remaining propeller blade was found. The tip of this blade was missing; the tip found earlier was identified to be from this particular blade. All recovered wreckage was transported under escort to the AAIU's facility in Gormanston on the day following the accident for detailed examination.

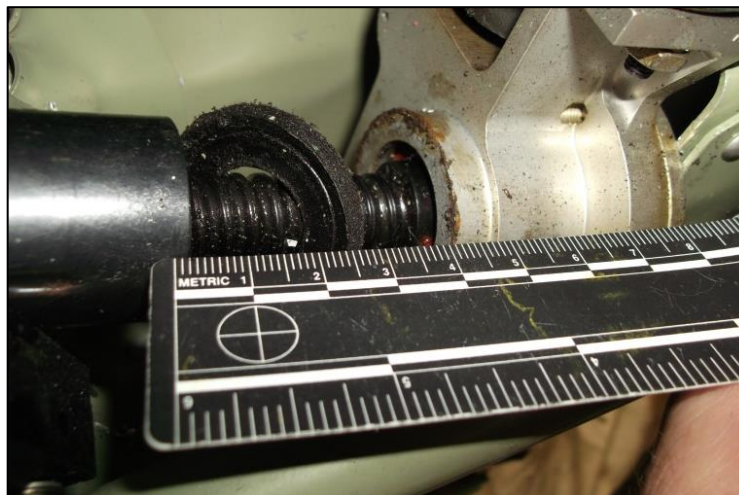
Photo No. 6: Measured extension of flap actuator

The flap actuator was found to be extended by approximately 40 millimetres (mm) (**Photo No. 6**). According to data provided by the Manufacturer, this equates to a flap setting of approximately 20°.

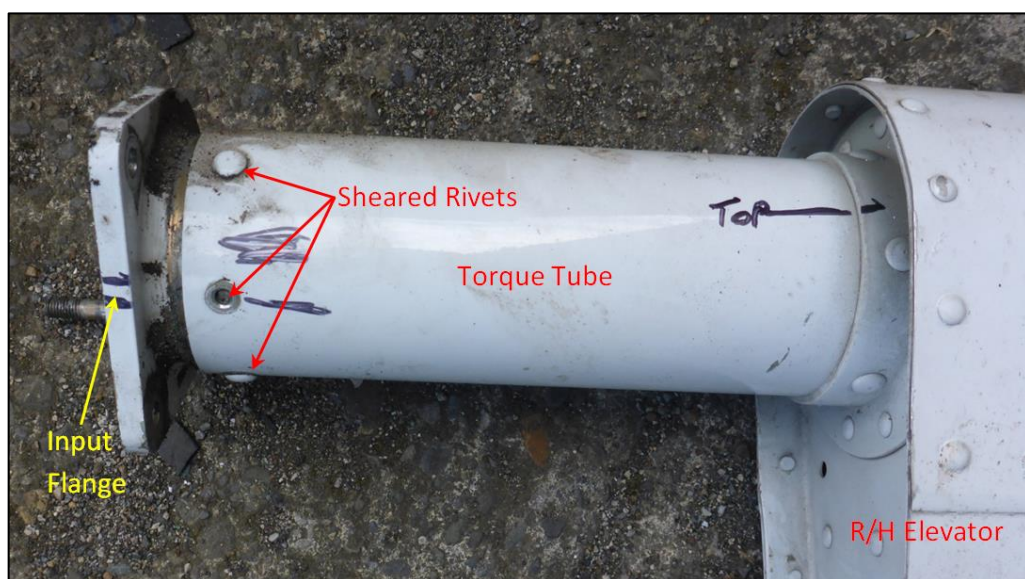
Photo No. 7: R/H Elevator Torque Tube (with elevator removed from aircraft)

The Investigation removed the right-hand elevator to permit further examination (**Photo No. 7**). The torque tube was removed from the elevator and sent to a metallurgist for detailed analysis.

'The appearance of the fracture surfaces [of the rivets] was consistent with instantaneous failure in shear', and that 'there was no evidence of fatigue crack growth'.

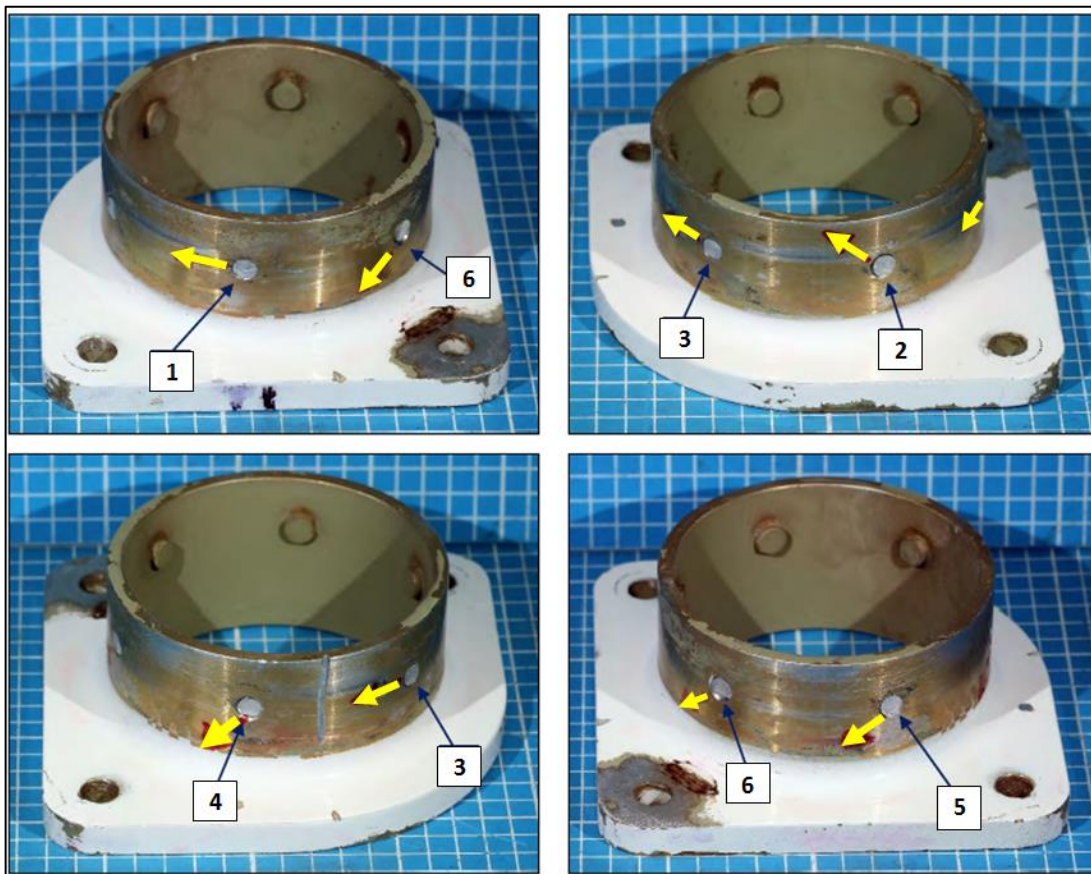
Figure No. 16: Four views of the input flange (with the torque tube removed). Yellow arrows indicate direction of movement of the input flange relative to the rivets (numbered 1-6)

Sheared elevator torque tube rivets were previously observed by the NTSB during their examination of another Cessna 208B aircraft following an accident that occurred in the US in 2014 (NTSB Accident Number ANC14FA022). The probable cause of that accident was deemed to be '[...] *delayed remedial action and initiation of a recovery procedure after a simulated pitch trim excursion, which resulted in a loss of airplane control*'. The wreckage examination noted that '*the left elevator torque tube separated from the center fitting along the rivet line*', that '*all of the examined fractures had a dull, grainy appearance consistent with overload failure*' and that '*there was no evidence of pre-existing corrosion or cracking [...]*'.

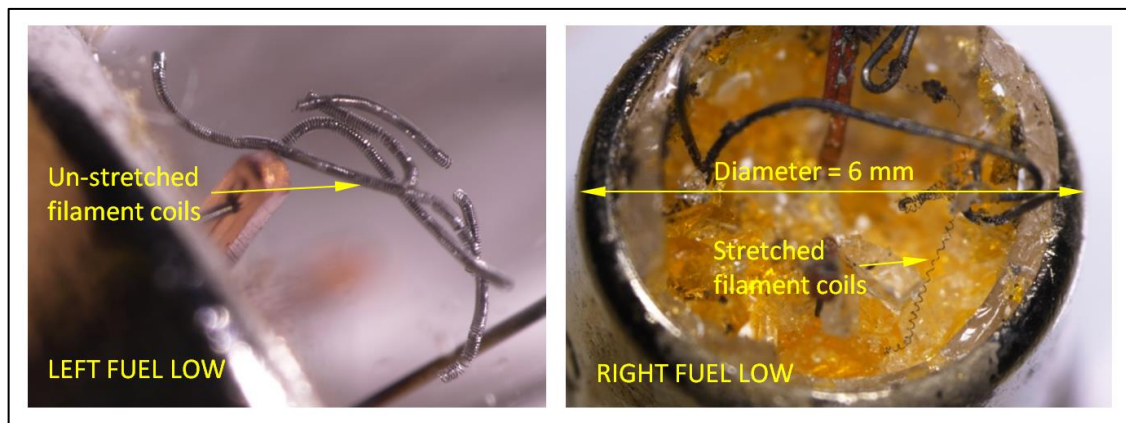
The Investigation also examined the bulbs in the *LEFT FUEL LOW* and *RIGHT FUEL LOW* caution lights (**Figure No. 17**). The bulbs in *LEFT FUEL LOW* light also appeared to have failed in an unlit state as indicated by broken, un-stretched filament coils. Due to impact damage, the glass was broken in each of the two bulbs from the *RIGHT FUEL LOW* light. The filament from one of the bulbs was missing; however, the filament from the other bulb appeared to have been illuminated at the time of impact, as indicated by the stretched filament coils.

Figure No. 17: Bulbs from *LEFT FUEL LOW* and *RIGHT FUEL LOW* caution lights

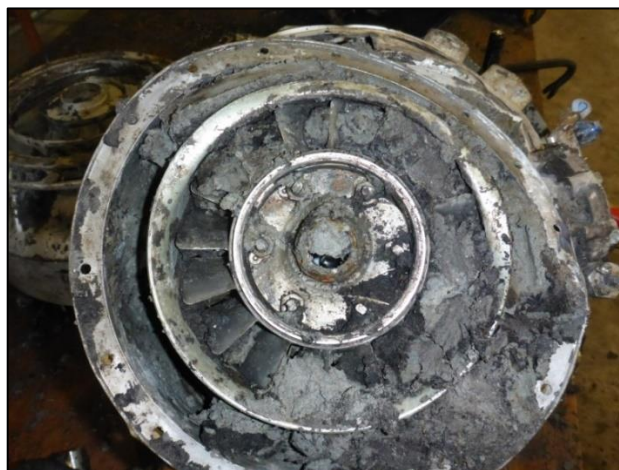
Photo No. 8: Engine compressor inlet

Organic debris was also found within the engine's combustion section and was present on the fuel nozzles.

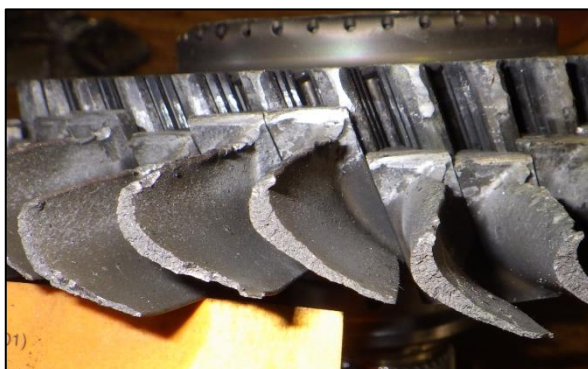
All of the blades on the power turbine were fractured (**Photo No. 9**). The fractured surfaces exhibited features consistent with overload. Several of the blades were bent in a direction opposite to the direction of rotation (**Photo No. 10**). The edges of the blades exhibited rubbing damage from contact with the power turbine vane ring. The contact also resulted in the blades being displaced in their mounting hub, in a downstream direction.

Photo No. 9: Fractured power turbine blades (*Engine Manufacturer*)

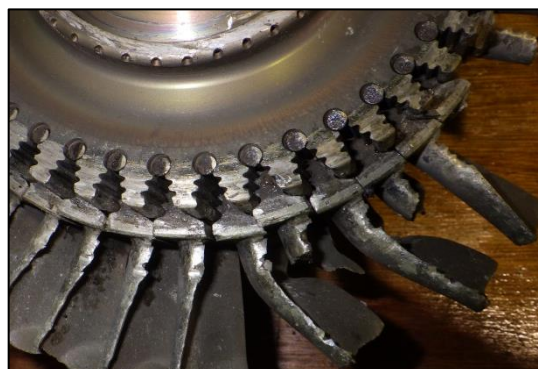
Photo No. 10: Blade bending in a direction opposite that of rotation (*Engine Manufacturer*)

The power turbine shroud exhibited rubbing damage from contact with the power turbine blades. All vanes on the power turbine guide vane ring were damaged as a result of contact with the power turbine blades. Fragments of the power turbine blades and blade tips were found within the exhaust case. The blade tips exhibited rubbing from contact with the power turbine shroud. The upstream side of the power turbine disc exhibited circular rubbing damage from contact with the power turbine shaft housing.
