AIRCRAFT ACCIDENT REPORT
OCCURRENCE NUMBER 03/3794
PACIFIC AEROSPACE CORPORATION 750XL
ZK-UAC
341 NM WSW OF SAN FRANCISCO
26 DECEMBER 2003

AIRCRAFT ACCIDENT REPORT

OCCURRENCE No 03/3794

Aircraft type, serial number and registration:	Pacific Aerospace Corporation 750XL, 103, ZK-UAC
Number and type of engines:	1 Pratt & Whitney Canada PT6A-34 turboprop
Year of manufacture:	2003
Date and time:	26 December 2003, 1701 ¹ hours
Location:	341 nm WSW of San Francisco VOR Latitude: N 35° 11.1' Longitude: W 128° 45.3'
Type of flight:	Ferry
Persons on board:	Crew: 1
Injuries:	Crew: 1 fatal
Nature of damage:	Substantial, but aircraft not recovered
Pilot's licence	Airline Transport Pilot Licence (Aeroplane)
Pilot's age	58 years
Pilot's total flying experience:	16564 hours, 180 on type
Information sources:	Civil Aviation Authority field investigation
Investigator in Charge:	Mr A J Buckingham

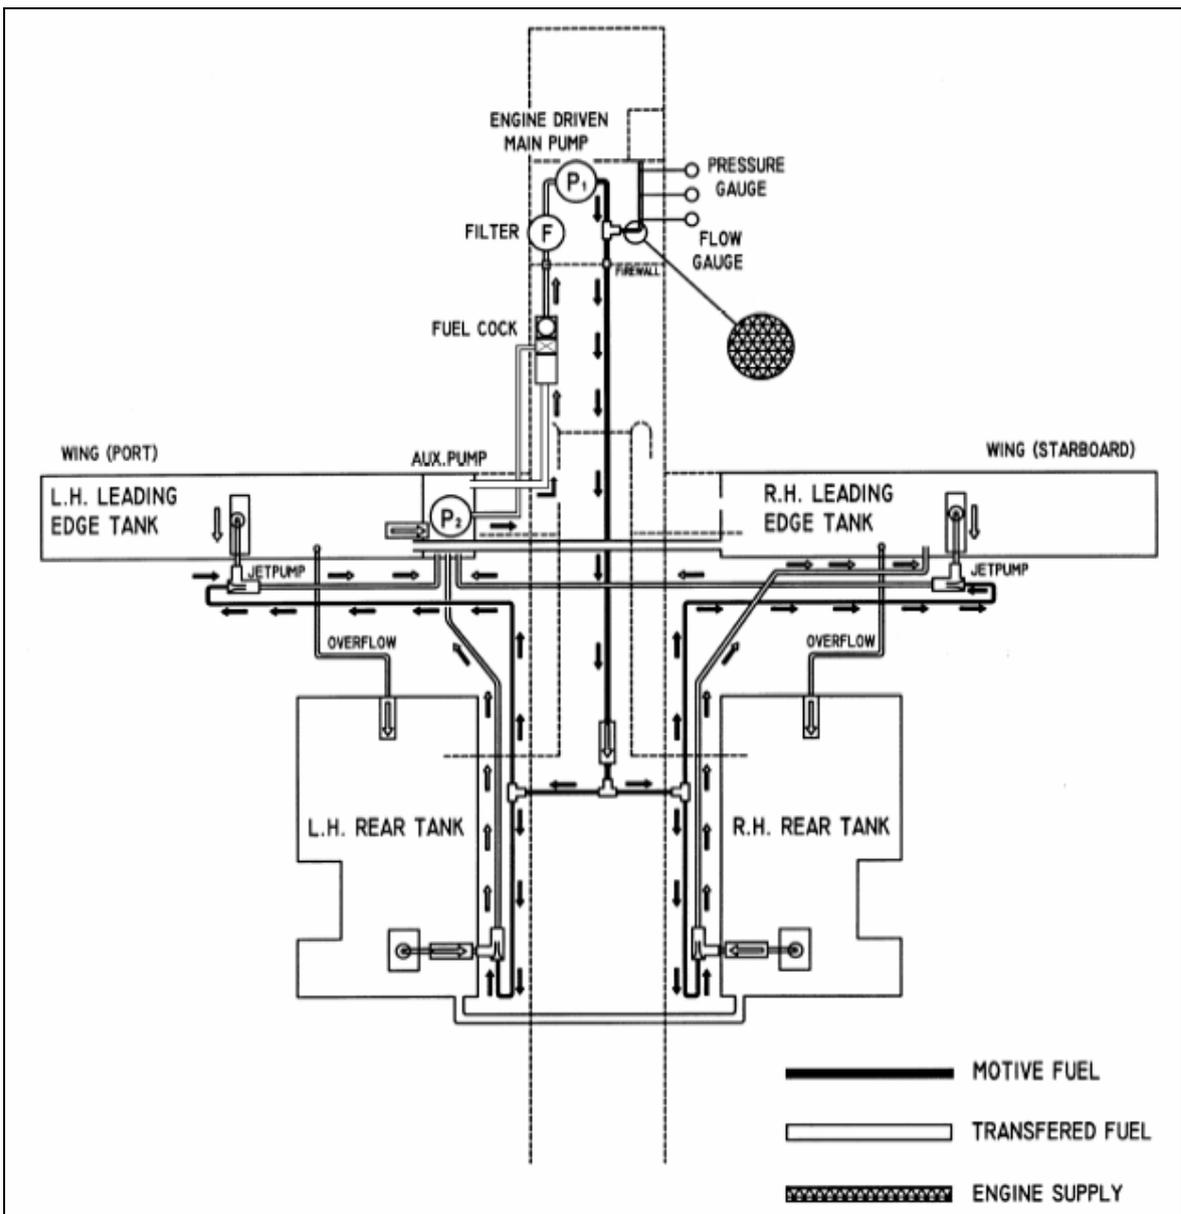
Figure 3: fuel system schematic

- 1.6.9 In normal operation, fuel is drawn from the 26-litre (6.8 US gallon) sump tank by an engine-driven pump. During starting and emergency operation an electric auxiliary pump mounted in the sump tank provides fuel motive flow. The quantity pumped by either pump exceeds that required for engine operation, and fuel not required by the engine is distributed to each tank where it passes through jet pumps. These uplift more fuel by venturi action.

- 1.6.10 Fuel from each rear tank jet pump is fed forward to its corresponding front tank (direct to the sump tank in the case of the left rear tank). Fuel from the front tank jet pumps is delivered to the sump tank. Overflow from each front tank goes via a non-return valve to the corresponding rear tank. Thus, the front tanks are kept full continuously until all rear tank fuel is consumed.

- 2.2 A notable feature of the 750XL fuel system is the continuous topping up of the front tanks by motive-flow transfer from the rear tanks, until the latter are empty. Only then will the contents of the front tanks begin to decrease. With the ferry tanks configured to replenish the rear tanks periodically, a considerable time will elapse before this happens.

- 2.3 The observations of the refueller at Hilo are particularly important. Fuel was escaping from around the left front fuel cap and running on to the apron, and the pilot had placed a bucket from the fuel truck under the wing in an attempt to minimise the spillage. This suggests that the aeroplane was standing in a slightly left-wing-low attitude, from either a sloping apron surface or asymmetric compression of the main gear legs. (Fuel was not able to flow under gravity from the ferry tanks to the front tanks.) Had the aeroplane been standing absolutely wings level or slightly right wing low, this leakage would not have been noticed.

- 2.4 The pilot’s comments that it would stop as soon as he started up and taxied were not supported by the system design – the loss would simply become less obvious. On virtually any other aeroplane type he may well have been correct, in that once the aeroplane was airborne, a small amount would be lost through aerodynamic suction until the level dropped far enough below the filler orifice for no further loss to occur.

- 2.9 Given the pilot's propensity for taking every last drop of fuel possible, it is surprising that he dismissed the leaking fuel as insignificant. Simply removing the fuel cap and reseating it may well have cured the problem. If not, further investigation and rectification would be required before further flight. The pilot's comments suggest that he had not considered, or simply had forgotten about, the unusual feature of the fuel system in that the front tanks were continuously topped up, and thus fuel could be lost over a long period.
