Accidents Investigation Branch

**Report on the accident to
Twin Otter G-BGPC
at Laphroaig, Islay, Scotland
on 12 June 1986**

Aircraft Accident Report No. 4/87
(EW/C969)

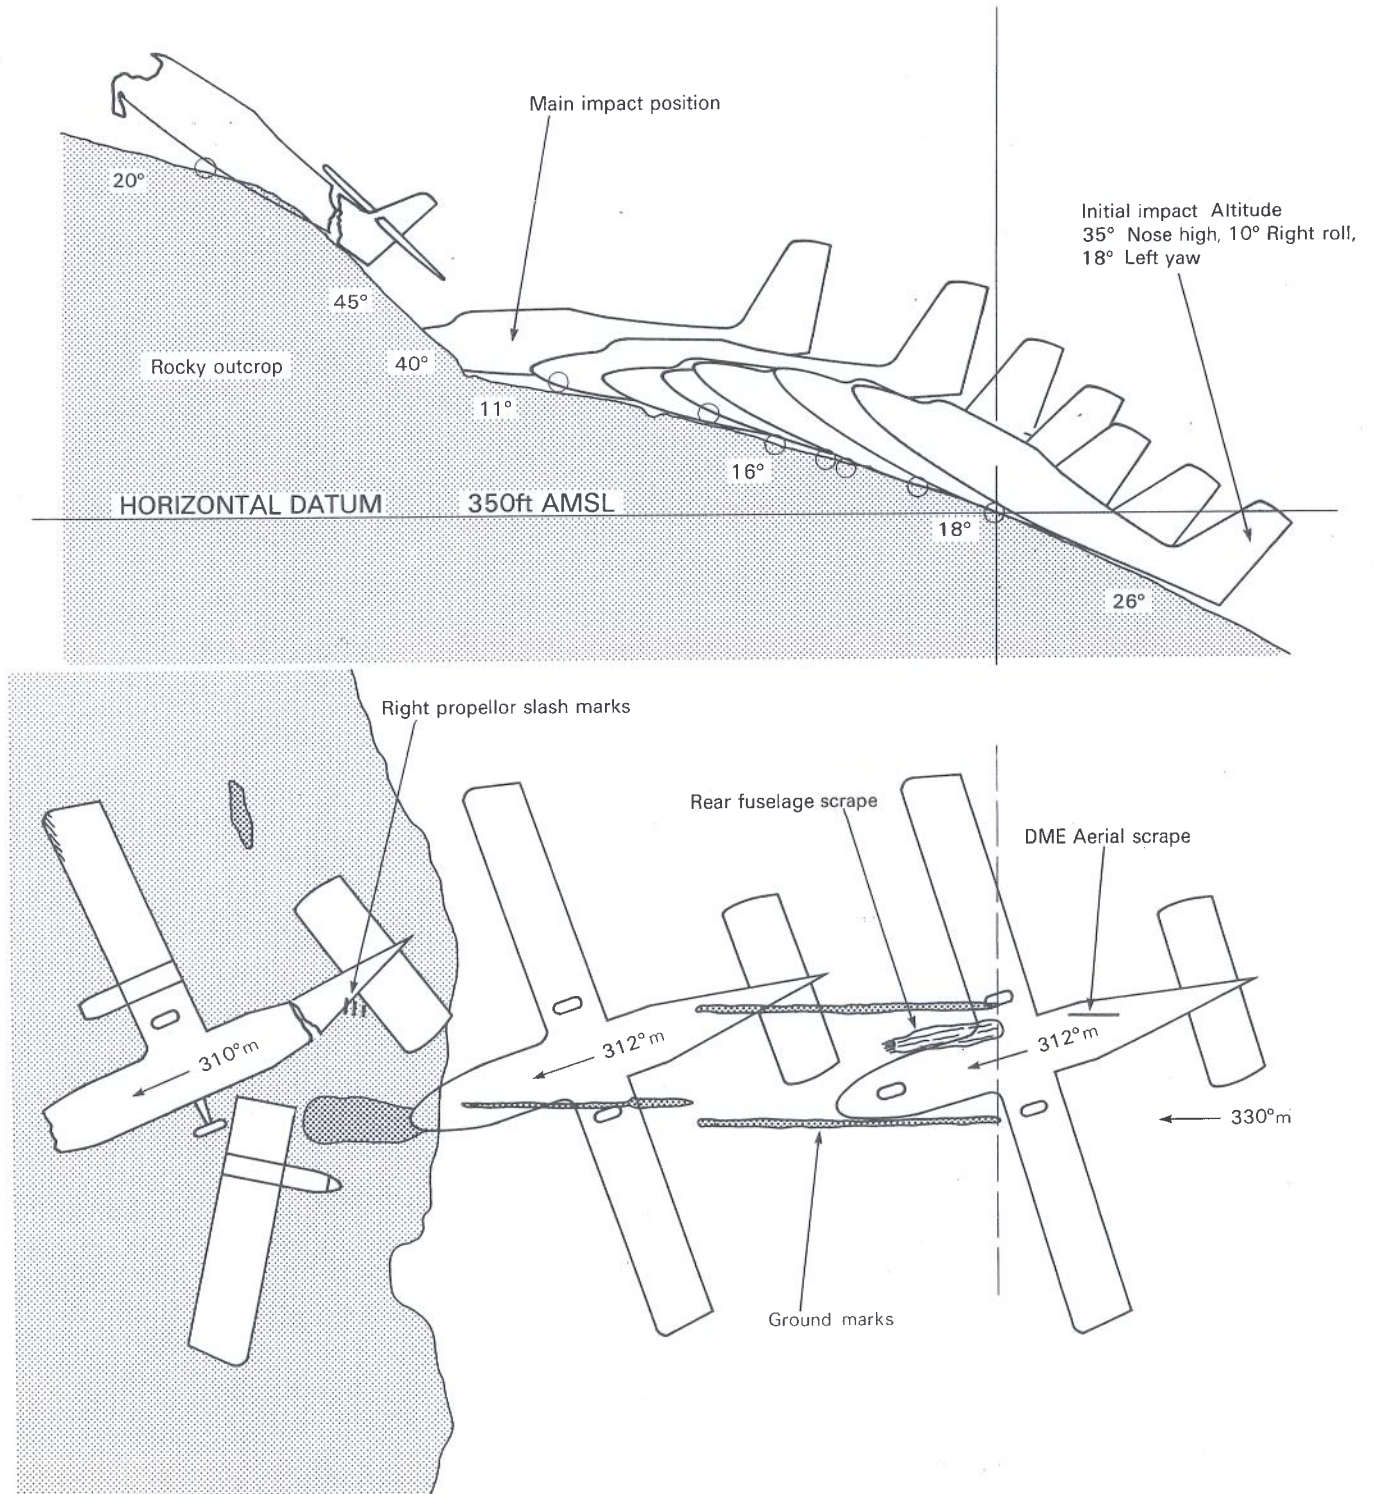
DIAGRAM SHOWING IMPACT SEQUENCE OF G-BGPC

After initially contacting the soft grass-covered slope, at a height of 360 feet amsl, the aircraft had pitched down, within its own length, to allow the nose landing gear to strike the ground firmly and, very shortly afterwards, to break off. It then continued in an almost level attitude, for a short distance, on the stub of the nose landing gear with the main wheels clear of the sloping ground. The nose then struck the steep rocky outcrop, whereupon the aircraft rapidly pitched nose up. In so doing the left wing rear spar-to-fuselage attachment failed, allowing the wing to pivot forward until failure of the front spar and wing strut attachments occurred. As a consequence of this sequence the left propeller blade tips, with the engine still under power, were able to enter the left rear side of the cockpit and subsequently strike the handling pilot.

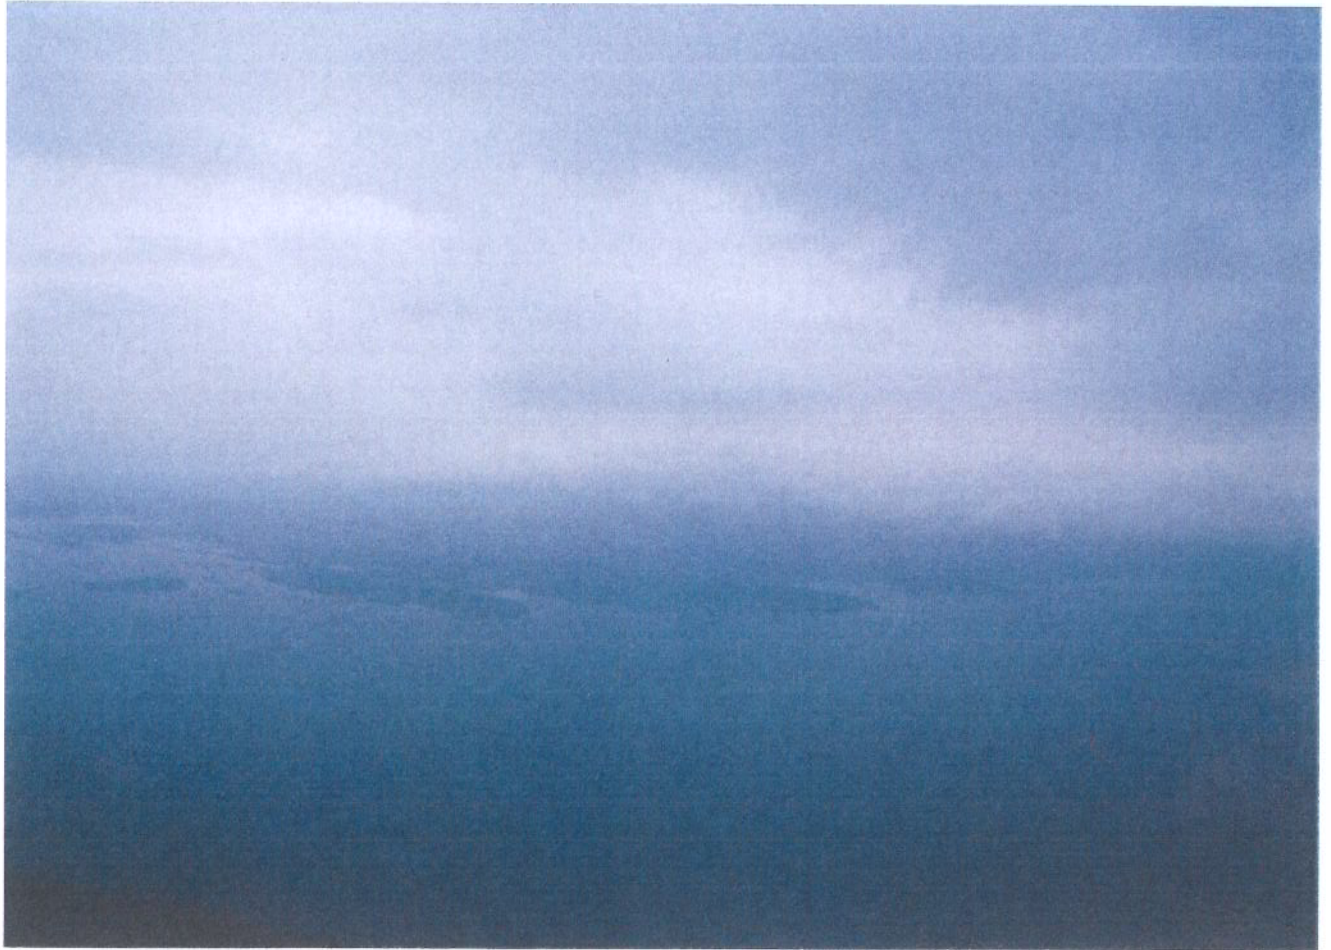
The weather on that morning was generally similar to that on 12 June 1986 in that a moist westerly airstream was producing extensive layers of stratus cloud; however, there was no precipitation and no significant cloud below 1000 feet. The aircraft was flown, at 6000 feet to overhead the Skipness VOR when a descent was commenced towards the south of the Isle of Islay. At the top of descent it was noticeable that the centre of the island and the high ground was obscured by cloud, but it was possible to see sufficient landmarks along the south coast through gaps in the cloud cover to enable a visual descent to be carried out. As the aircraft descended, conditions appeared to worsen as it became apparent that the tops of even the smaller hills inland were obscured by stratus (Photograph 1 in Appendix 5 refers).

The Island of Islay under typical stratus cloud in a westerly airstream
