NATIONAL TRANSPORTATION SAFETY BOARD

AIRCRAFT ACCIDENT REPORT

**BAR HARBOR AIRLINES FLIGHT 1808
BEECH BE-99, N300WP
AUBURN-LEWISTON MUNICIPAL AIRPORT
AUBURN, MAINE
AUGUST 25, 1985**

NTSB/AAR-86/06

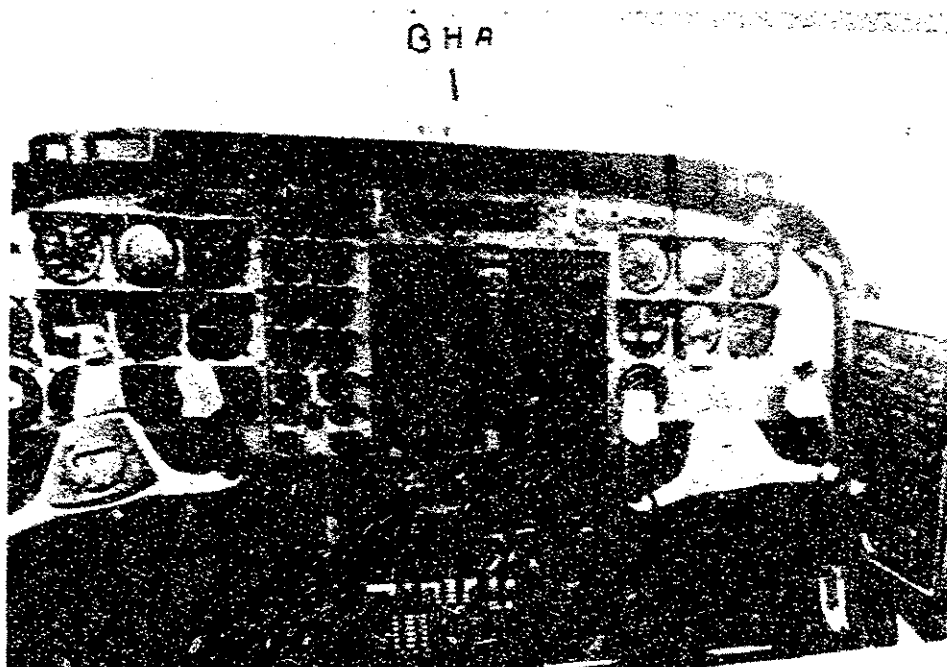
Figure 4.—Cockpit instrument panel and right controls.

A NARCO DME-190 receiver, which was installed in the lower part of the center panel, sustained substantial impact and internal heat damage. It disclosed no useful information. (See figure 4.)

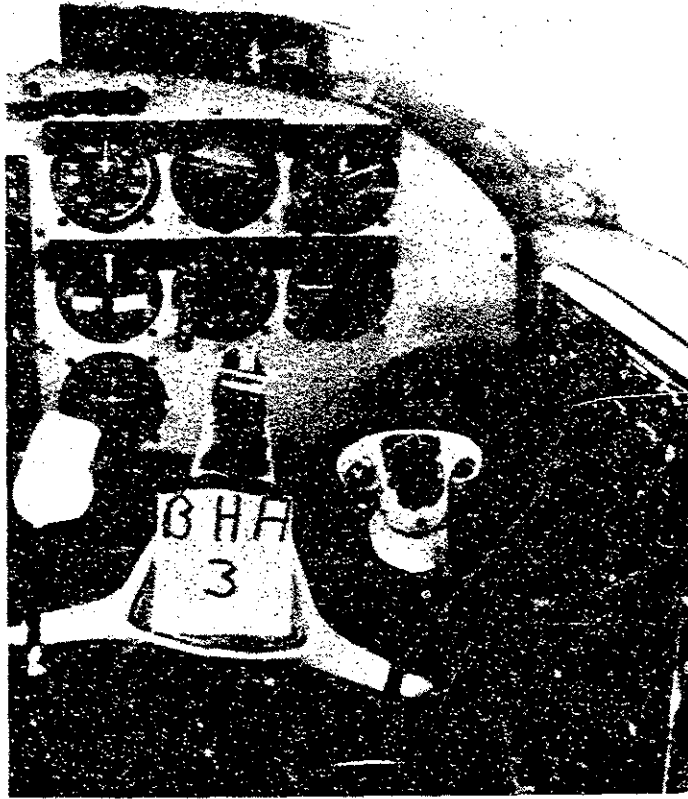
A King KI-214, VOR/LOC Converter Indicator with glideslope, installed in the lower left-hand corner of the first officer's instrument panel, sustained damage to both the front and rear sides of the unit. (See figure 5.) The heading selector was set at 040. Although the VOR/LOC needle was stopped at 1 1/2 dots left of center and the glideslope (GS) needle was stopped at 1 1/2 dots below center, the manufacturer believed that both needles may have been displaced from their original positions and captured by broken glass and a distorted bezel. No meaningful information could be obtained from a similar unit installed in the lower left-hand corner of the captain's instrument panel. The "repeater" indicator installed to the right side of the captain's ILS indicator, and remoted to the No. 2 NAV, was not located. (See figure 6.)

Figure 5.—First officer's instrument panel.

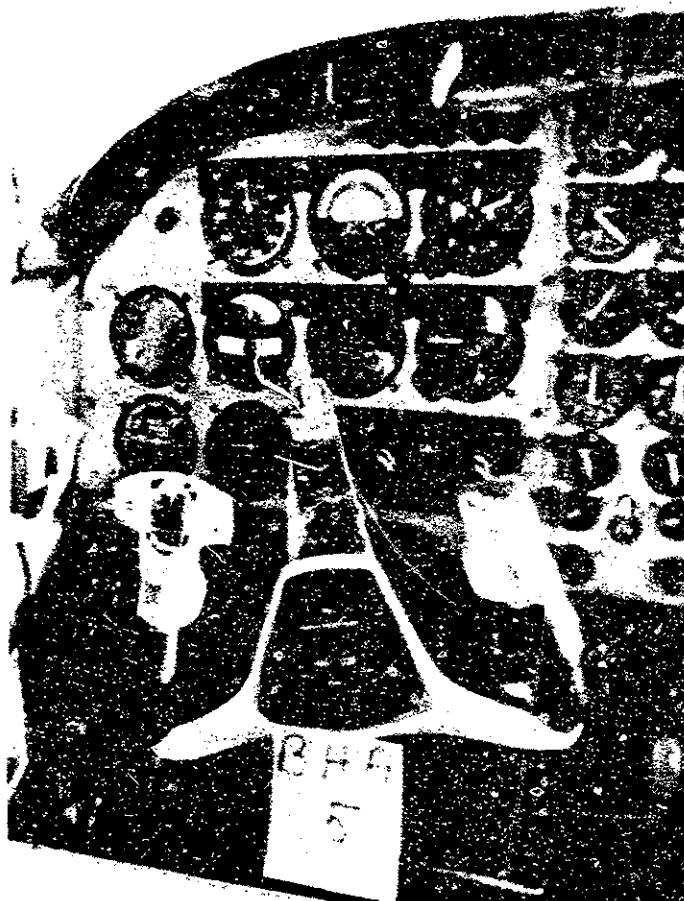
Figure 6.—Captain's instrument panel.

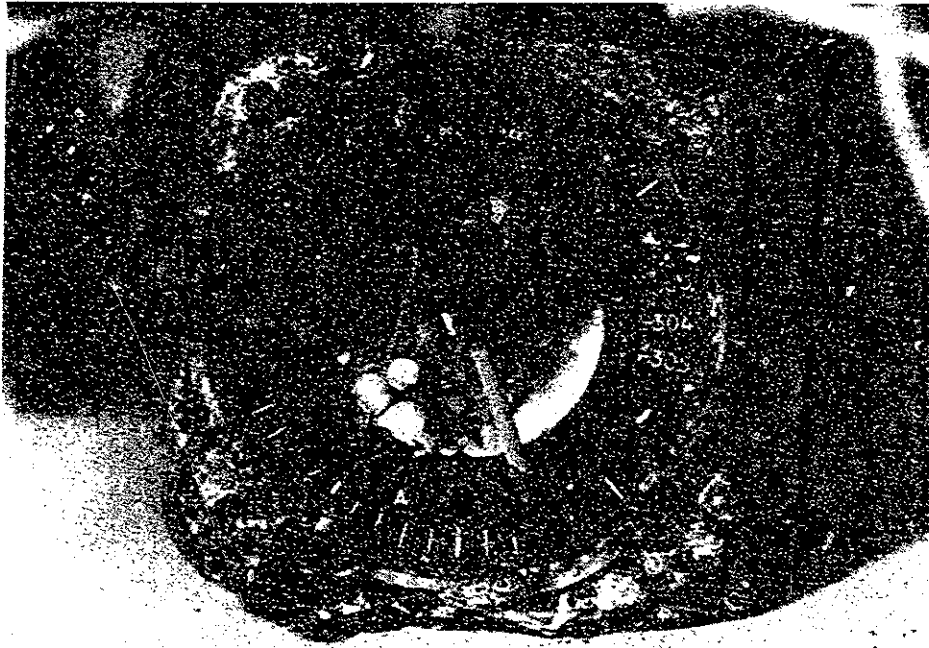
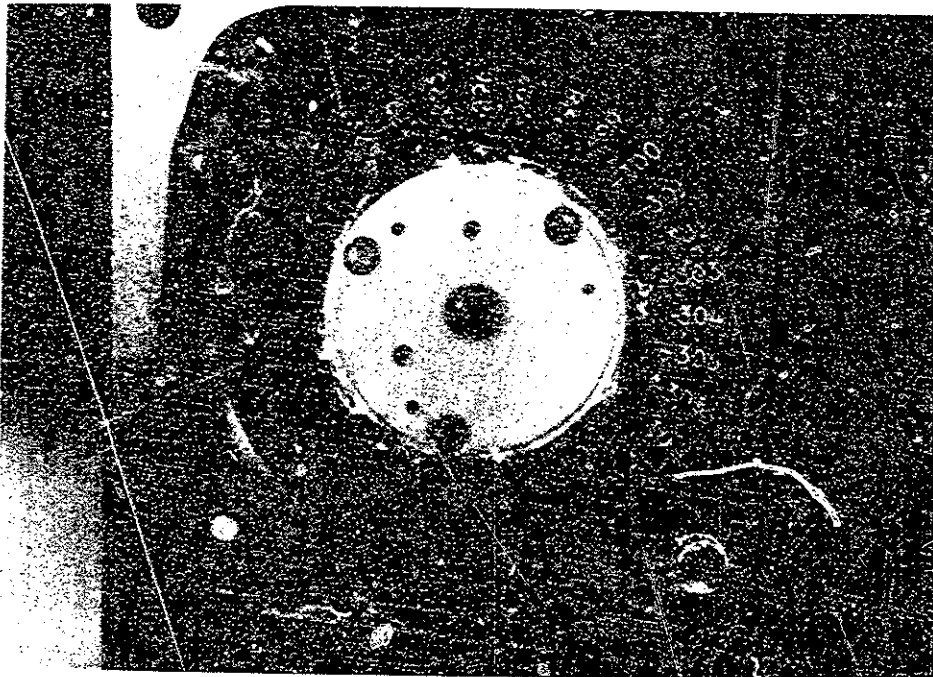
Extensive fire damage to the captain's altimeter. There was no evidence of barometric setting, gear system derangement and the gear train was in good condition despite the fire damage and moisture contamination found upon disassembly. There was no damage to the front end pressure gear train pivots and gears. The barometric setting adjustment knob shaft (steel) was bent and the case was melted against the shaft input gear which prevented the shaft from rotating. (See figure 7.) There were no broken pivots or jewels within the altimeter pressure mechanism. The primary damage to the altimeter was due to heat and moisture. There was no apparent indication of altimeter malfunction prior to impact and fire damage.

Figure 7.—Top view: Captain's Kollsman Alti-Coder II altimeter.
Bottom view: Position of the barometric dial showing the front end gear train and adjustment knob shaft at lower left-hand corner.

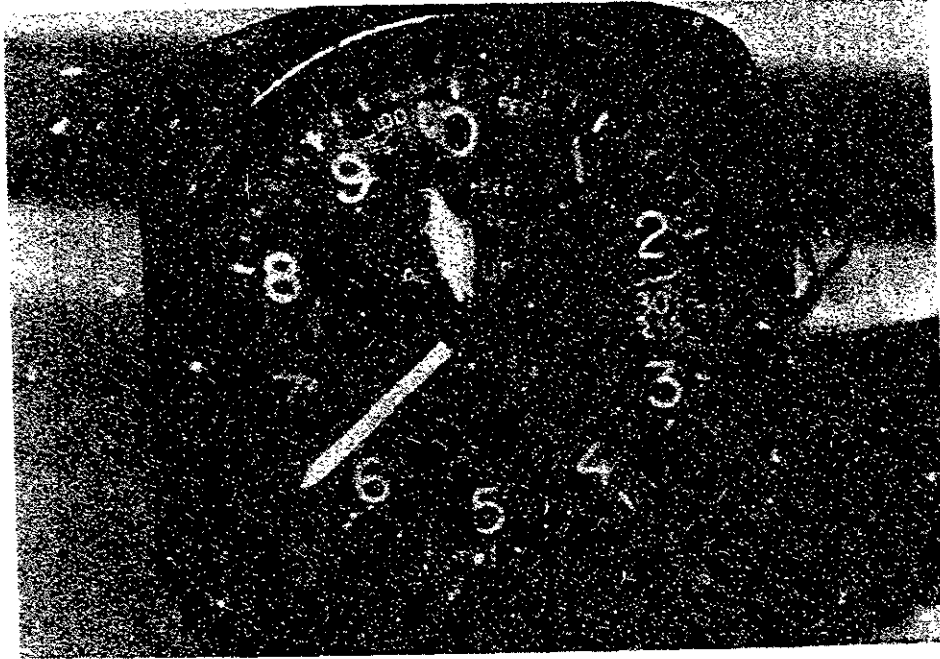
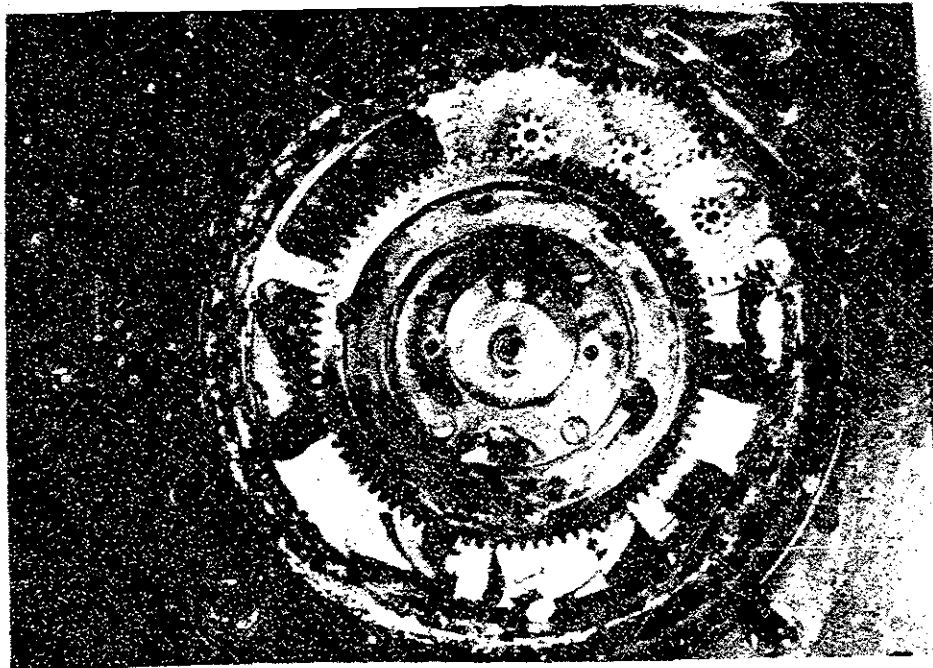
The first officer's altimeter showed little external fire damage, but extensive moisture and foam (white powdery substance) damage. The barometric adjustment knob was broken off at the flange and missing. (See figure 8.) Rotation of the case showed that the 1000-foot per turn needle was free to rotate, indicating that the shaft was broken. Disassembly revealed that the shaft was broken, but there was no apparent indication of derangement of the barometric setting gears as a result of the accident. There were several broken parts in the pressure mechanism and the intermediate gear shaft pivots as a result of impact forces.

Figure 8.—First officer's altimeter.
