Loss of Control While Maneuvering
Pilatus PC-12/45, N128CM
Butte, Montana
March 22, 2009

NTSB/AAR-11/05
PB2011-910405

Aircraft Accident Report

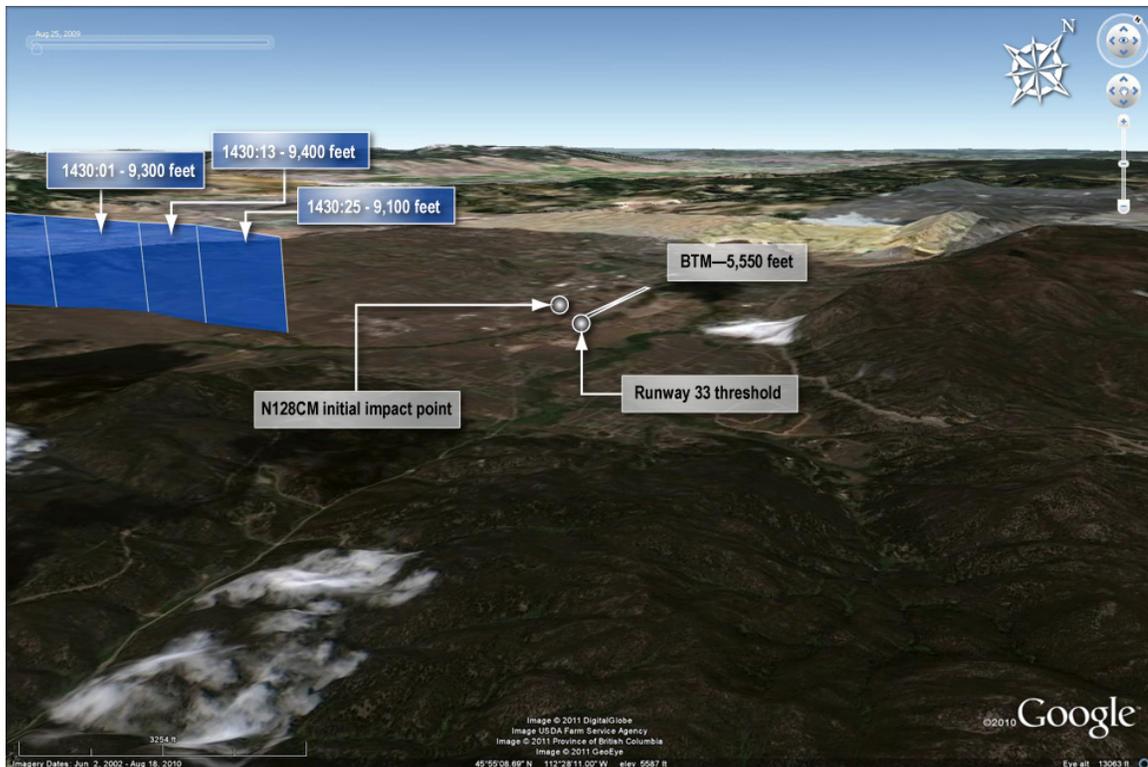
Figure 2. Final radar targets and terrain surrounding Butte, Montana (looking northwest).

The airplane impacted the ground about 2,100 feet west of the runway 33 centerline. The first emergency call reporting the accident to police was received at 1432:26. Witnesses to the accident reported that the airplane was approaching runway 33 at a higher altitude than other airplanes that land at the airport. The witnesses also reported that the airplane had entered a steep left turn at an estimated altitude of 300 feet agl and that the nose of the airplane then pitched down suddenly. No witnesses reported any indications of smoke or an in-flight breakup.¹⁸ CAWS data, along with radar data and assumptions about fuel burn (described in section 1.16.3) indicated a left-wing-heavy fuel condition before the accident occurred.

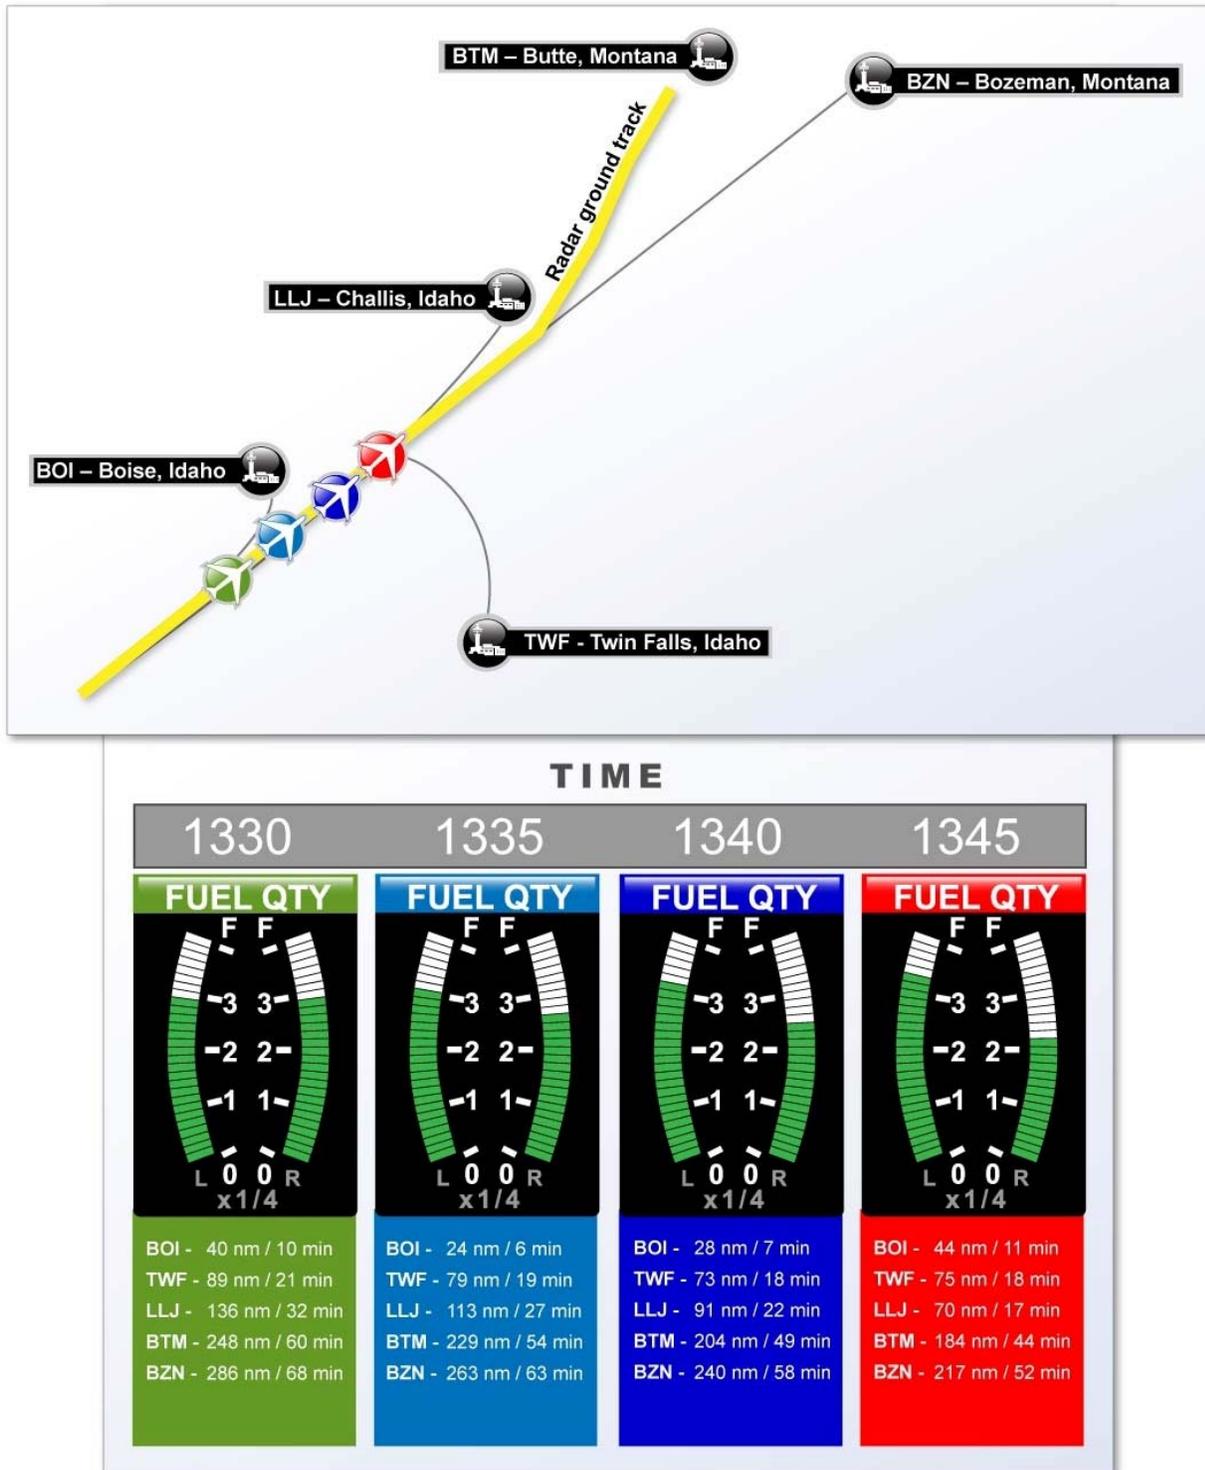
Figure 6. Available airports about the time of the maximum allowable fuel imbalance.

About 1400, the airplane was located about 16 miles and 4 minutes southeast of LLJ. Despite the airplane's proximity to LLJ and an estimated fuel imbalance of 15 bars, about 1402 the pilot initiated the divert to BTM, which was located about 119 miles and 29 minutes away. By 1405, while established on its new flightpath to BTM, the airplane passed LLJ. The next alternate airport along the route of flight, DLN, was located about 63 miles and 15 minutes to the northeast of the airplane's position. About 1415 and with an estimated fuel imbalance of about 22 bars, the airplane passed about 30 miles and 7 minutes to the west of DLN. At that time, the airplane was still about 55 miles and 13 minutes from BTM.

Figures 6 and 7 show the airplane's position along the route of flight in relation to the airports that were available for landing, the times and distances to the airports as the flight progressed, and the fuel imbalance at those times. The NTSB concludes that, if the pilot had diverted earlier in the flight to one of several suitable airports along the airplane's route of flight, the outcome of this flight would likely have been different because the airplane would have had a less severe fuel imbalance and the pilot would not have had to contend with the airplane's deteriorating performance as the imbalance steadily progressed.
