PB94-910404
NTSB/AAR-94/02/SUM

AIRCRAFT ACCIDENT/INCIDENT SUMMARY REPORT

IN-FLIGHT LOSS OF CONTROL,
LEADING TO FORCED LANDING
AND RUNWAY OVERRUN
CONTINENTAL EXPRESS, INC., N24706
EMBRAER EMB-120 RT
PINE BLUFF, ARKANSAS
APRIL 29, 1993

Accident No:	FTW93-M-A143
Airplane Owner/Operator:	Continental Express, Inc.
Airplane Type and Registration:	Embraer EMB-120 RT, N24706
Location:	Pine Bluff, Arkansas
Date and Time:	April 29, 1993, 1555 cdt ¹
Injuries:	13 Minor
Type of Occurrence:	Stall, Loss of Control, and Landing Overrun

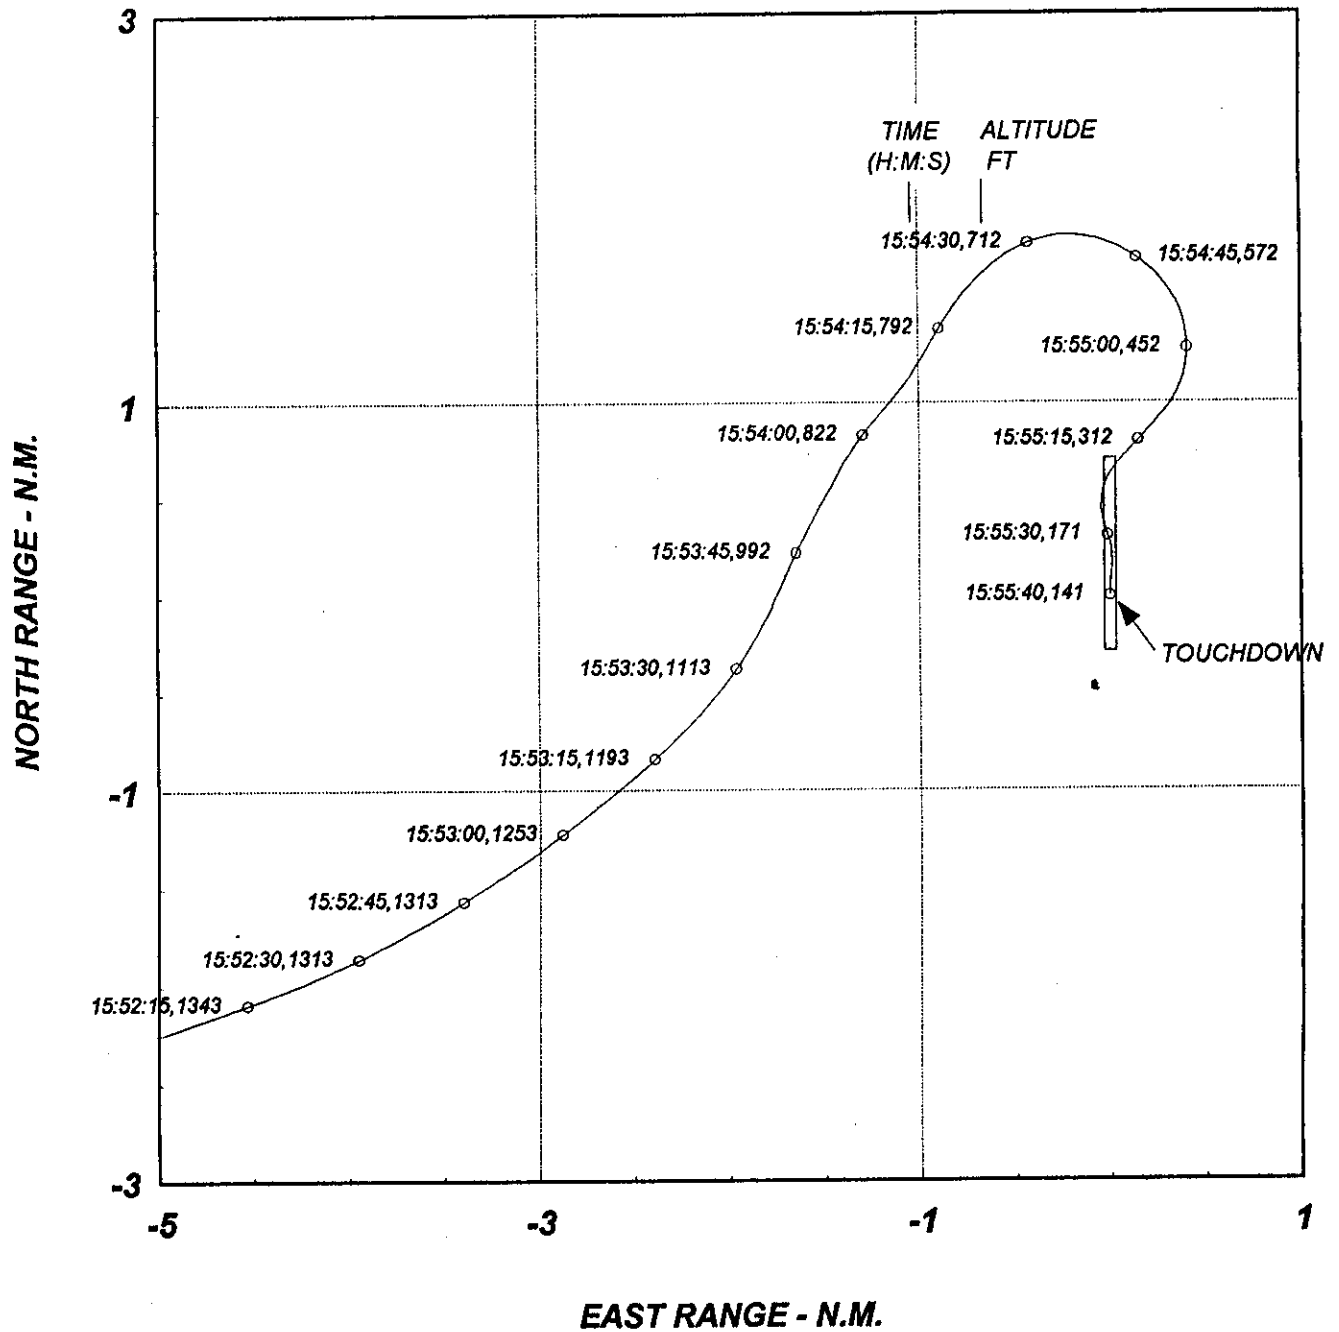
CONTINENTAL EXPRESS FLT 2733 APPROACH AND LANDING ON RUNWAY 17 AT PBF

that he overshot the right turn to final for runway 17 due to control problems. The investigation revealed that the airplane touched down with 1,880 feet of runway remaining. The captain further stated that he applied the brakes at touchdown and the airplane immediately began hydroplaning on the wet surface and went off the departure end onto wet rough sod, avoiding the vehicle and construction personnel that remained near the end. Both flightcrew members stated that braking action was nonexistent on the runway and that both braking and steering were nonexistent in the wet grass off the runway. Landing gear tire tracks were found on the runway consistent with those associated with hydroplaning.

Figure 2.--Flightpath of the airplane during the approach to PBF

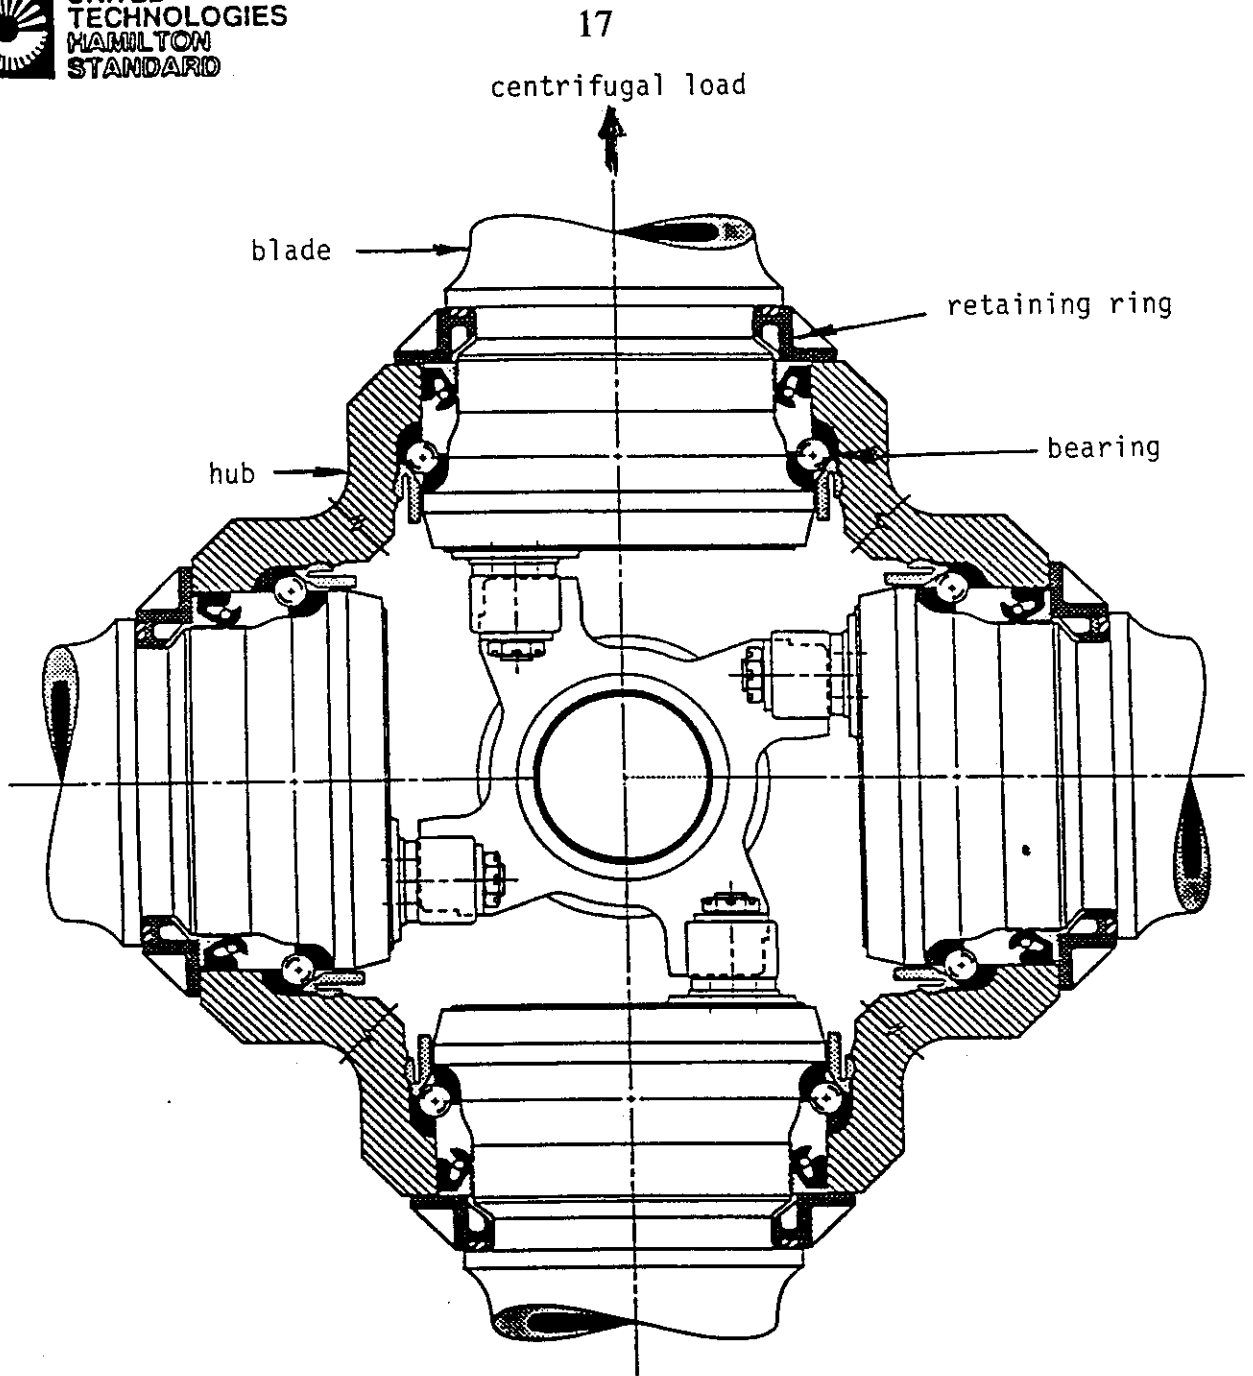
UNITED
TECHNOLOGIES
HAMILTON
STANDARD

The Hamilton Standard Model 14RF-9 propeller assembly consists of four blades inserted into a hub as shown in Figure 3. During normal operation, the blades are retained in the hub by high centrifugal loads holding the blade outward against the bearing, and any bending loads are overcome by the high centrifugal loads. When there are no centrifugal loads on the propeller assembly, the retaining rings will retain the blades statically from dropping into the hub.

The three propeller blades that separated from the left hub following the loss of control were never found. The fourth blade remained loose in the hub. Its pitch change pin and roller were pinched in the actuator yoke by a bent yoke arm. The FDR, flight data acquisition unit (FDAU), and CVR data indicated that the blade separation sequence probably started about 35 seconds after the onset of the loss of control. Postaccident examination of remnants of the left propeller system indicated that the hub was intact, and the individual blade deice leads were attached at the time of separation.

The hubs installed on the accident airplane were equipped with composite material (Rynite) retaining rings for each blade. The evidence indicated that the composite blade retaining rings fractured and led to the blade loss. During departure from normal flight attitudes, the roll and yaw oscillations cause significant angle-of-attack changes on the blades, which produce increasingly severe propeller cyclic loads. Damage signatures observed in the left propeller hub were consistent with the blade departing the hub by rocking in the plane of rotation. The rocking motion of the blades would load the retaining rings so as to produce a fracture.

Figure 3.--Hamilton Standard 14RF-9 Propeller Assembly

Following earlier blade loss events on other Hamilton Standard Model 14 propellers installed on other types of airplanes, the FAA issued AD 88-20-08 requiring the replacement of composite material blade retaining rings on those propellers with aluminum blade retaining rings. The 14RF-9 submodel, installed on the EMB-120, and the 14RF-21 submodel, installed on the CASA CN-235, were excepted from this AD. When AD 88-20-08 was created, it was thought that because the 14RF-9 and 14RF-21 models were turned by lower power engines, their blade retaining rings did not need to be made of aluminum. Following this

accident, however, the FAA issued a notice of proposed rulemaking⁵ to propose an AD that would require the submodels 14RF-9 and 14RF-21 to also have aluminum retaining rings. The final rule has not been issued as of the date of this report.
