NATIONAL TRANSPORTATION SAFETY BOARD

AIRCRAFT ACCIDENT REPORT

UNCONTROLLED COLLISION WITH TERRAIN
AMERICAN INTERNATIONAL AIRWAYS FLIGHT 808
DOUGLAS DC-8-61, N814CK
U.S. NAVAL AIR STATION
GUANTANAMO BAY, CUBA
AUGUST 18, 1993

Abstract: This report explains the crash of American International Airways Flight 808, a DC-8-61, about 1/4 mile from the approach end of runway 10 at Leeward Point Airfield, U.S. Naval Air Station, Guantanamo Bay, Cuba, on August 18, 1993. The safety issues discussed in the report include flightcrew scheduling, the effects of fatigue on flightcrew performance, training on special airports, and the dissemination of information about special airports. Safety recommendations concerning these issues were made to the Federal Aviation Administration, American International Airways, Inc., and the Department of Defense.

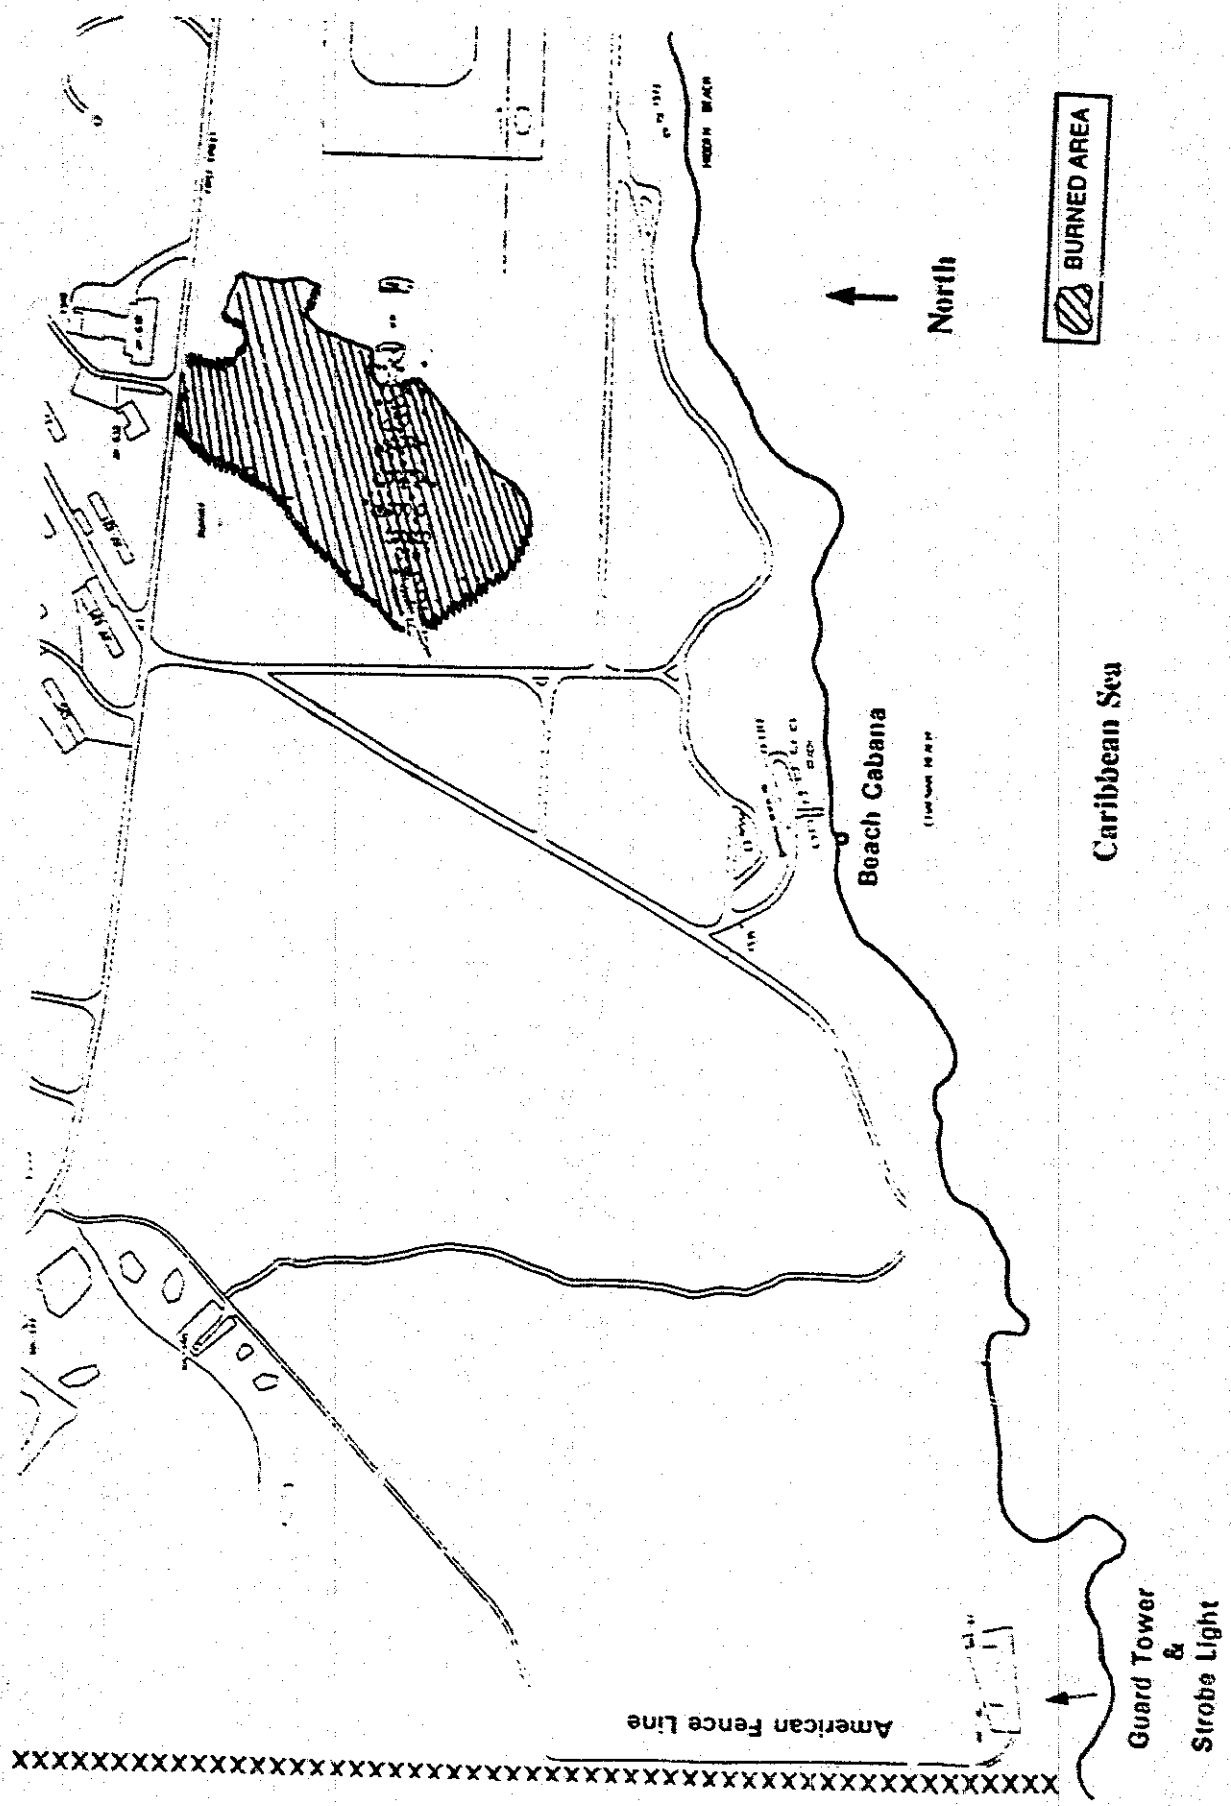
Figure 2.--Location of airplane wreckage.

The airplane initially struck the ground 200 feet north of the extended runway centerline and 1,400 feet west of the runway 10 threshold (see figure 2). The wreckage debris was oriented on a magnetic heading of approximately 100 degrees and extended for a distance of about 1,000 feet from the initial impact point. The debris found at the farthest point from the runway consisted primarily of right wing structure and skin, as well as parts from the Nos. 3 and 4 engines.

The initial impact mark was a thin, shallow trough that fanned outward to about 25 feet wide and extended 150 feet in the direction of flight. The right wing tip, found 200 feet north of the first impact point, exhibited compression damage and scratch marks that were consistent with the airplane in a roll attitude of 51 degrees at the point of initial ground impact.

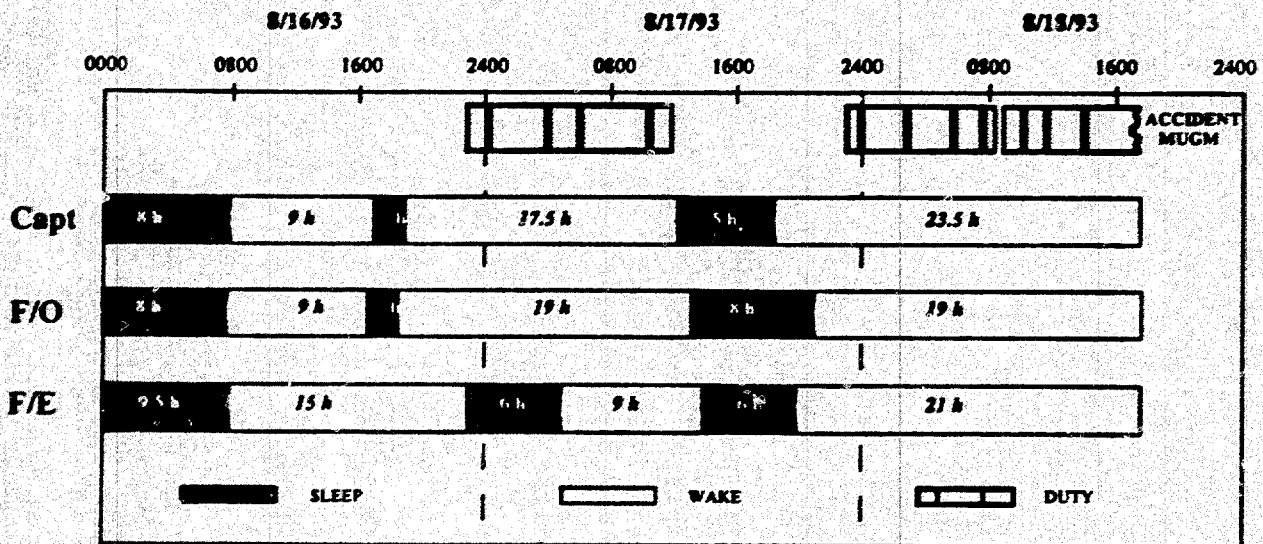
Figure 3.--Flightcrew sleep/wake histories.

The researchers found in their study of the crewmembers' sleep/wake periods that in the 28.5 hour period prior to the accident, the cumulative totals for sleep and wakefulness for the captain, first officer, and flight engineer were: 23.5 hours awake with 5 hours of sleep, 19 hours awake with 8 hours of sleep, and 21 hours awake with 6 hours of sleep, respectively. (See figures 3 and 4).

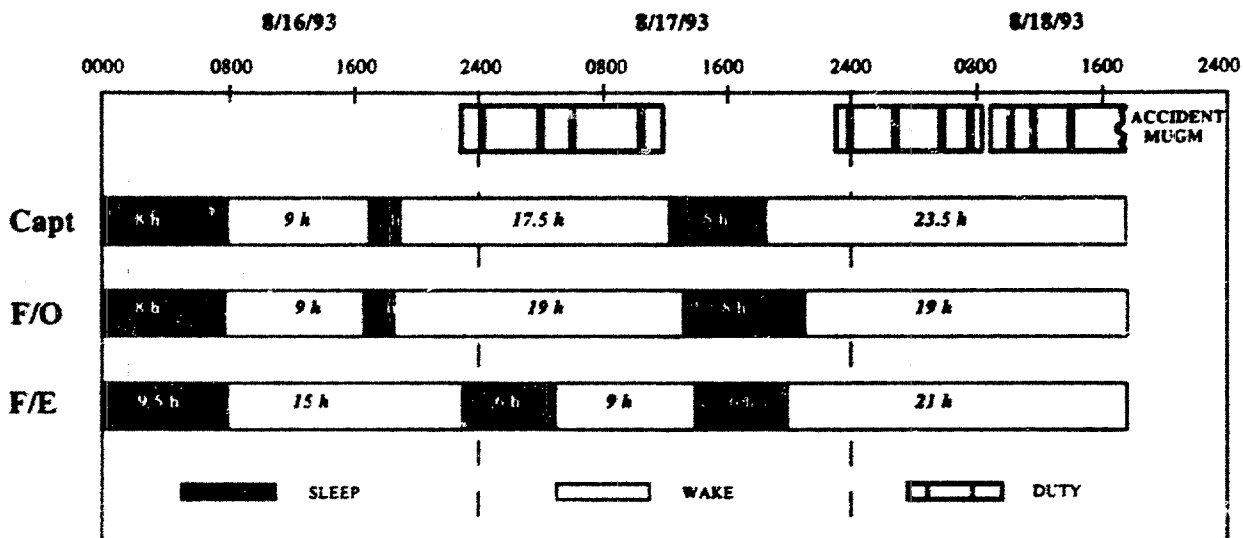
Figure 1. AIA Flight 808 Crew Sleep/Wake Histories

The first horizontal bar in Figure 1 displays the sleep/wake history of the Captain. He reported a typical sleep requirement of 8 hours. The Captain awakened on 8/16/93 after 8 hours of sleep and was awake for 9 hours before taking a 2-hour nap prior to his all-night duty period. Following his nap, the Captain was awake for 17.5 hours. He reported a 5-hour sleep period during a daytime sleep opportunity in a Dallas-Ft. Worth Airport hotel during layover. The Captain was then awake for 23.5 hours until the accident occurred at Guantanamo Bay. This 23.5 hour period included an all-night duty period after which the Captain was released from duty. However, he was called back to operate Flight 808 prior to his return home, and therefore was continuously awake until the accident.

Overall, this information demonstrates that the entire crew displayed cumulative sleep loss and extended periods of continuous wakefulness. It should be noted that the cumulative sleep loss can be partially attributed to the reversal of the circadian pattern, with nighttime sleep periods at home followed by daytime sleep periods due to all-night duty periods. Sleep obtained in opposition to the body's circadian rhythms is more disturbed than sleep that coincides with times when the body is programmed for sleep. The time of day factor also played a role. Also, the accident occurred at about 4:56 PM in the 3-5 PM window of sleepiness.

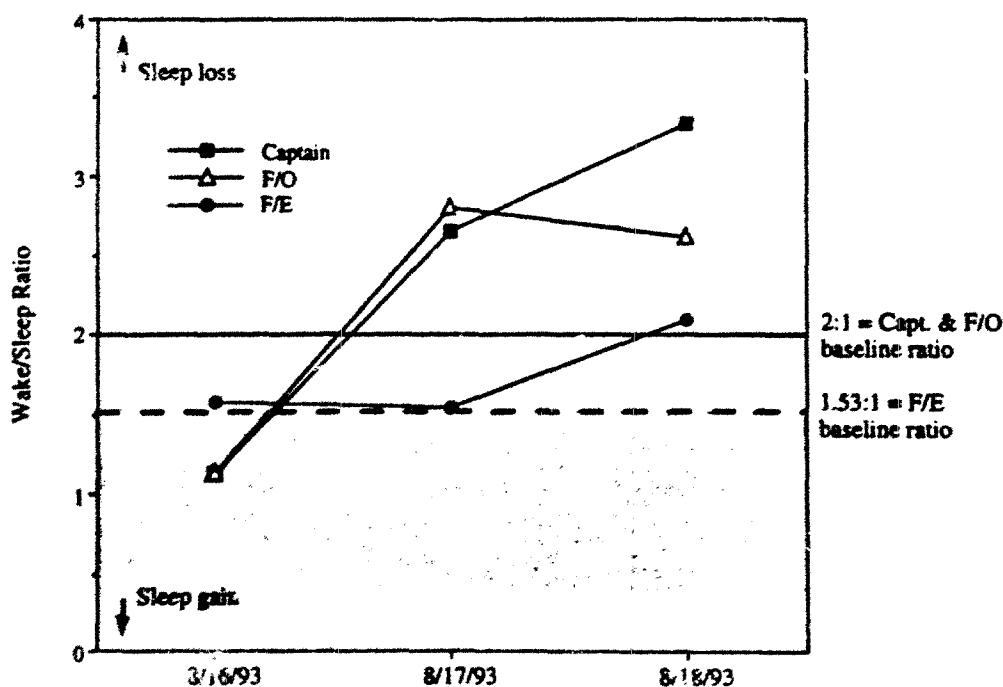
Figure 2. Cumulative Sleep/Wake Debt

The Captain and First Officer reported a usual sleep requirement of 8 hours and therefore, a wake/sleep ratio of 2 would be their appropriate self-defined norm. As evidenced in Figure 2, the wake/sleep ratio for both the Captain and First Officer is greater than 2 (indicated by the solid line) over the two days prior to the accident, reaching greater than 3 for the Captain. The Second Officer reported a usual sleep requirement of 9.5 hours. This represents a wake/sleep ratio of 1.53 as his self-defined norm (indicated by the dashed line). He approximates this on 8/16 and 8/17 and exceeds a ratio of 2 prior to the accident.
