# **NATIONAL TRANSPORTATION SAFETY BOARD**

## **AIRCRAFT ACCIDENT REPORT**

**CONTROLLED FLIGHT INTO TERRAIN  
FEDERAL AVIATION ADMINISTRATION  
BEECH SUPER KING AIR 300/F, N82  
FRONT ROYAL, VIRGINIA  
OCTOBER 26, 1993**

**Adopted: April 12, 1994  
Notation 6218B**

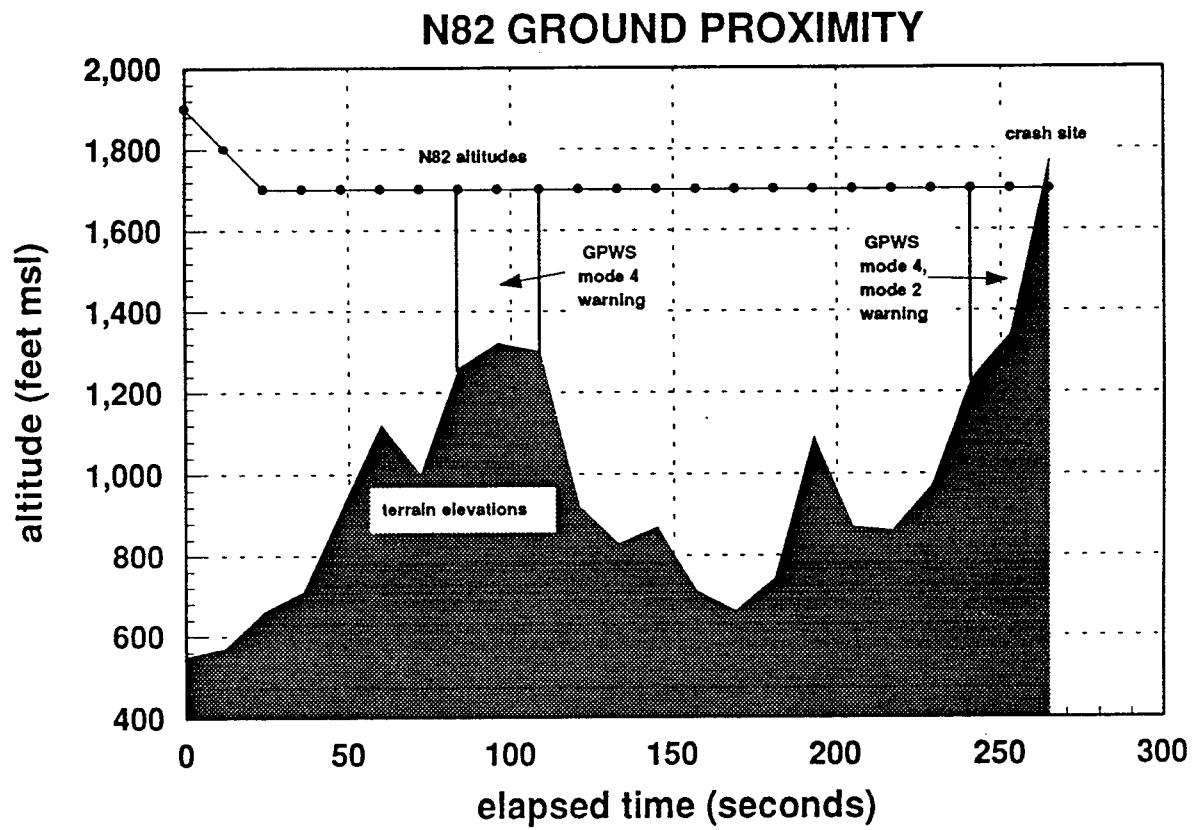
Figure 5.--GPWS warnings from ground track reconstruction.

<sup>11</sup>Modern GPWS equipment provides a variety of situational warnings. In the context of this accident, Technical Standard Order-C92b specifies that the mode four warning becomes active at an altitude below 500 feet agl and that the mode two warning becomes active at varying terrain closure rates related to height above the terrain.
