FINAL REPORT 96-71/A-16

Douglas DC-3C, Dakota, PH-DDA
near Den Oever
25 September 1996

Final report of the investigation into the probable causes of the accident with the Dutch Dakota Association, Douglas DC-3C, Dakota, PH-DDA near Den Oever on 25 September 1996, conducted by the Netherlands Aviation Safety Board, composed of:

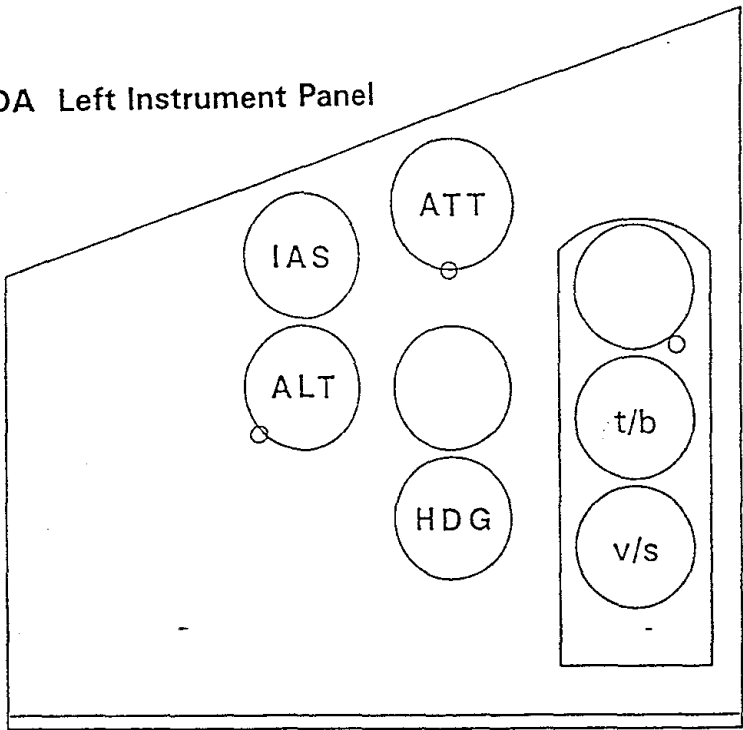
Figure 4

The layout of the flight instrument panels of the PH-DDA was not arranged according to the basic-T standard. In addition, the layout of the left panel was different to that of the right panel, and the distances between the respective instruments were up to a factor of 1.9 larger than basic-T distances (see figure 4 and 5).

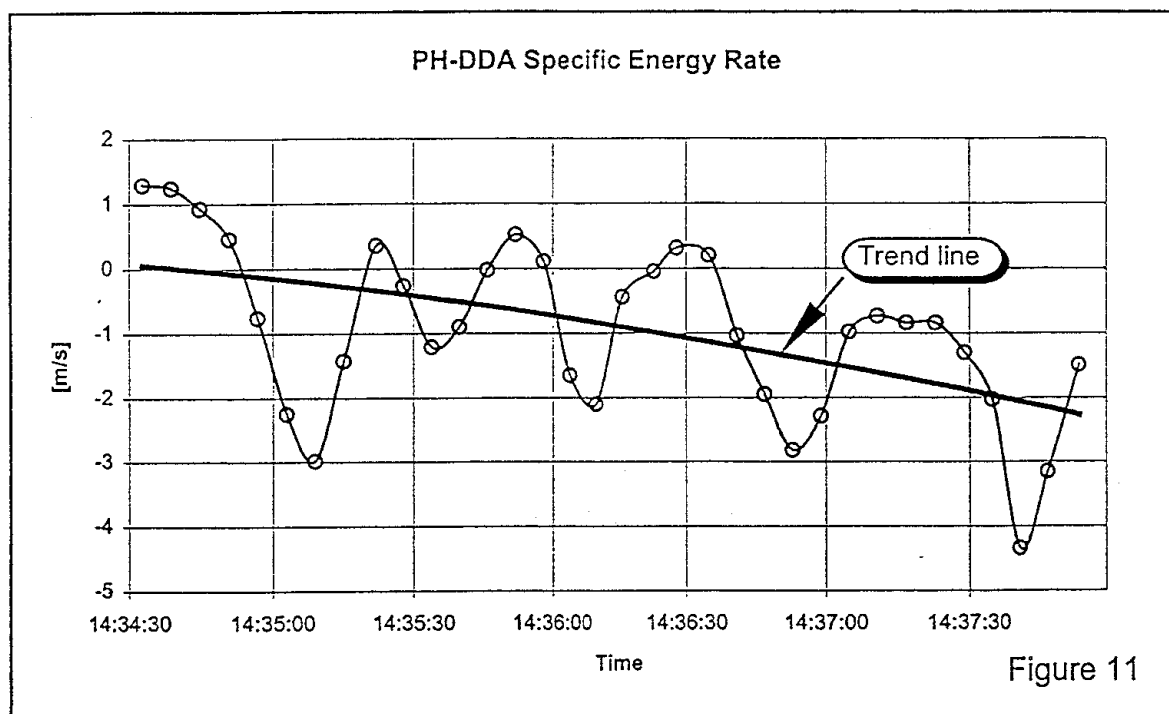
From the energy profile, as shown in figure 11, it can be concluded that the total energy of the aircraft is constantly decreasing, indicating that the aircraft had a power deficit to sustain level flight. To illustrate this, the power for level flight has been computed for each radar data point, using the associated airspeed and altitude for both feathered and unfeathered propeller. Results are shown in figure 13, indicating that with the propeller feathered excess power is available to either climb or accelerate, whereas with the propeller unfeathered a substantial power deficit is shown.

From figure 11 it can be further determined that the actual power deficit had a periodic nature.

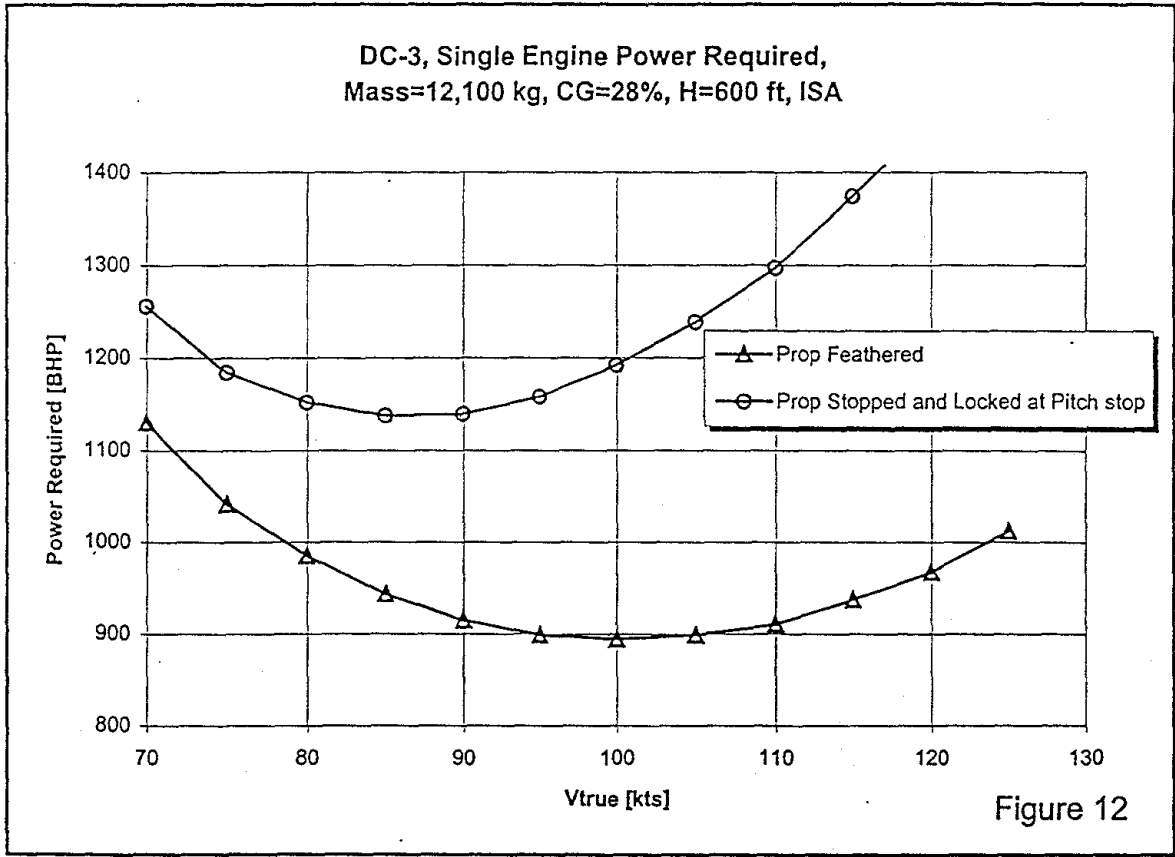
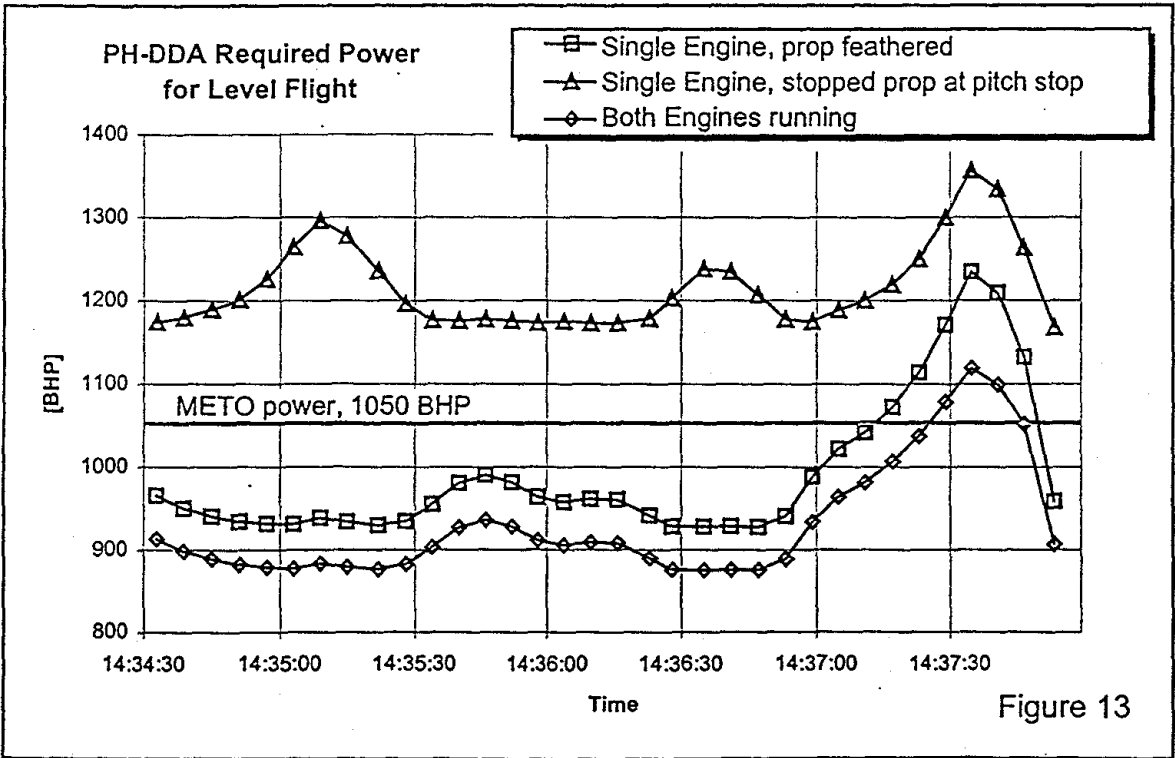
In figure 12 and 13 it is shown that available single engine METO power (1,050 BHP) is insufficient to sustain level flight, in case the stopped propeller is fully unfeathered.

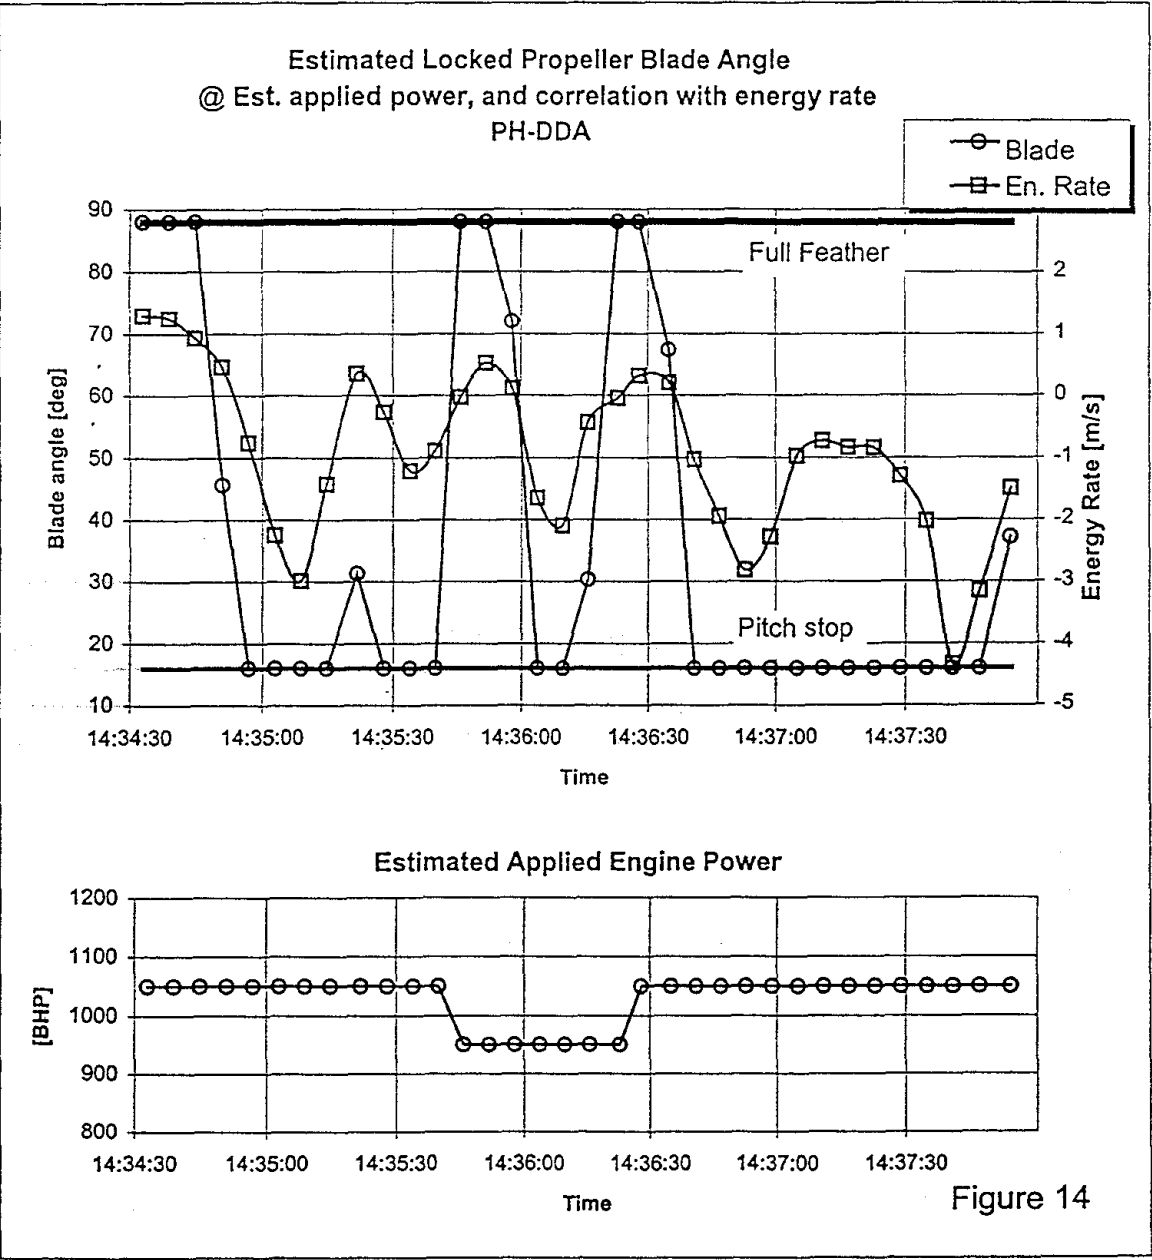
Figure 14

The stopped propeller blade angle estimated, using this scenario, is shown in figure 14. In the same plot also the specific energy rate is depicted, indicating a good correlation between the propeller blade position and energy rate. The plot on engine power shows the assumed power reduction.
