No. 96-006

Cessna 208 Caravan

ZK-SFA

Aircraft Accident Report No. 96-006

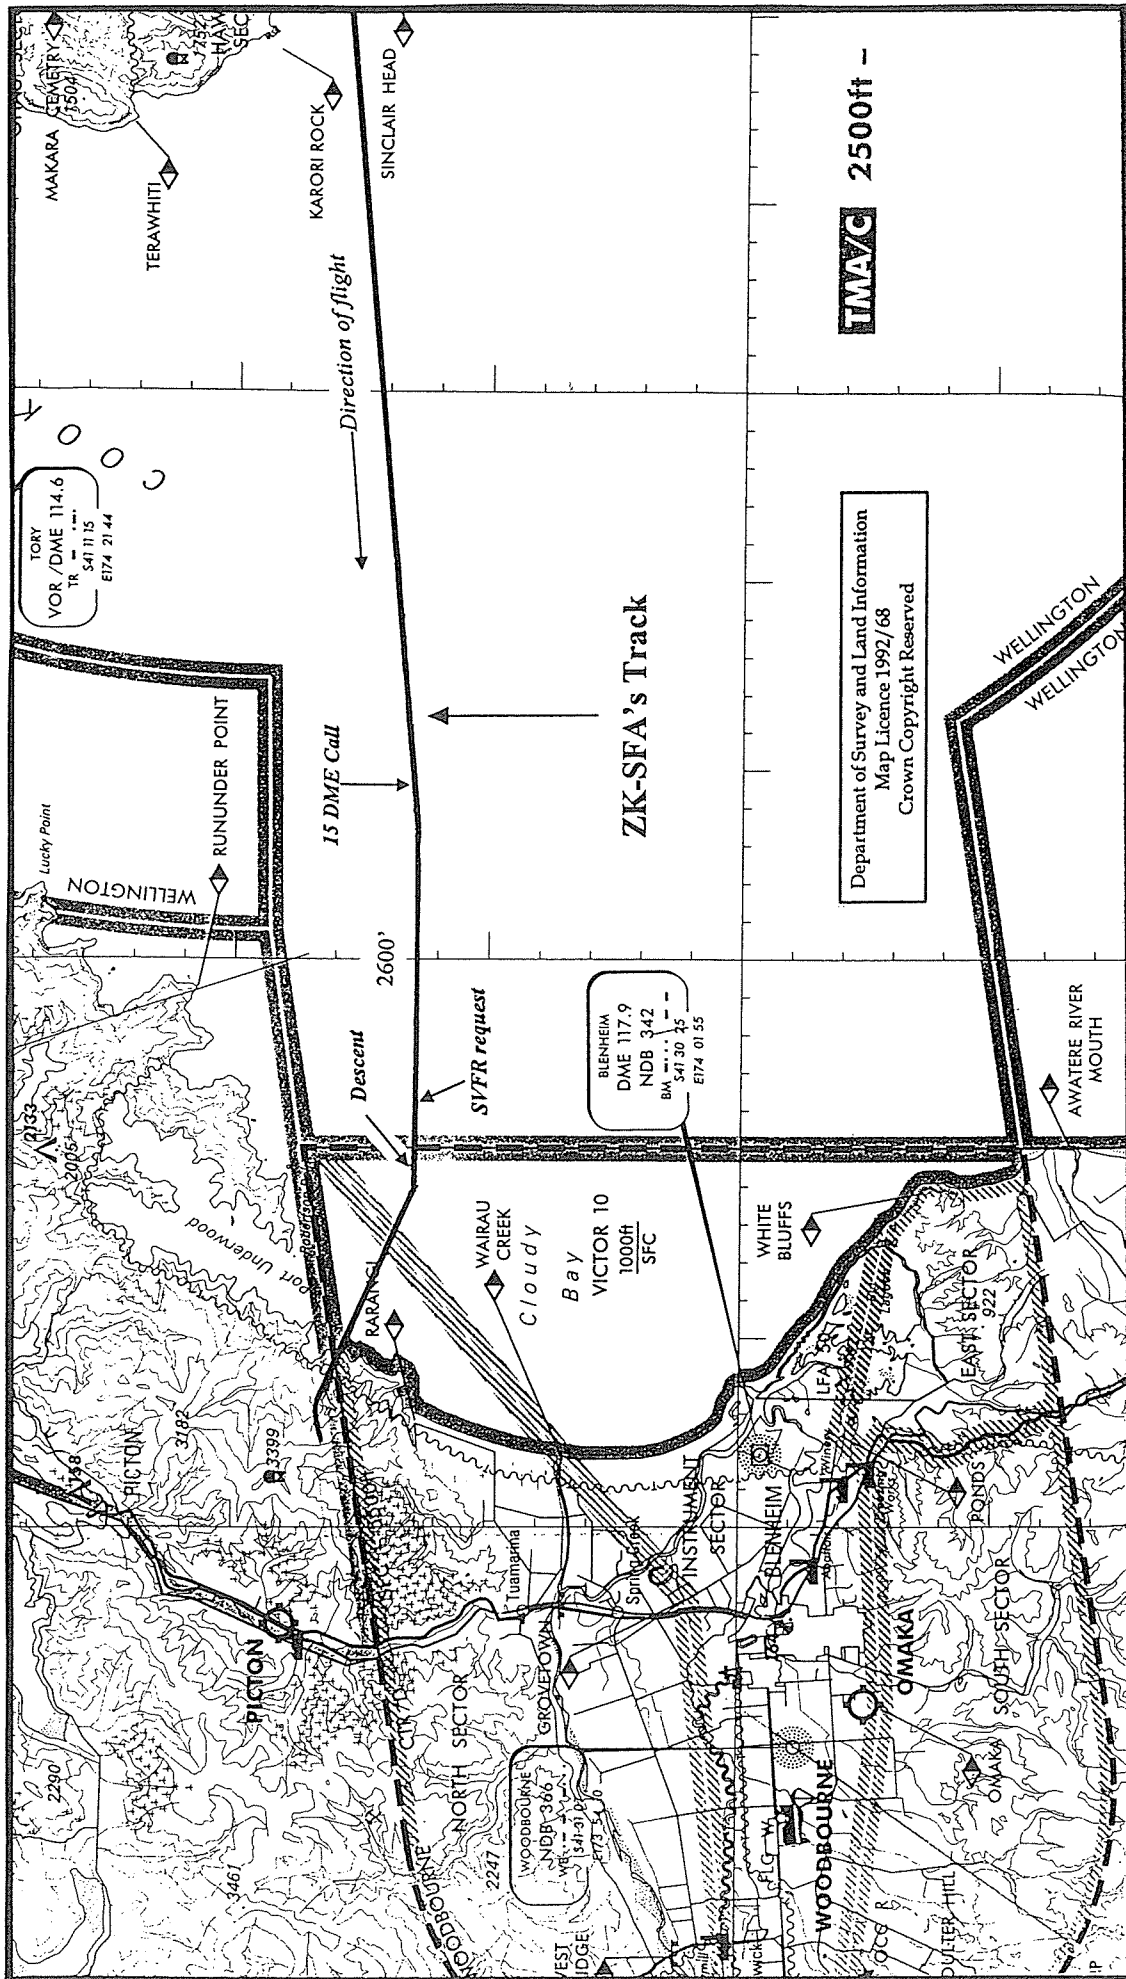
Diagram of ZK-SFA's track

- 1.1.7 The radar plot indicated that the aircraft commenced a descent at 1625 hours, about 3½ nm from the coast. The aircraft altered its heading some 23° to the right and continued on this new heading, crossing the coast 2 nm north-east of Rarangi. It descended to 1400 feet (according to the radar plot and unverified) and its ground speed increased from around 150 knots in the cruise to 173 knots.

- 1.1.8 The pilot recalled seeing a layer of “stratiform” cloud ahead, and decided to descend and track beneath the cloud to the southern end of the Koromiko valley, and then up the valley to Picton Aerodrome. He was anticipating a descent to between 1000 feet and 1200 feet and at that point there was nothing about the weather conditions and visibility to cause him concern. He expected the descent to be routine and believed he was tracking as planned. Apart from “turning slightly to the north”, after passing 15 DME, the pilot could not recall making a significant turn (see paragraph 1.18.5). As the descent progressed under the cloud layer the pilot became aware of clouds beneath him, and hills to his left and ahead of the aircraft. Then realising that he was north of Rarangi and his planned track, and rapidly approaching rising terrain, the pilot applied full power and at the same time initiated a left climbing turn to the south, towards lower ground. Shortly afterwards the aircraft collided with steeply rising, heavily wooded terrain on the eastern slopes of Mount Robertson. (See diagram).
