Aviation Investigation Report A99Q0151

Controlled flight into terrain

Raytheon Beech 1900D C-FLIH

12 August 1999

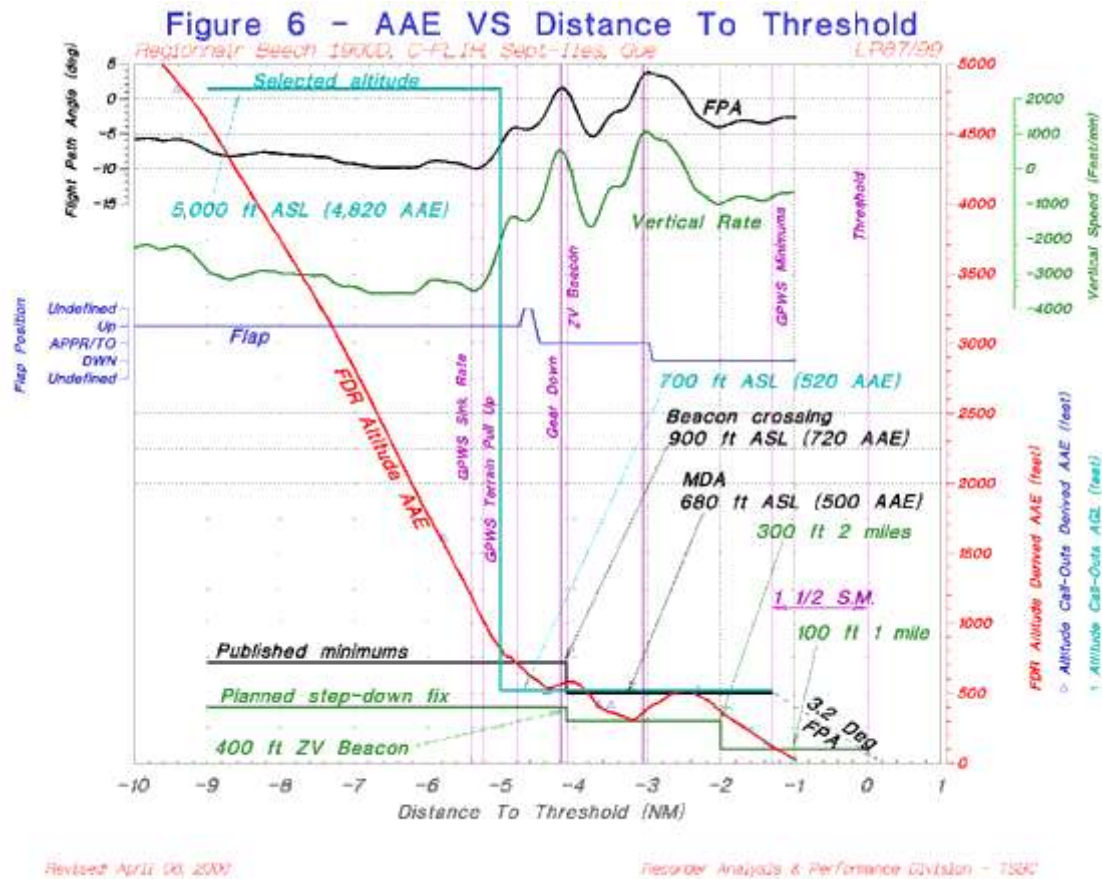
Appendix C—Flight Data Recorder Data

During the descent into Sept-Îles from cruising altitude, the aircraft's flight profile was high and fast in relation to its range to the ZV NDB. The captain felt that a shuttle-type manoeuvre such as a 360 turn might provide for a more stabilized approach beyond the beacon and expressed his concern. The pilot flying replied that this should not cause a problem, and the captain allowed the flight to continue. At 1 nm from the NDB, the aircraft's rate of descent was still approximately 3000 fpm. The airspeed was 200 knots, and the flaps and the landing gear were up. The approach flap was selected as the aircraft arrived at the NDB, but the pilot flying had to raise the nose of the aircraft to slow down to the landing gear limiting speed. The aircraft's rate of descent between the NDB and 2.5 nm from the threshold varied between 1000 fpm and 1500 fpm, after which it stabilized at 850 fpm until impact. The indicated airspeed decreased from 200 knots at the NDB to approximately 137 knots at 2 nm from the threshold, then increased steadily to reach 153 knots at impact.
