**REPORT ON ACCIDENT TO
M/S AERIAL SERVICES Pvt. Ltd. SUPER KINGAIR
B-200 AIRCRAFT , VT-EIE , ON JULY 29, 2000 ,
NEAR VILLAGE JHUGGI , H.P.**

INVESTIGATION REPORT OF ACCIDENT
TO SUPER KING AIR B-200 AIRCRAFT VT-EIE
NEAR VILLAGE JHUGGI
ON 29.07.2000

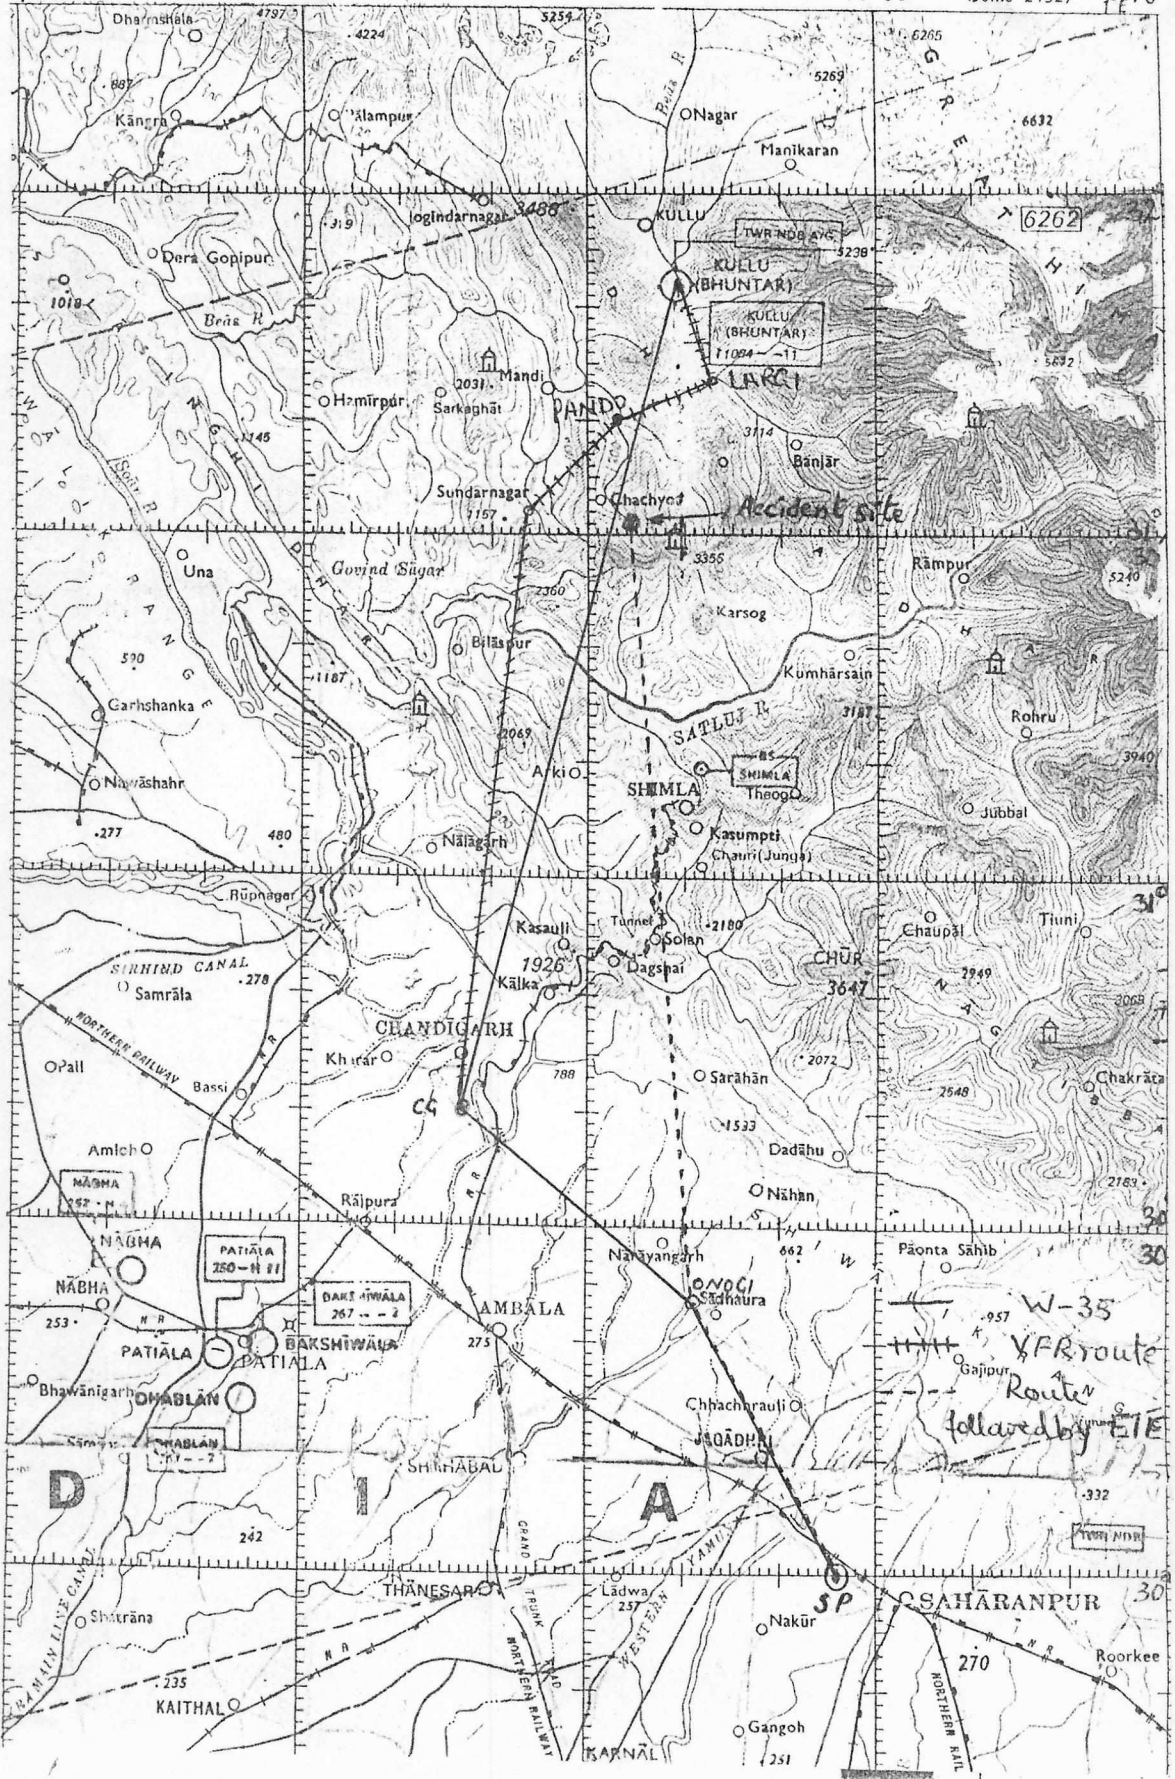
W-35
VFR route
Route followed by ETE
