Accident  
on 22 June 2003  
at Guipavas (21)  
to the Bombardier Canadair  
CL-600 2B 19  
registered F-GRJS  
operated by Brit Air

REPORT TRANSLATION  
[f-js030622a](#)

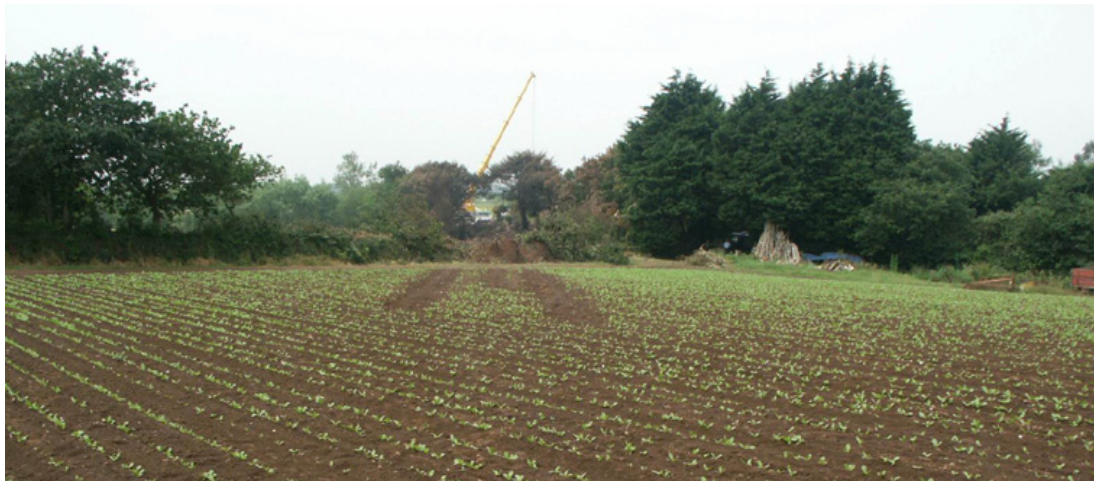
**Marks left by the main landing gear wheels**

First contact with the ground occurred in a mud field with a slight slope (about 3%). The main landing gear wheels left marks oriented along a 281° heading, without any marked furrowing, which indicates that the contact was not violent, with a low vertical speed.

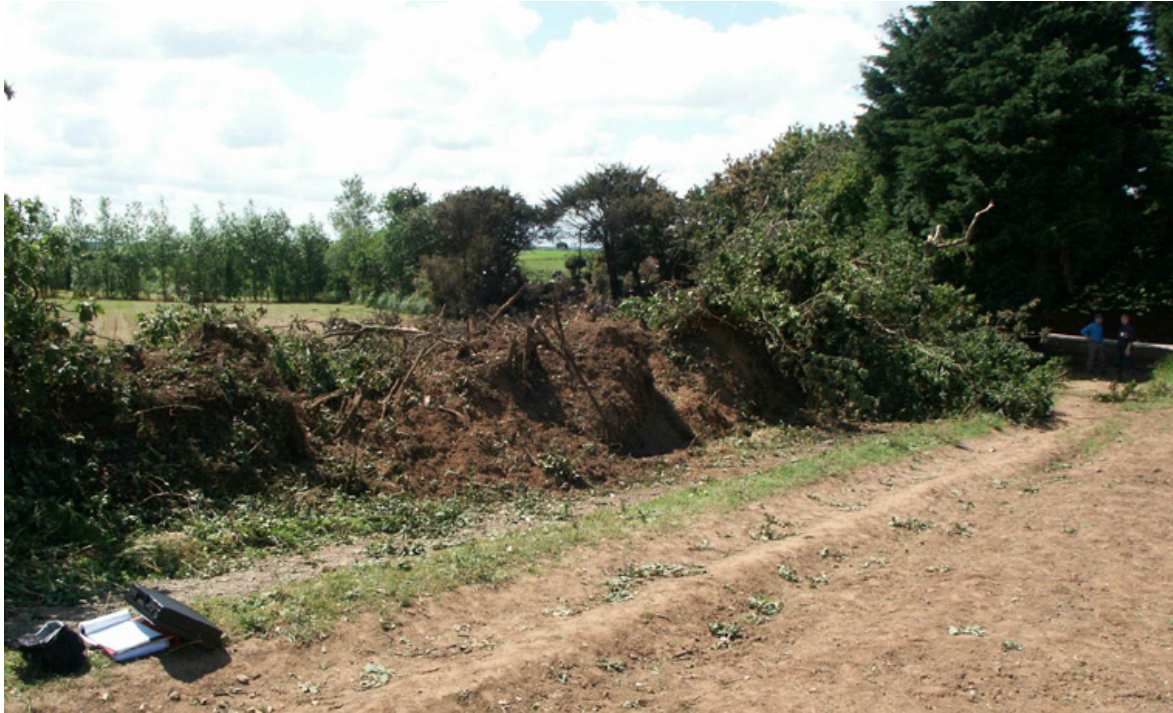
**Wooded embankment**

Thirty-four meters from the beginning of the marks left by the left main landing gear and forty-one meters from those left by the right main landing gear, the aeroplane struck a wooded embankment about one meter fifty high, oriented 45° to its path. On the embankment, the trees were cut off over a width of about twenty meters. In the middle of the damaged area, there were marks left by the two main landing gears. There were no marks attributable to the nose gear. The tip of the left wing, cut off at about one-third of span, was found about thirty-five meters from this point.

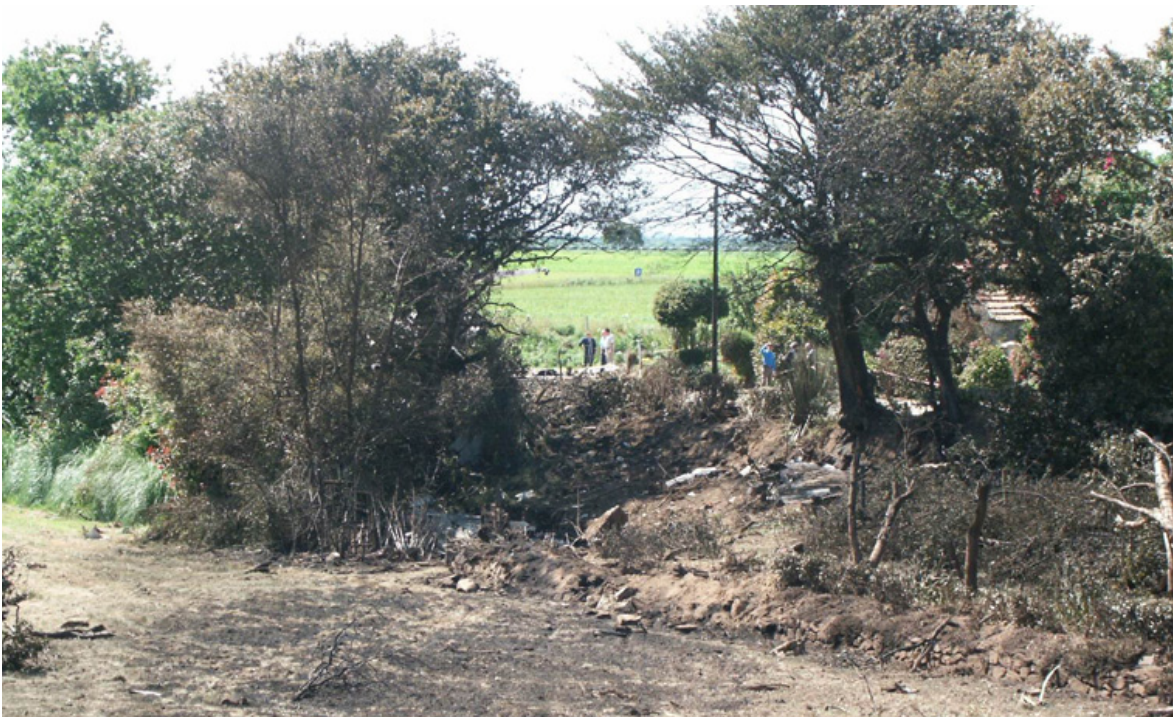
**Stone wall**

After the embankment, the aeroplane slid into a mown field. This was blackened by the fire. About fifty-five meters after the embankment, the aeroplane struck a stone wall about sixty centimetres high.

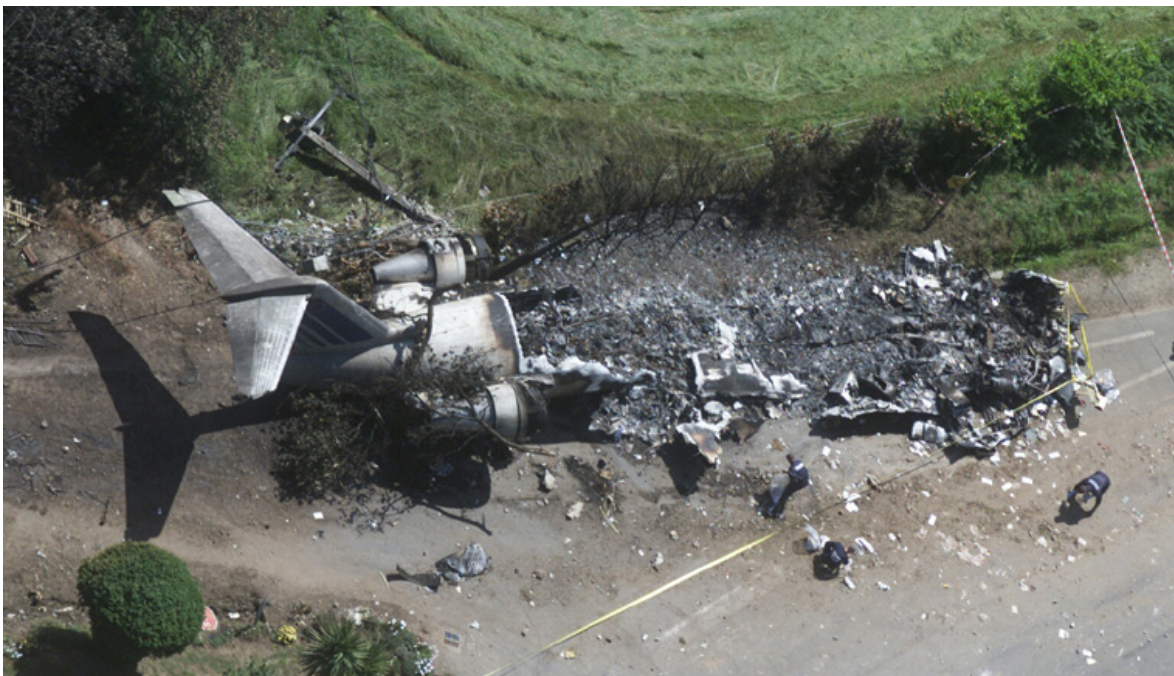
**Wreckage**

A few meters after the wall, some large trees were damaged. The tip of the right wing, cut off and with its winglet, was resting at the foot of a tree, about six meters from a shallow pond. The right wing, from the inboard flaps to the tip, was resting flat on the ground to the right of the pond in relation to the aeroplane's general path.

The left wing root and the left landing gear were on the other side of the pond, at the foot of a large tree, damaged. The inboard flaps were turned over but still attached to their hinges.

The right landing gear was cut off at the level of the main oleo strut and the end of the wing-side actuating cylinder. It was on the edge of the road, about fifteen meters from the right wing.

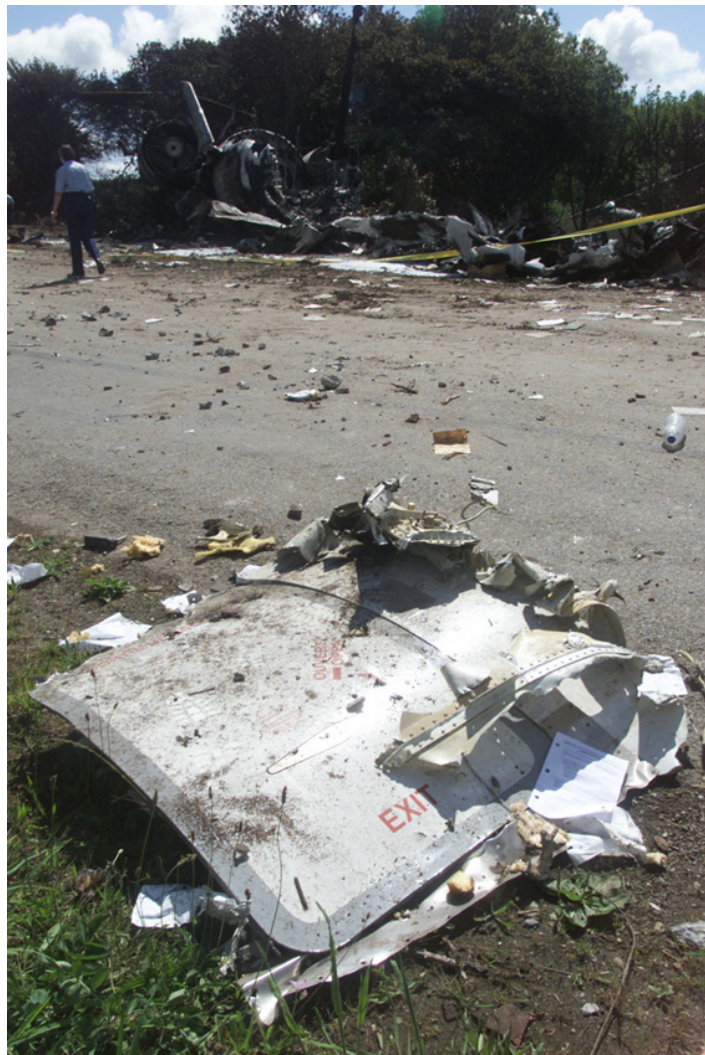
Forward right service door

The forward right service door, still attached to its frame, was partially cut off in the upper quarter. The handle was in the locked position. The tumblers and the control mechanism operated when the handle was moved. The door showed no traces of fire.
