AIRCRAFT ACCIDENT REPORT

4/2008 (ADC/2006/10/29/F)

**Report on the Accident to
ADC Airlines, Boeing 737-2B7
Registration 5N-BFK at Tungar Madaki, Abuja on
29th October, 2006.**

Aircraft Accident Report No: (ADC/2006 /10 /29/F)

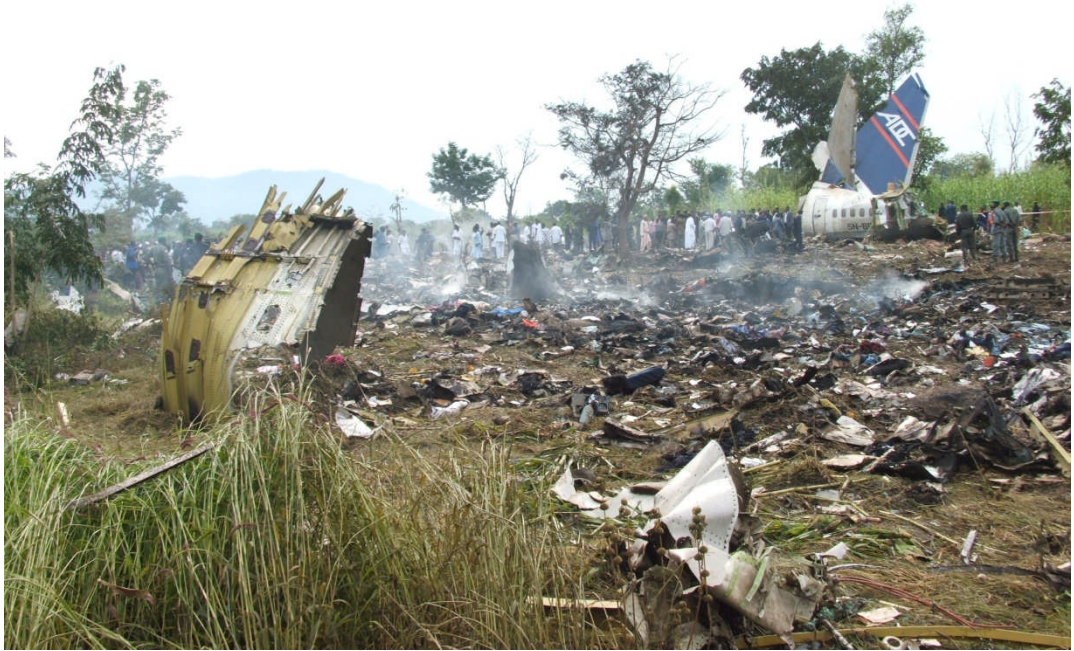
The aircraft was destroyed (See fig 1-1 and 1-2).

Fig 1-1 Photograph showing wreckage site

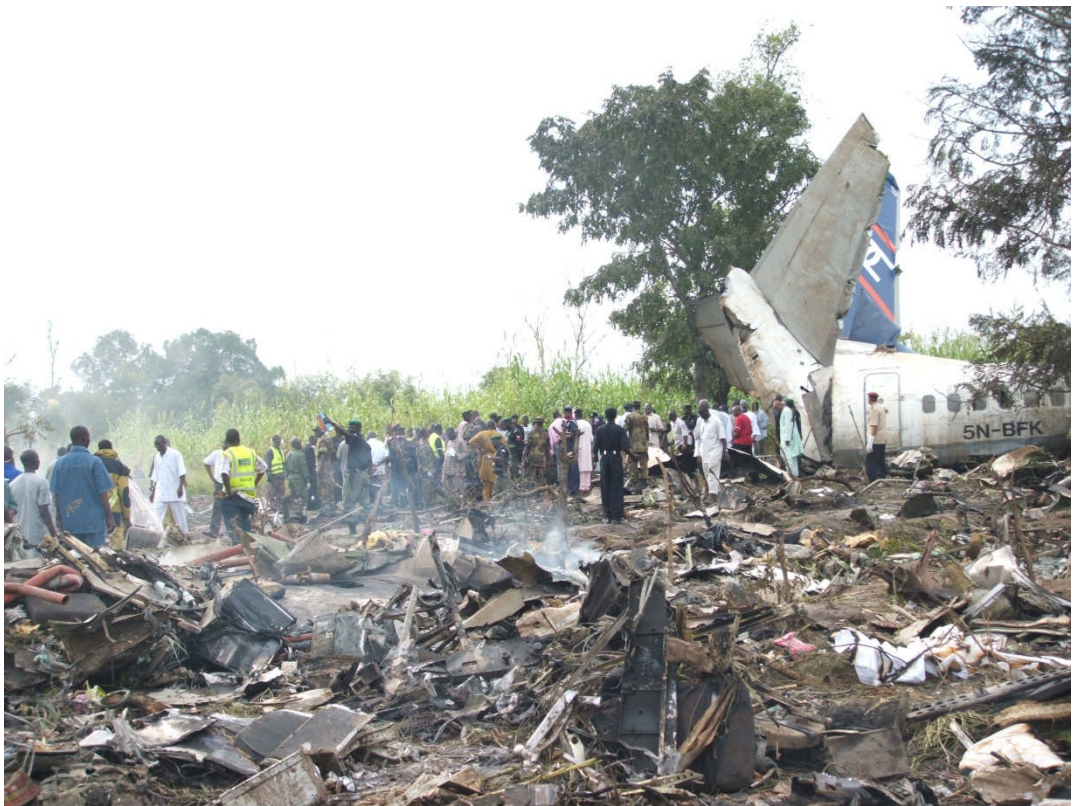
Fig 1-2 Photograph showing aircraft destruction

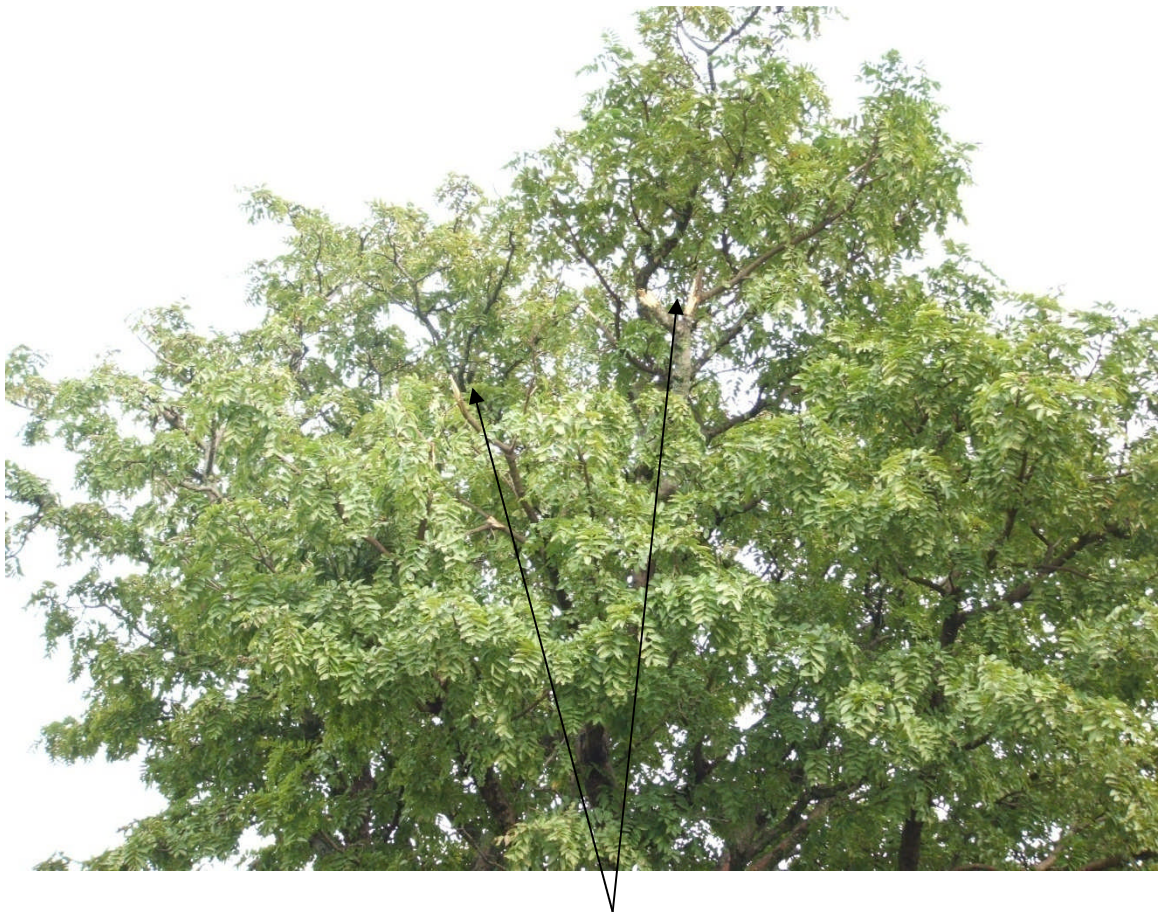
The left wing of the aircraft had the first contact with a tree branch and immediately a portion of the leading edge structure was severed from the wing as evident at the crash site, thereafter the aircraft impacted the ground. Evidence indicated that the impact was nose low and in an extreme left bank. The airplane disintegrated and much of the center wing box and attached right wing caught fire. (See fig. 1-4 and fig. 1-5).

Fig 1-4 Arrow showing first contact with the tree before ground

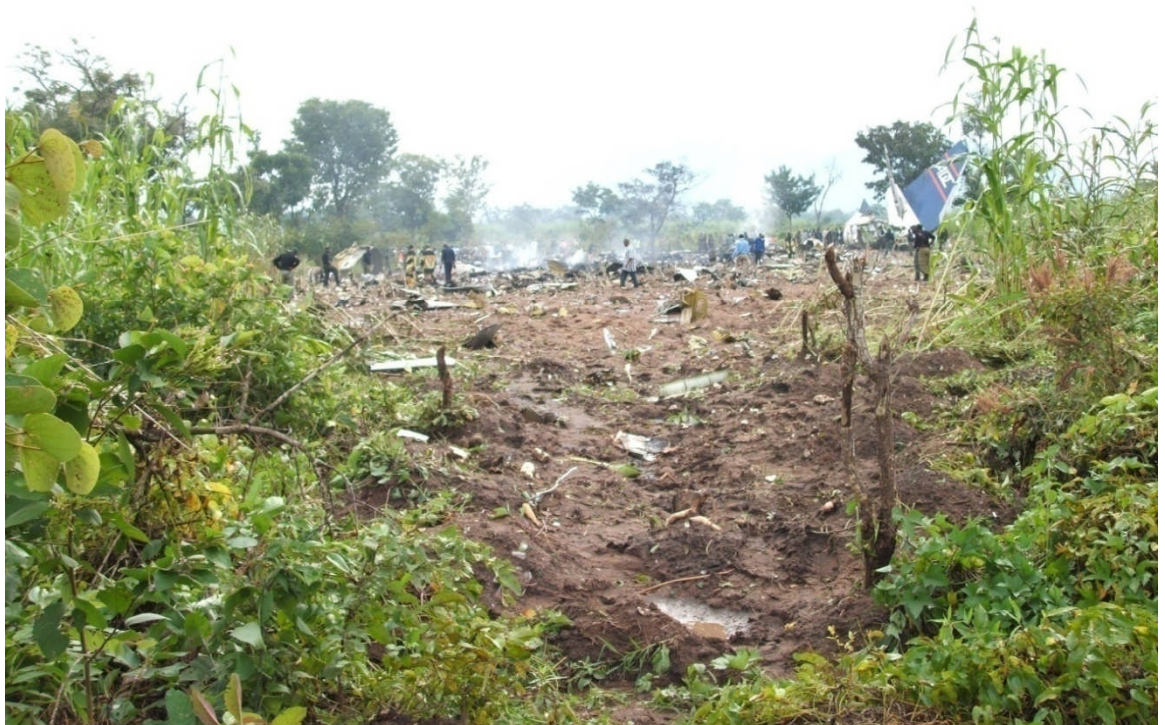
Fig 1-5 Wreckage trail from the first impact with the ground

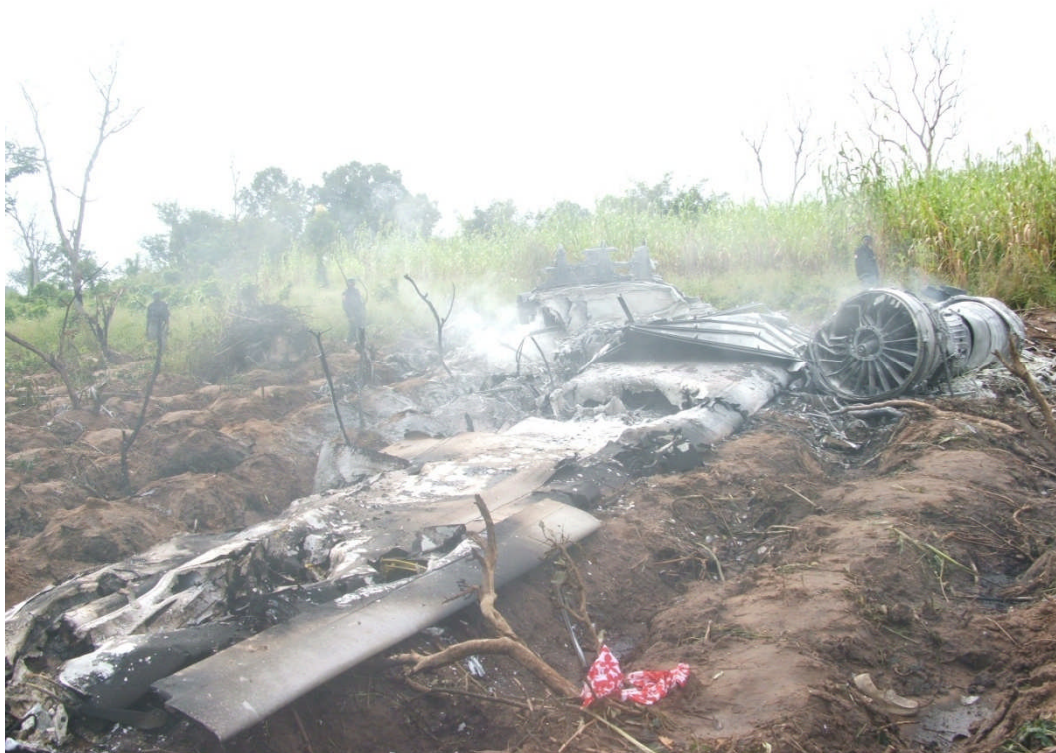
The aircraft impacted the ground, disintegrated and a portion (center wing box and attached right wing) caught fire. There was evidence of aircraft fluid spillage covering a wide area at the crash site.

Fig 1-6 Photograph showing aircraft wreckage consumed by fire

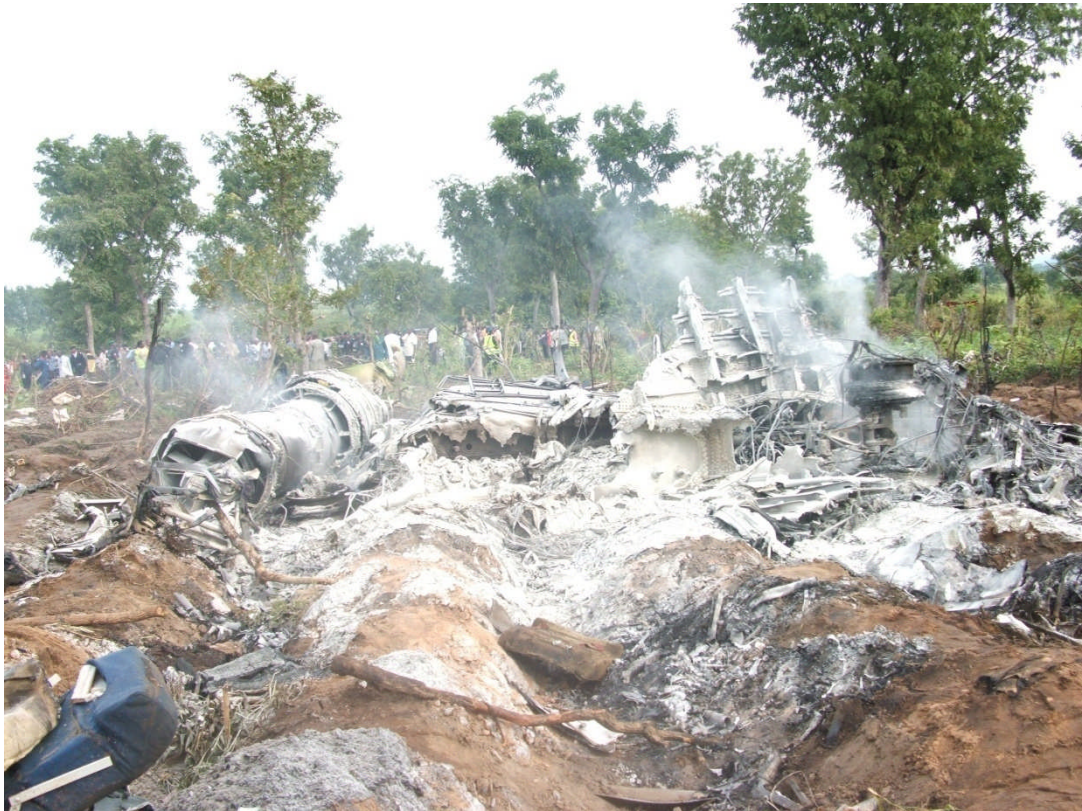
Fig 1-7 Photograph showing evidence of fire

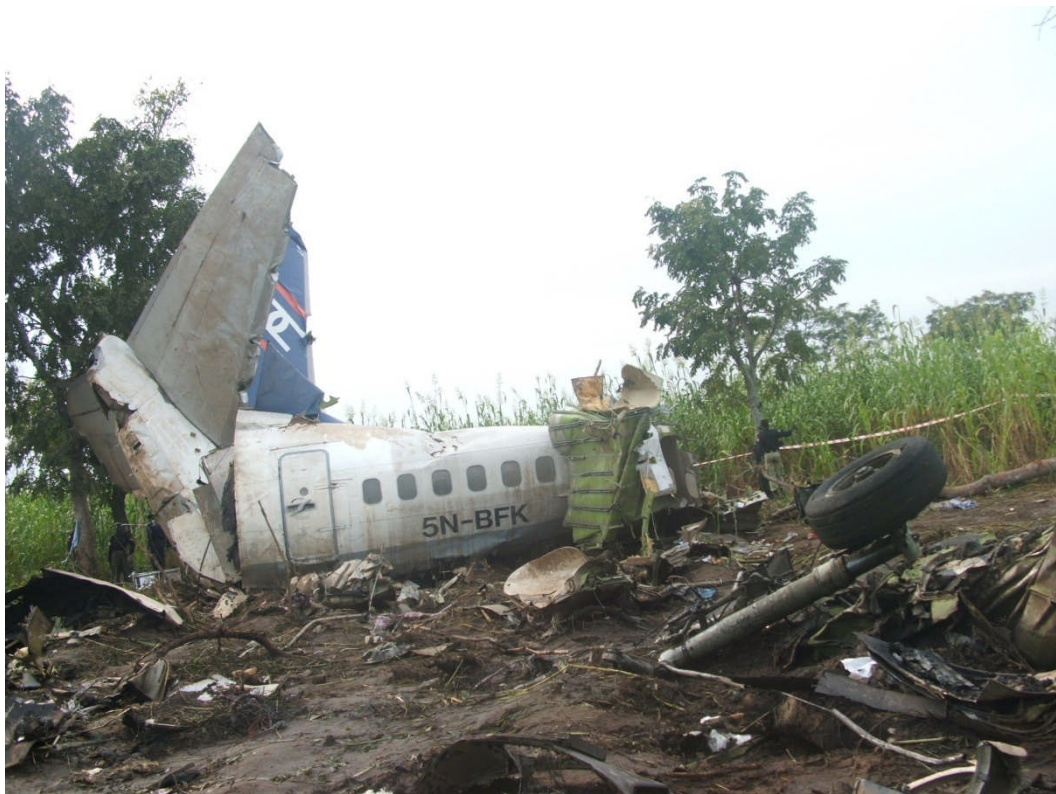
Ninety six of the one hundred and five persons-on-board were fatally injured by impact forces and post-crash fire as the majority of the fuselage section of the aircraft was destroyed, while one cabin crew, aft seated, survived along with eight other passengers as the structure in their immediate environment remained substantially intact to the extent that a liveable volume was available throughout the crash.

Fig 1-8 Photograph of damaged aircraft showing the area where the few survivors were found

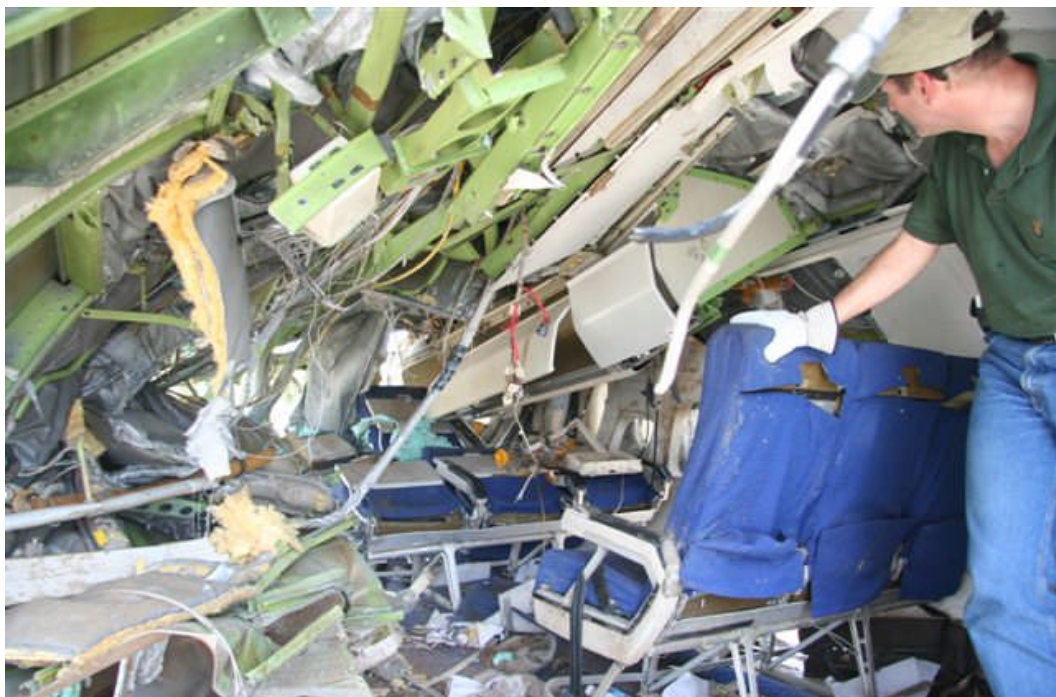
Fig 1-9 Photograph of damaged aircraft showing cabin debris and seats where the few survivors were found

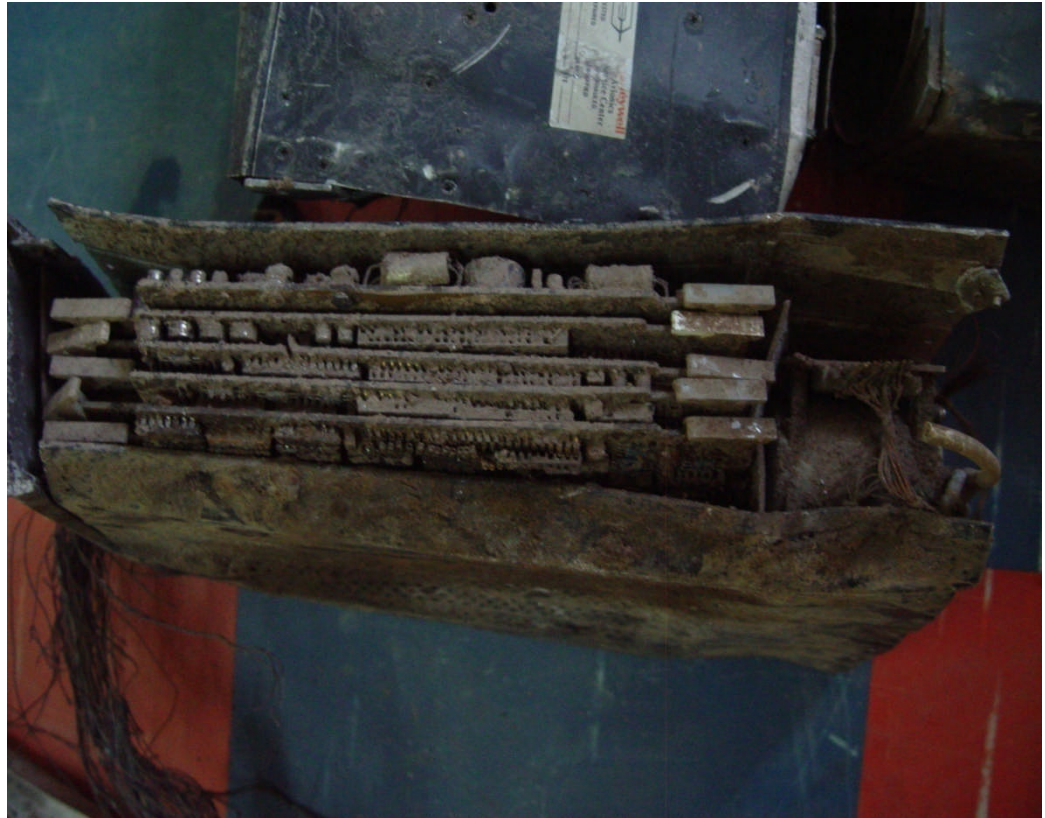
Fig 4-5 Windshear computer

According to Honeywell, the roll range test is considered failed if the windshear computer determines that the roll data input exceeded a limit of +/- 60°. The mode number 0 indicates that the windshear computer was "not standby". Examination of the windshear computer logic and flight data recorder information suggested that the windshear computer was likely in takeoff mode, which indicates weight off wheels, altitude less than 1500ft above field level, or less than 3 mins since weight off wheels.

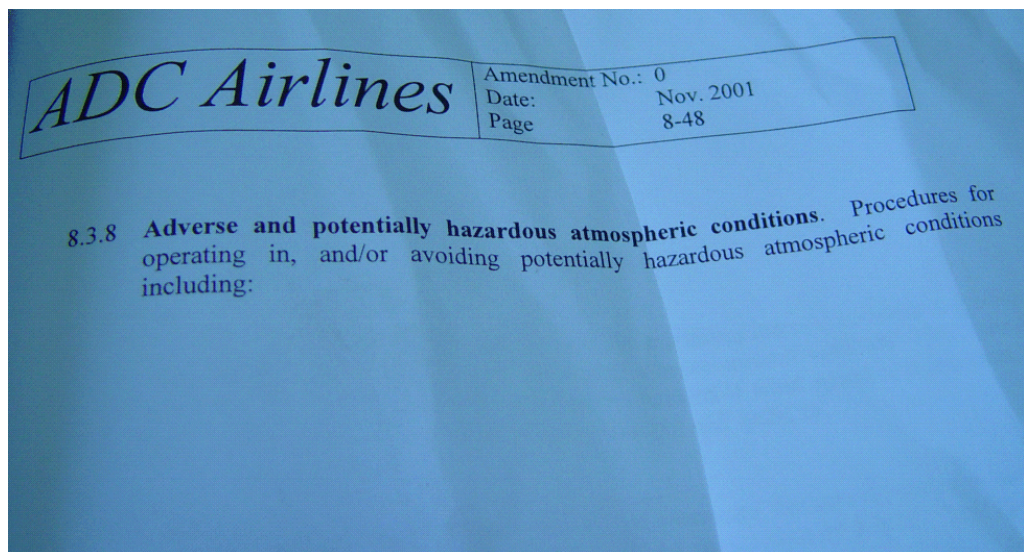
Adverse and potentially hazardous atmospheric conditions were left blank in the Airline's Operations Manual (Section 8.3.8). (See fig. 4-3).

Fig 4-3 ADC Policy on adverse weather operation - “nil”

The airline had no policy on operation in adverse and potentially hazardous atmospheric condition. This section was left blank in their Operations Manual which was approved by the Regulatory Authority. This could have guided the pilots on the decision to go or not to go in adverse and potentially hazardous atmospheric conditions.

NCAA should ensure that Operators Operations Manual/Standard Operating Procedures (SOP), which guides the crew decisions in times of adverse weather and potentially hazardous atmospheric conditions, be designed to be explicit to the crew before such manuals are approved.
