# National Transportation Safety Board Aviation Accident Final Report

<b>Location:</b>	Port Alsworth, Alaska	<b>Accident Number:</b>	ANC17FA004
<b>Date &amp; Time:</b>	October 28, 2016, 18:28 Local	<b>Registration:</b>	N5308F
<b>Aircraft:</b>	FAIRCHILD HELI-PORTER PILATUS PC-6	<b>Aircraft Damage:</b>	Substantial
<b>Defining Event:</b>	Controlled flight into terr/obj (CFIT)	<b>Injuries:</b>	1 Fatal
<b>Flight Conducted Under:</b>	Part 91: General aviation - Personal

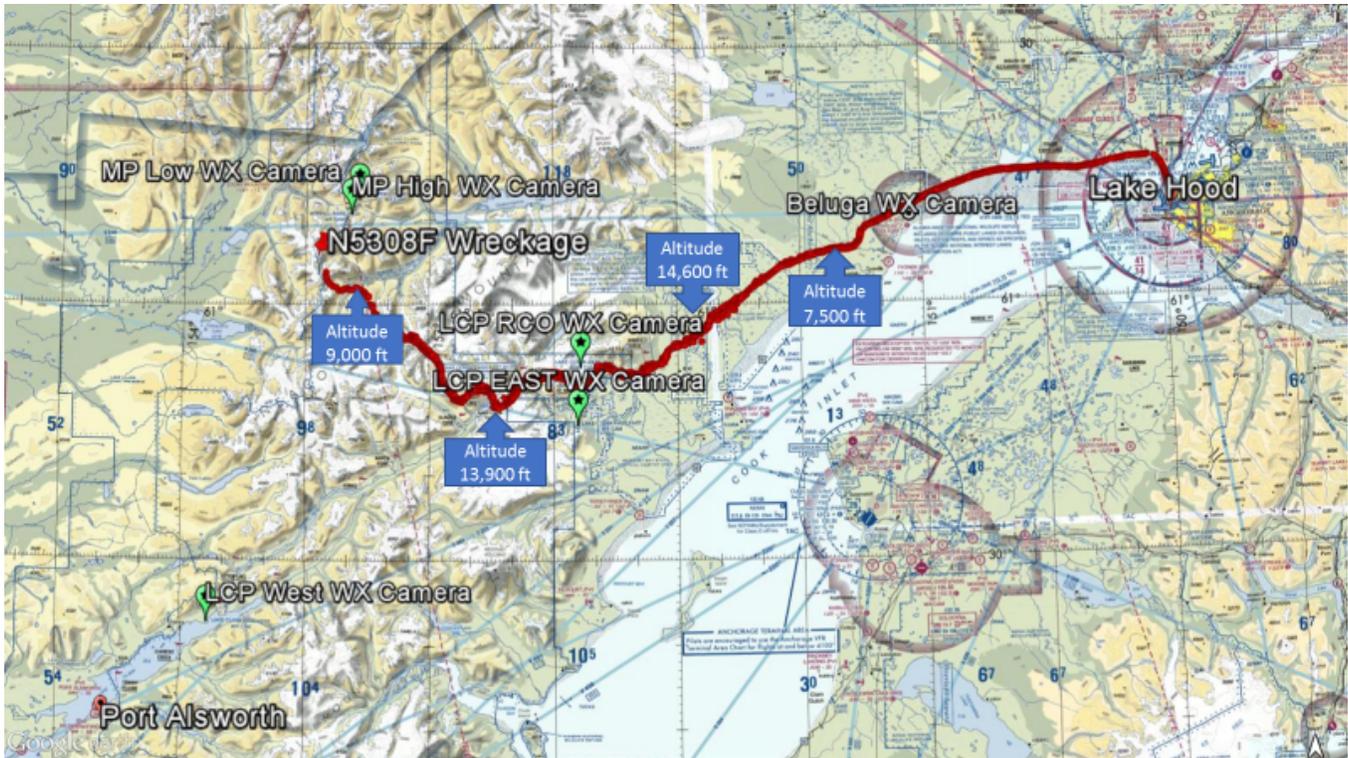
Primary radar data obtained from the FAA Anchorage Air Route Traffic Control Center Terminal Radar Approach Control Facility showed the accident airplane departing LHD about 1711. The airplane flew westbound along the coastline and climbed to 5,600 ft mean sea level (msl). It remained about 5,600 ft for nearly 25 miles before descending to 4,600 ft, where it remained for about 8 miles before beginning a climb to 14,700 ft. The airplane made a series of "s" turns and began tracking west. About 1810, at 13,200 ft, the airplane turned to the northwest and began a descent. The track continued for about 25 miles, descending to the last recorded altitude of 7,600 ft about 1827 and about 2 miles southeast of the accident site. A search of archived FAA air traffic control records revealed no voice communications with the accident airplane during the accident flight. A radar study prepared by an NTSB senior air traffic investigator is available in the public docket.

Flight track radar data and FAA Weather Cameras.

A review of archived FAA weather camera images at Lake Clark Pass East, Lake Clark Pass RCO, Merrill Pass Low and Merrill Pass High all indicated deteriorating weather starting about 1530 and visibilities of 1 mile or less in snow showers with mountain terrain obscured by 1600. The Lake Clark Pass West northeast view, which was closest to the planned destination, revealed that, at 1838, the clouds were above the highest terrain and visibility was unrestricted, which was corroborated by the family member's observations provided to the pilot. The FAA weather camera website states that the camera weather images are supplementary products and may only be used to improve situational awareness. The closest upper air sounding was from the NWS Anchorage (PANC) Forecast Office, about 105 miles east of the accident site. A review of the 1600 sounding indicated a high potential for moderate rime-type icing conditions at 9,330 ft within the shallow layer of broken altostratus type clouds. The air sounding wind profile indicated that, at the accident airplane's cruising altitudes between 9,500 ft and 10,500 ft, the wind was from 210° at 20 knots, with a temperature of -10°C. At 14,500 ft, the highest altitude the airplane operated at during the flight, the wind was from 235° at 23 knots with a temperature of -11°C. The primary freezing level aloft was about 4,880 ft.
