National Transportation Safety Board Aviation Accident Final Report

Location:	Uvalde, Texas	Accident Number:	CEN19LA054
Date & Time:	January 12, 2019, 11:30 Local	Registration:	N813WT
Aircraft:	Canadair CL 600 2A12	Aircraft Damage:	Substantial
Defining Event:	Hard landing	Injuries:	9 None
Flight Conducted Under:	Part 91: General aviation

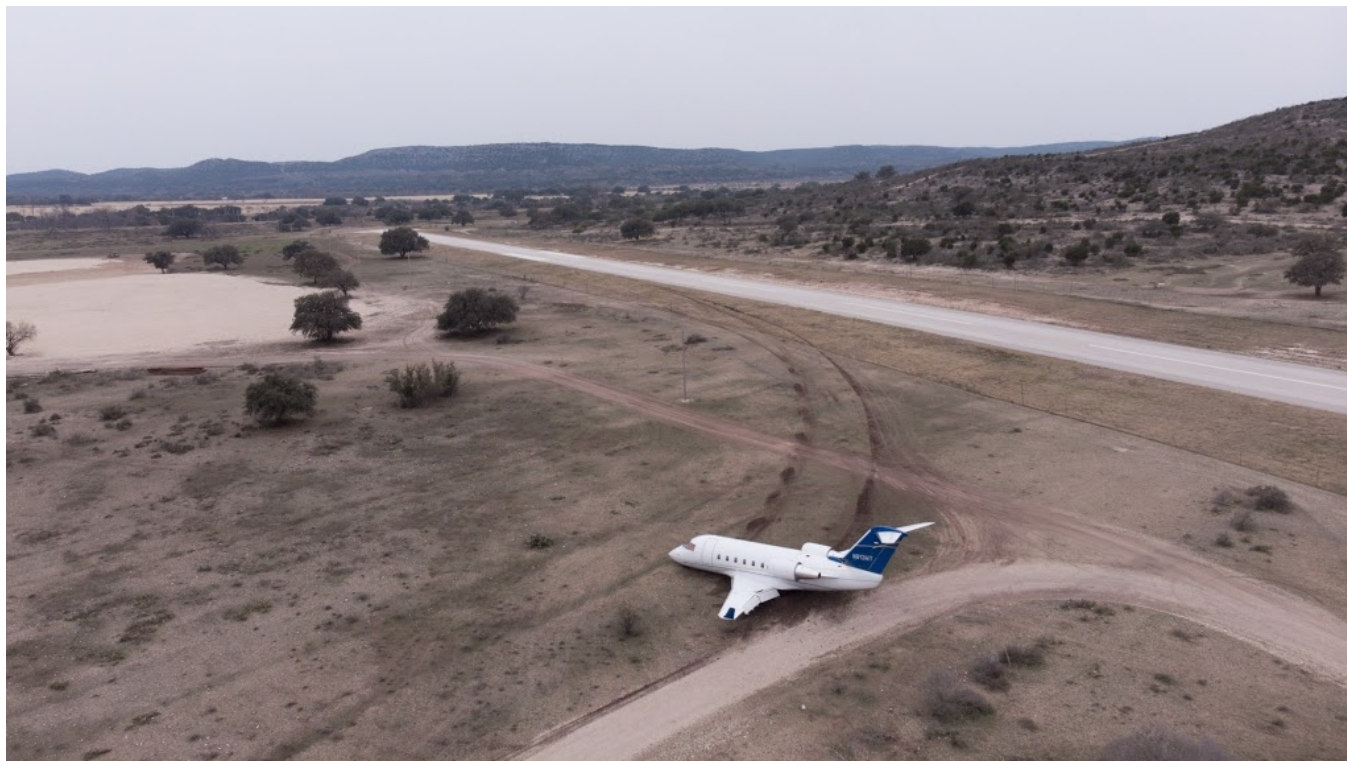
Figure 1: Accident Scene

A representative for the airport reported that the airplane on landing hit hard. About two-thirds of the way down runway 35, the airplane slid off the right side of the runway. The airplane proceeded through a ditch and struck a perimeter fence before coming to a stop.

The airplane wreckage was in a field near a dirt service road on airport property, about 2,100 ft. east of runway 35. The airplane was upright and oriented on a 170° heading. Preceding the airplane were two sets of parallel skid marks in the dirt that began about 1,600 ft from the runway threshold and curved along the ground ending at the airplane. Also preceding the airplane was a three inch wide, 2 inch deep, and 1,500 ft long gouge in the runway asphalt that began 53 ft from the runway threshold and ran parallel to the right side of the runway to where it ended, the point where the airplane departed the right side of the runway.

The airplane was intact and rested on the right wing, left main landing gear, and the nose section beneath the flight deck. A portion of the airport perimeter fence was found embedded in the vertical fin leading to the vertical stabilizer. The right main landing gear was broken aft and collapsed under the right wing. It remained attached to the airplane at the main gear side strut retraction actuator. The right winglet and leading edge of the right wing showed impact damage along their spans. The trailing edge of the right wing and spar structure at the right main landing gear wheel well were bent and broken upward. The inboard portion of the right inboard flap was broken upward at the wing root. A black rubber mark corresponding to the tread of the right main landing gear outboard tire was found smeared on the underside of the broken inboard piece of the right inboard flap.
