National Transportation Safety Board Aviation Accident Final Report

Location:	Addison, Texas	Accident Number:	CEN19MA190
Date & Time:	June 30, 2019, 09:11 Local	Registration:	N534FF
Aircraft:	Textron Aviation B-300	Aircraft Damage:	Destroyed
Defining Event:	Loss of control in flight	Injuries:	10 Fatal
Flight Conducted Under:	Part 91: General aviation - Personal

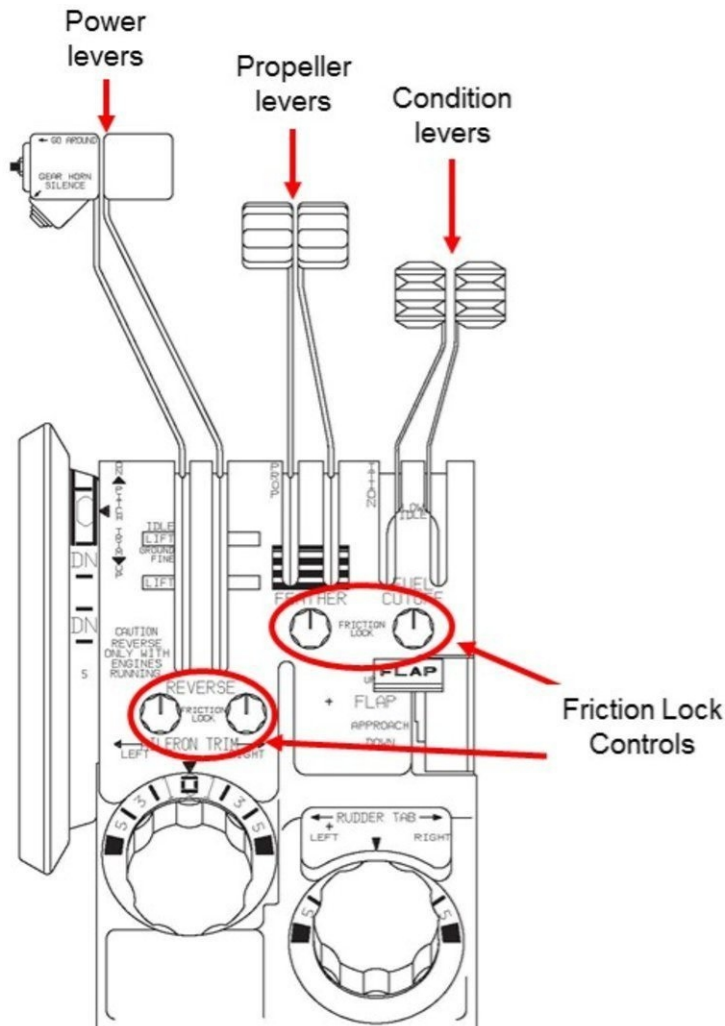
Figure 1. Diagram of B-300 Engine and Propeller Controls

The engine and propeller control levers on the accident airplane model are located between the two cockpit seats. The power quadrant includes two power levers (which controls engine power from idle through takeoff) and two propeller levers (which control propeller speed and feathering) to the right of the power levers. Two engine condition levers are to the right of the propeller levers and have three positions: FUEL CUTOFF, LOW IDLE, and HIGH IDLE; the idle settings limit idle speed at 62% N1 (39,000 gas generator rpm) minimum for low idle and 70% N1 minimum for high idle. The left condition lever controls the left engine, and the right condition lever controls the right engine (see figure 1).

Friction lock control knobs are located on the power quadrant. Each power lever has its own friction lock control knob at the base of the quadrant to adjust the power levers' tension. One friction knob controls the tension of both propeller levers. Turning the knobs counterclockwise increases tension and turning them clockwise reduces tension (see Additional Information for more information on friction adjustment). The force required to move the power lever or the propeller control lever aft with the friction setting fully disengaged is 0.6 lbs and 2 lbs, respectively.

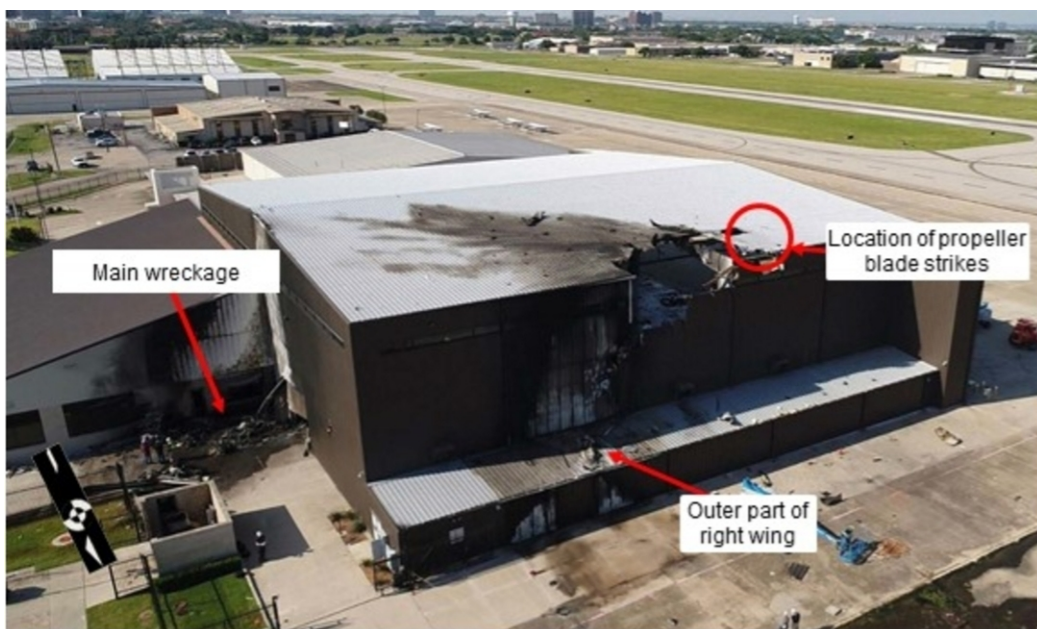
Figure 2. Photograph of an aerial view of the accident site

located on top and inside of the hangar and immediately to the north of the hangar. The main wreckage, which included the right engine and the fuselage, was located outside of the hangar and came to rest on its right side adjacent to a brick wall. Portions of all the crew and cabin seats were identified, and all showed evidence of various degrees of fire consumption. Some seats exhibited deformation consistent with impact damage. Wreckage examination found no evidence of an in-flight fire before the impact with the hangar.

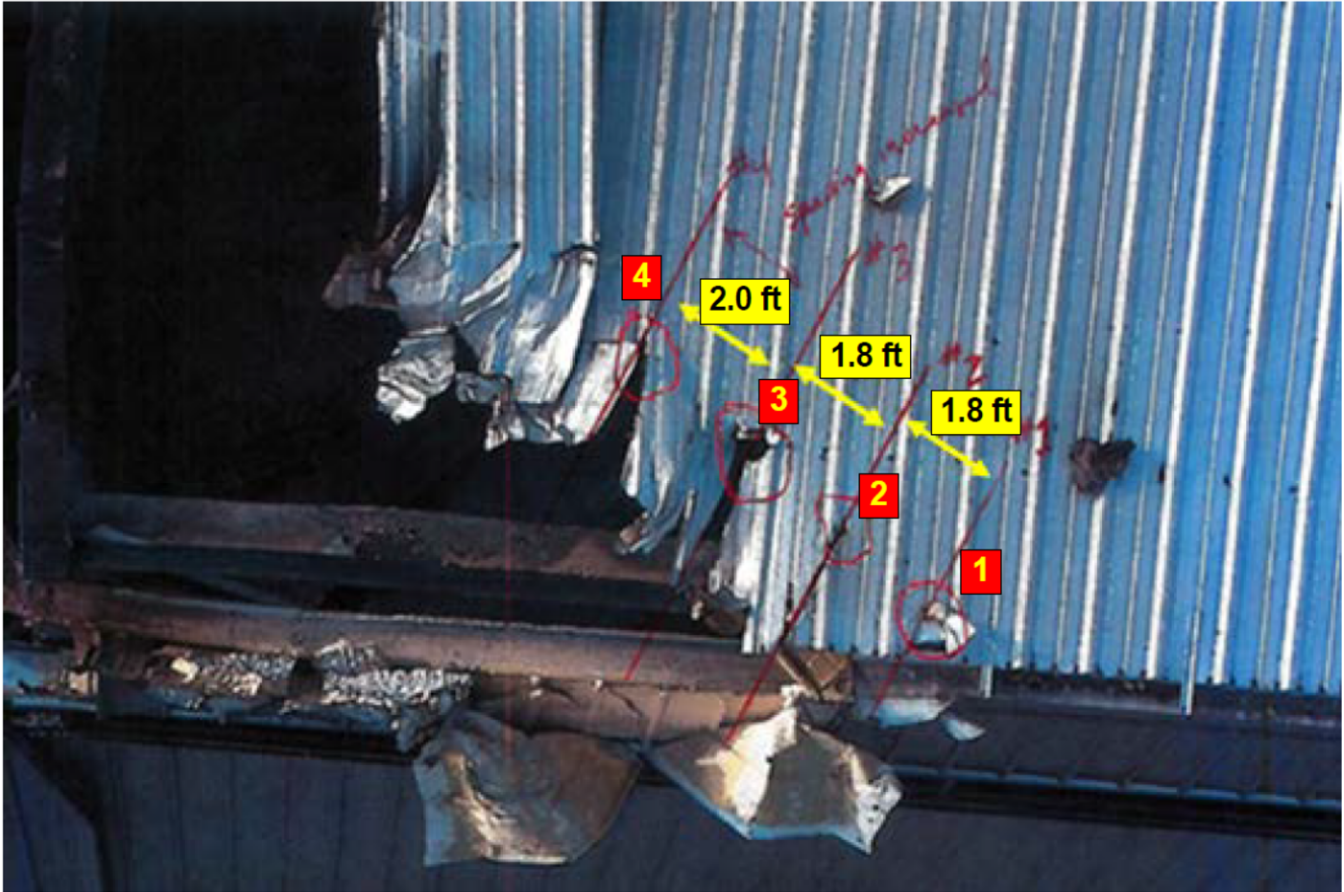
Figure 3. Photograph of propeller blade strikes in hangar roof

Propeller blade strikes (see figures 2 and 3) were observed at the airplane's initial point of impact including a strike to a hangar roof truss, which was coated white. Evidence indicates that the strikes were made by the left propeller. The distances between the propeller blade strikes were measured to determine propeller speed at impact (see figure 3). The left propeller's speed at impact was estimated at 1,259 to 1,300 rpm.
