National Transportation Safety Board Aviation Accident Final Report

Location:	Windsor Locks, Connecticut	Accident Number:	ERA20MA001
Date & Time:	October 2, 2019, 09:53 Local	Registration:	N93012
Aircraft:	Boeing B17	Aircraft Damage:	Destroyed
Defining Event:	Landing area undershoot	Injuries:	7 Fatal, 5 Serious, 2 Minor
Flight Conducted Under:	Part 91: General aviation - Other work use

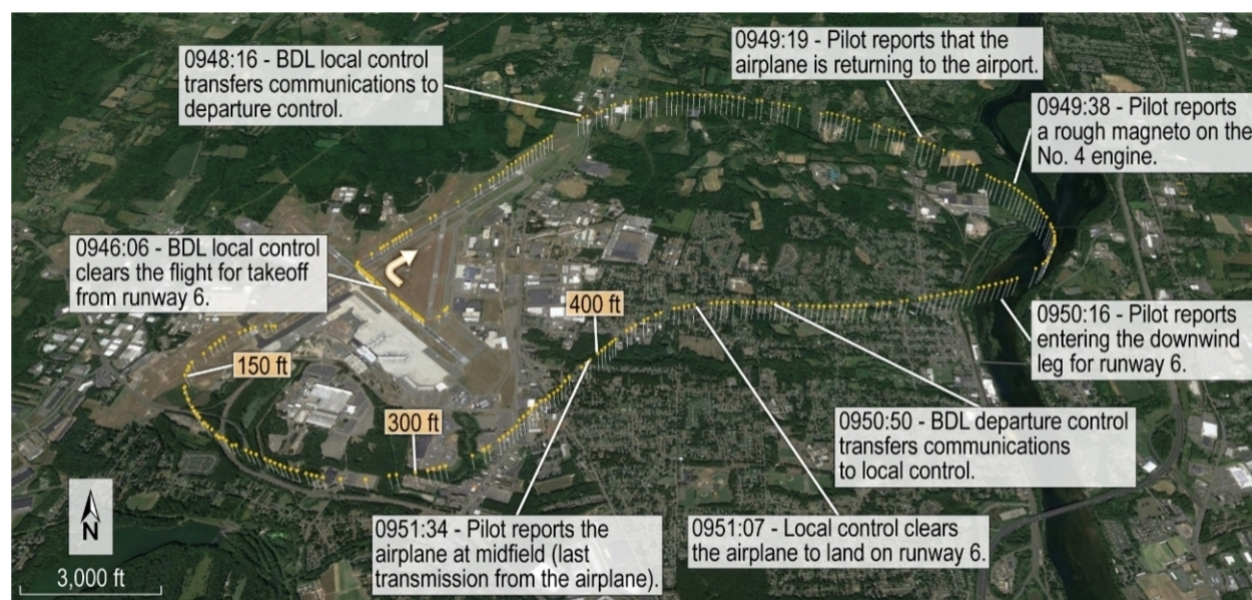
Figure 2. ADS-B-derived flightpath and select voice radio transmissions

The airplane was descending through an altitude of 300 ft as it turned onto the base leg of the traffic pattern for runway 6. The airplane then turned onto final approach at an altitude of 150 ft; at that time, the airplane was about 0.4 nautical mile from the runway threshold. Figure 2 depicts the airplane's ADS-B-derived flightpath overlaid onto aerial imagery of the airport and surrounding area along with relevant voice radio transmissions between air traffic control (ATC) and the airplane.

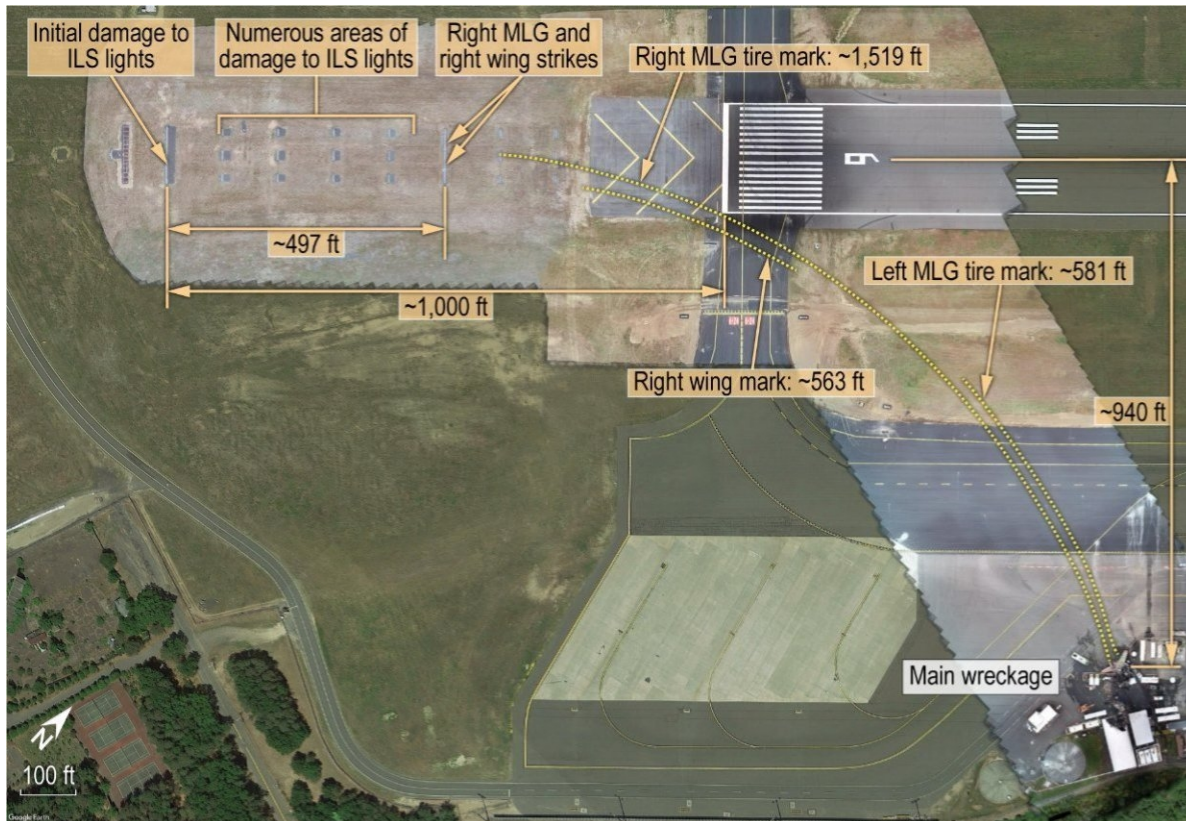
Figure 4. Overhead image depicting the airplane's path to final impact

Witness statements and video indicated that the airplane struck the runway 6 approach lights in a right-wing-down attitude about 1,000 ft before the runway. The airplane contacted the ground about 500 ft before reaching runway 6. The engine noise increased, and the airplane accelerated as it veered to the right of the runway. The airplane then collided with vehicles and a deicing fluid tank before coming to rest upright about 940 ft to the right of the runway 6 centerline and oriented to the east. A postcrash fire ensued.

Figure 4 is an overhead image that shows the runway 6 approach area, the areas of impact damage to the instrument landing system (ILS) lighting equipment, and the location of witness marks from the airplane's main landing gear (MLG) and right wing. The figure also shows the airplane's final resting position about 940 ft to the right of the runway 6 centerline. Most of the cabin, cockpit, and right wing were consumed by a postcrash fire, as shown in figure 5.
