Aviation Investigation Final Report

Location:	LAFAYETTE, Louisiana	Accident Number:	CEN20MA044
Date & Time:	December 28, 2019, 09:21 Local	Registration:	N42CV
Aircraft:	Piper PA 31T	Aircraft Damage:	Destroyed
Defining Event:	Loss of control in flight	Injuries:	5 Fatal, 2 Serious, 2 Minor
Flight Conducted Under:	Part 91: General aviation - Executive/Corporate

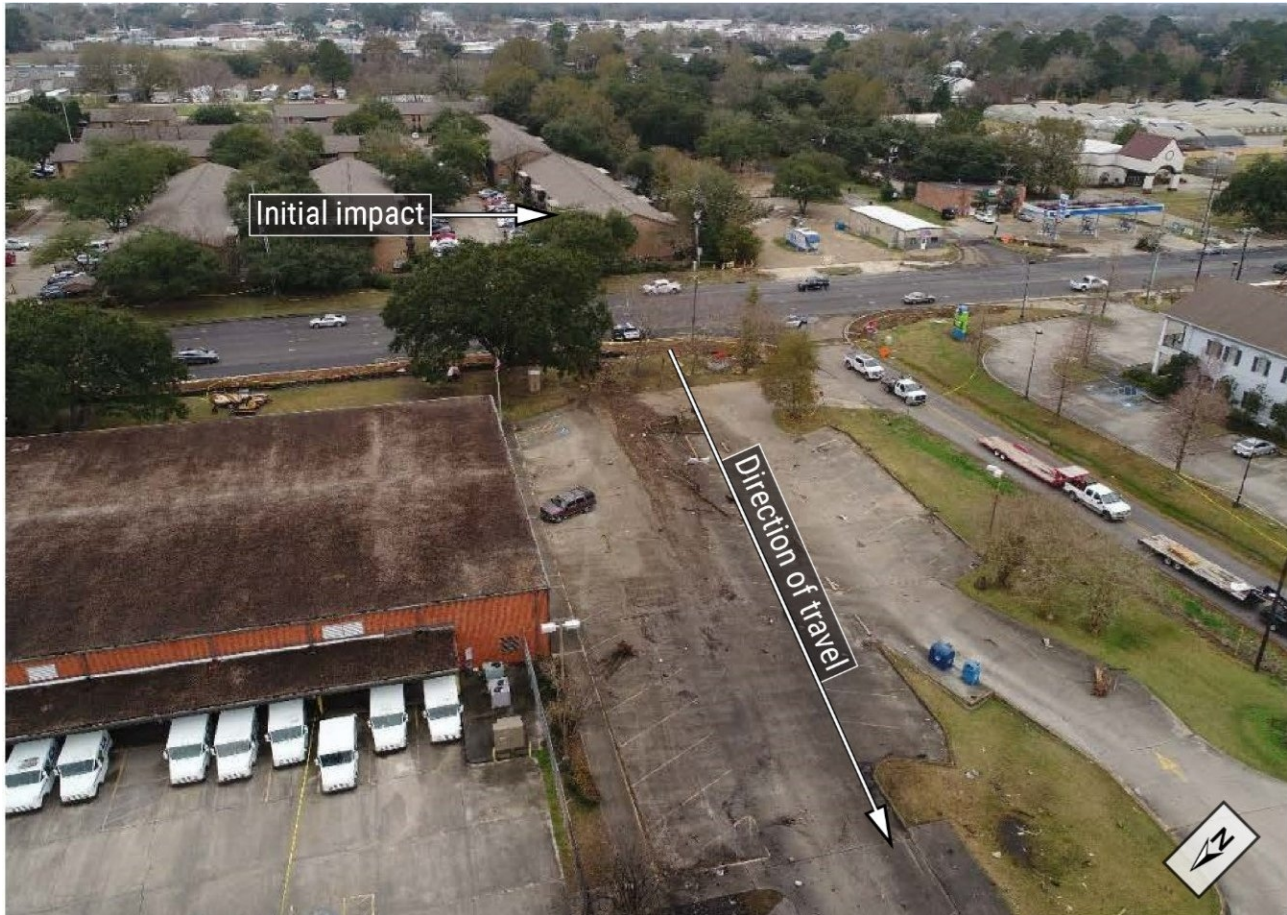
The airplane impacted trees and transmission lines on the south edge of a road. A scar on the first tree that was struck indicated that the airplane’s attitude was right wing low. The first ground scar was located on the north edge of the road. The wreckage path, which included fragmented and burned pieces of the airplane and tree debris, extended 789 ft from the trees and transmission lines along a bearing of about 315°. The accident site encompassed the parking lot of a post office, as shown in figure 2, and an adjacent open field, as shown in figure 3. The aft fuselage came to rest at the end of the wreckage path, which was located about 1.5 miles from the departure end of LFT runway 22L.

Figure 2. Initial impact point and direction of travel across post office parking lot.

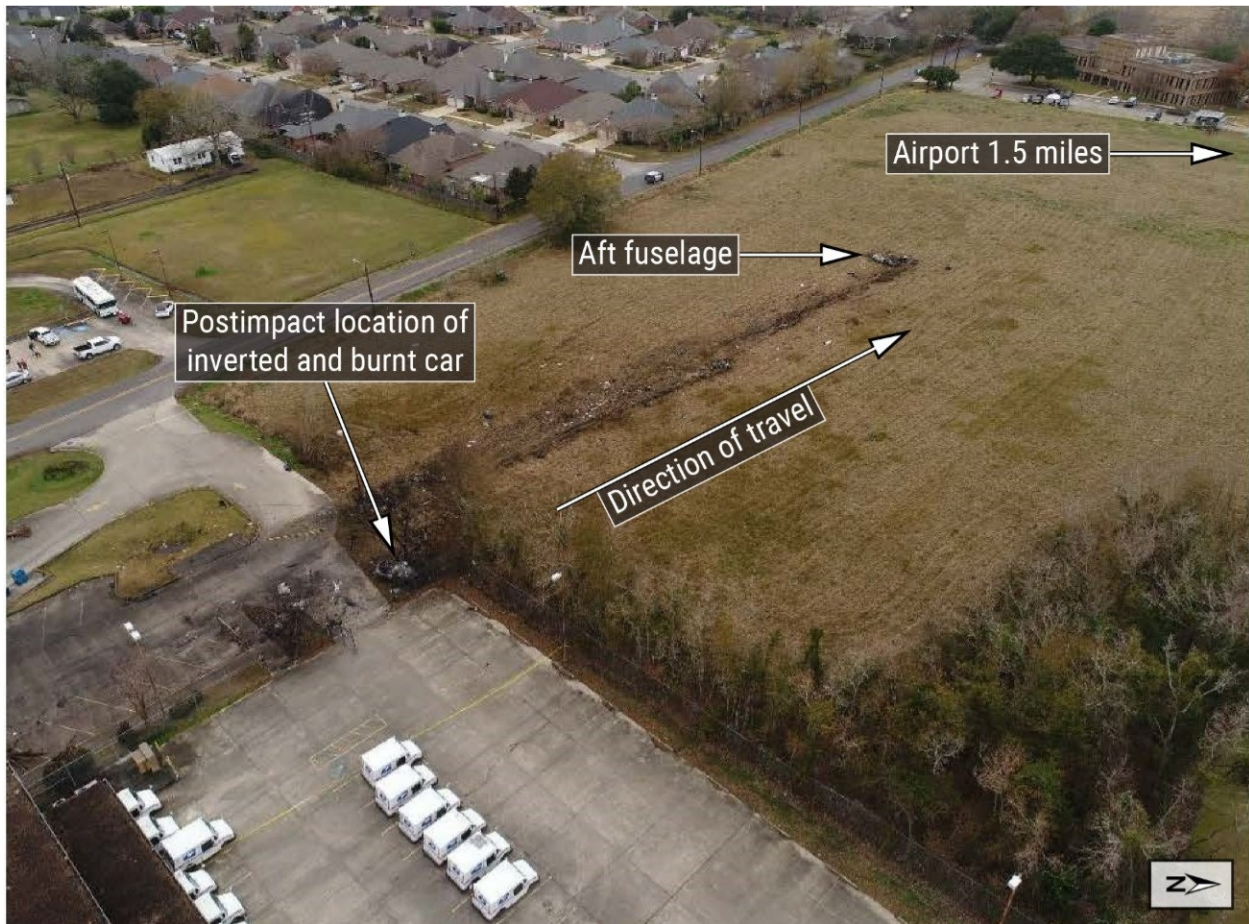
Figure 3. Wreckage path in field adjacent to post office.
