# Aviation Investigation Final Report

<b>Location:</b>	Bethel, Alaska	<b>Accident Number:</b>	ANC19LA031
<b>Date &amp; Time:</b>	July 8, 2019, 15:05 Local	<b>Registration:</b>	N9448B
<b>Aircraft:</b>	Cessna 208	<b>Aircraft Damage:</b>	Destroyed
<b>Defining Event:</b>	Loss of control in flight	<b>Injuries:</b>	6 Minor
<b>Flight Conducted Under:</b>	Part 135: Air taxi & commuter - Scheduled

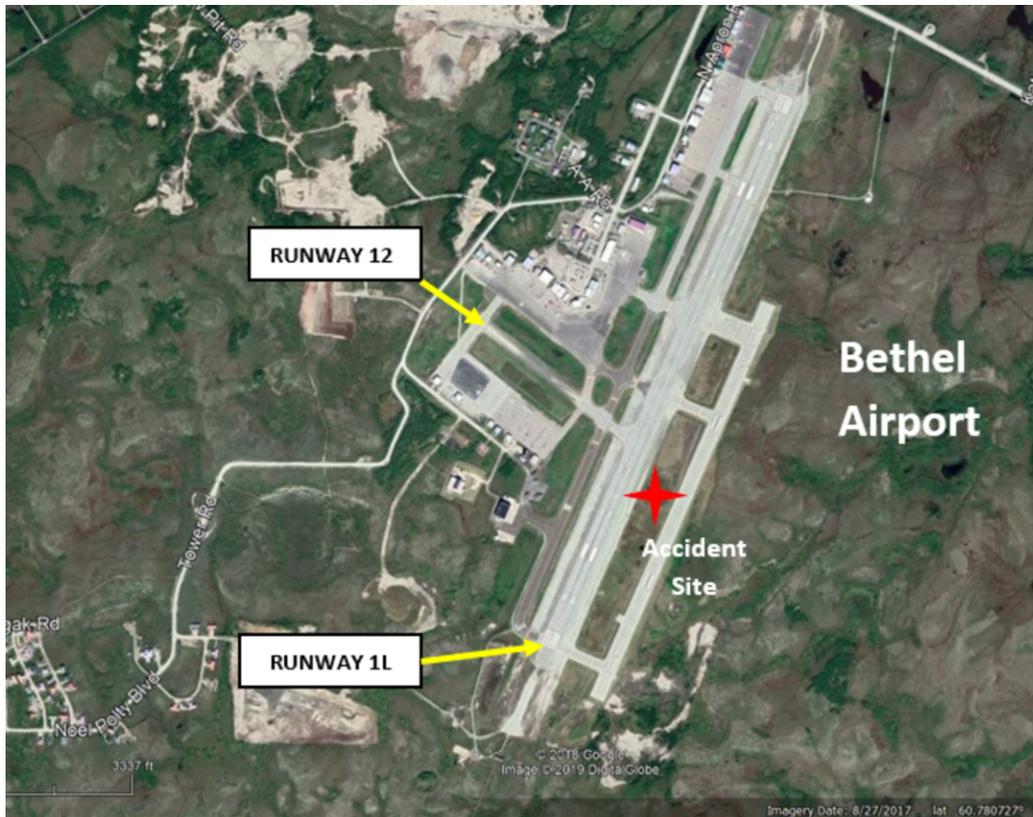
During the landing flare, the airplane floated about halfway down the runway, and the pilot executed a go-around due to insufficient runway stopping distance remaining. He advanced the throttle to maximum, retracted the flaps to 20°, increased the airplane's pitch attitude as the main landing gear momentarily touched down. The pilot transmitted on the tower frequency that he was going around and the ATCT local controller (LC) instructed him twice to turn left immediately. The pilot stated that he was aware that an airplane was on short final approach to runway 1L, but he did not know where the other airplanes were and was concerned about conflicting with cross traffic flow. In an attempt to comply with tower instructions and deconflict with traffic, he applied left aileron and the airplane stalled, rolled right and descended, impacting the ground in a right-wing-low attitude. He attempted to regain control and he recalled selecting the flaps up. The airplane came to rest on its right side in the grass covered drainage ditch between runways 1L and 1R. The pilot stated that he saw fire through the right window, and immediately went to the back of the airplane to help with the evacuation of the two children and three adult passengers through the left cargo door before the airplane was consumed by fire. See figure 1 for BET airport diagram and accident site information.

Figure 1. Airport Google Earth image with runways and accident site labeled.

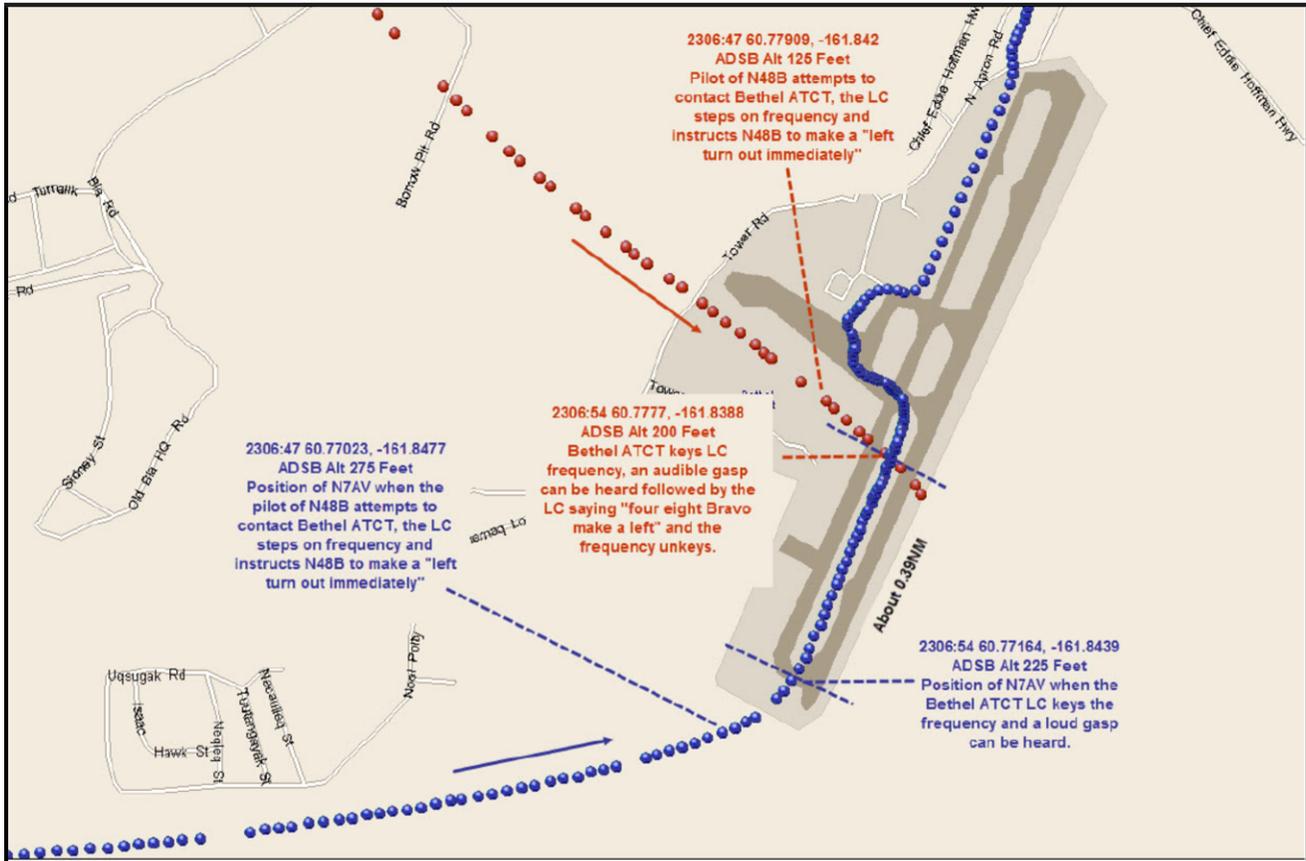
A review of air traffic control audio files and automatic dependent surveillance-broadcast (ADS-B) data that was processed through the L3 Harris Technologies Inc. OpsVue program indicated that the airplane arrived about 0.1 mile from the runway threshold at 149 ft above runway threshold height and 110 knots of groundspeed, and then was 49 ft over the threshold at 98 knots of groundspeed. At 1506:47, while the airplane was climbing out during the go-around at the departure end of the runway, the LC urgently instructed “left turn out immediately.” Seven seconds later, as another airplane arrived at the runway 1L threshold for landing and the accident airplane crossed runway 1L, the LC instructed “four eight Bravo, make a left” and the frequency unkeyed. Refer to figure 2.

Figure 2. ADS-B data for accident airplane (red) and landing traffic (blue) with ATCT audio excerpts from LC frequency.
