# National Transportation Safety Board

## Aviation Accident Factual Report

<b>Location:</b>	Colonia, New Jersey	<b>Accident Number:</b>	ERA20FA020
<b>Date &amp; Time:</b>	October 29, 2019, 10:58 Local	<b>Registration:</b>	N959MJ
<b>Aircraft:</b>	Cessna 414	<b>Aircraft Damage:</b>	Destroyed
<b>Defining Event:</b>	Loss of control in flight	<b>Injuries:</b>	1 Fatal
<b>Flight Conducted Under:</b>	Part 91: General aviation - Personal

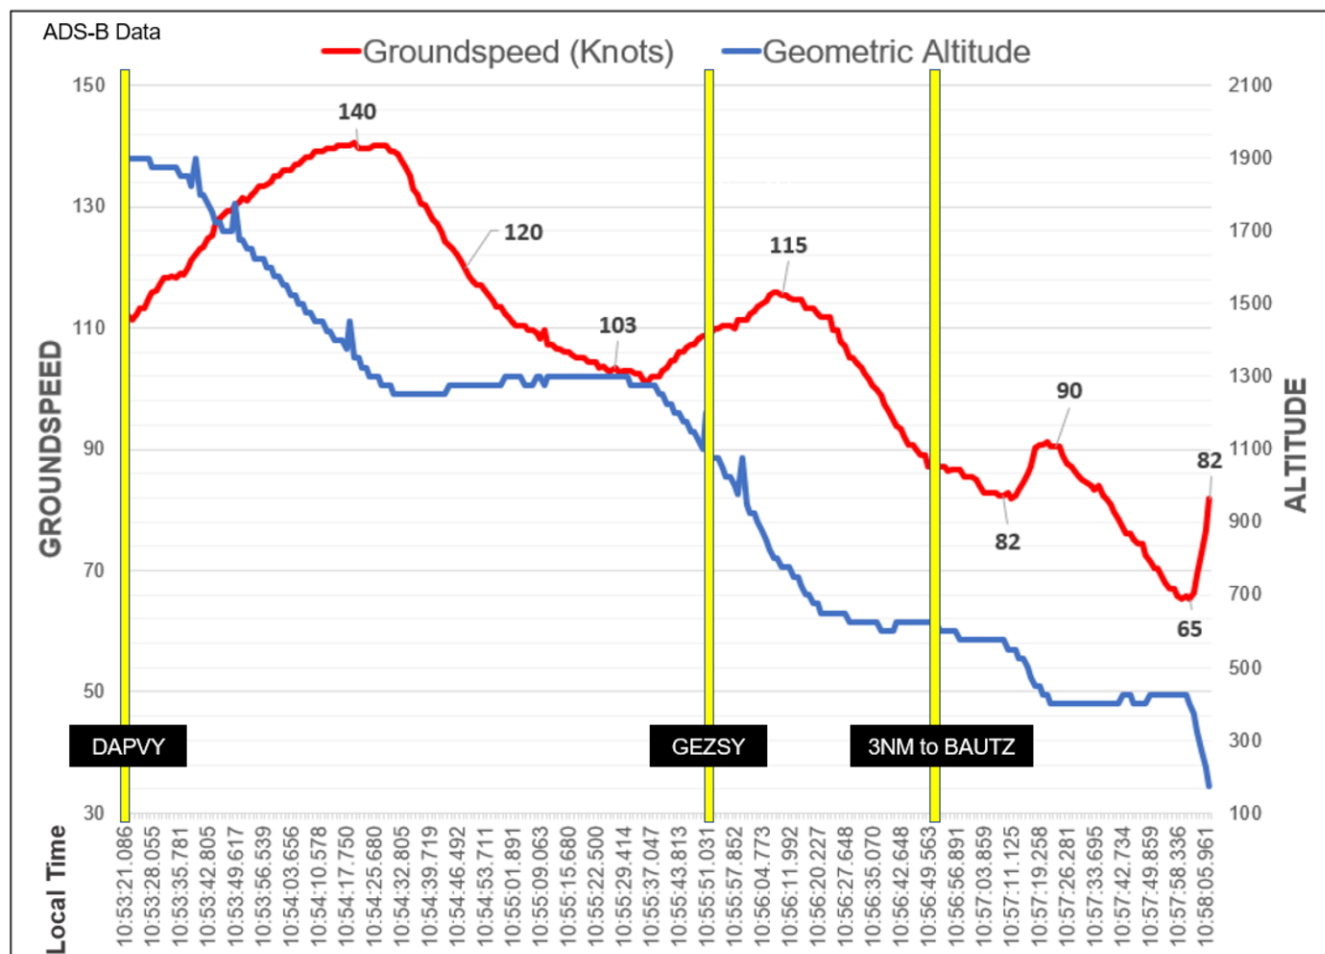
The airplane subsequently descended to 600 ft msl, maintained course, and remained at 600 ft for about 1 minute. During this time, groundspeed varied and increased from about 80 knots to 90 knots before decreasing to 65 knots. At 1058:02, the airplane's flight track turned left off

course and the airplane rapidly descended. The final radar return, at 1058:07, was less than 1/10 mile from the accident site and showed the airplane at 200 ft msl headed northwest.

Figure 1 shows the automatic dependent surveillance-broadcast (ADS-B) data for the final 5 minutes of the flight. The data presented are calculated groundspeed and geometric altitude, which is the height of the airplane above the earth ellipsoid calculated by GPS (the airplane's ADS-B signal did not report barometric altitude). The yellow bars denote the position of the aforementioned GPS approach waypoints.

Figure 1: ADS-B data from the final 5 minutes of the flight.

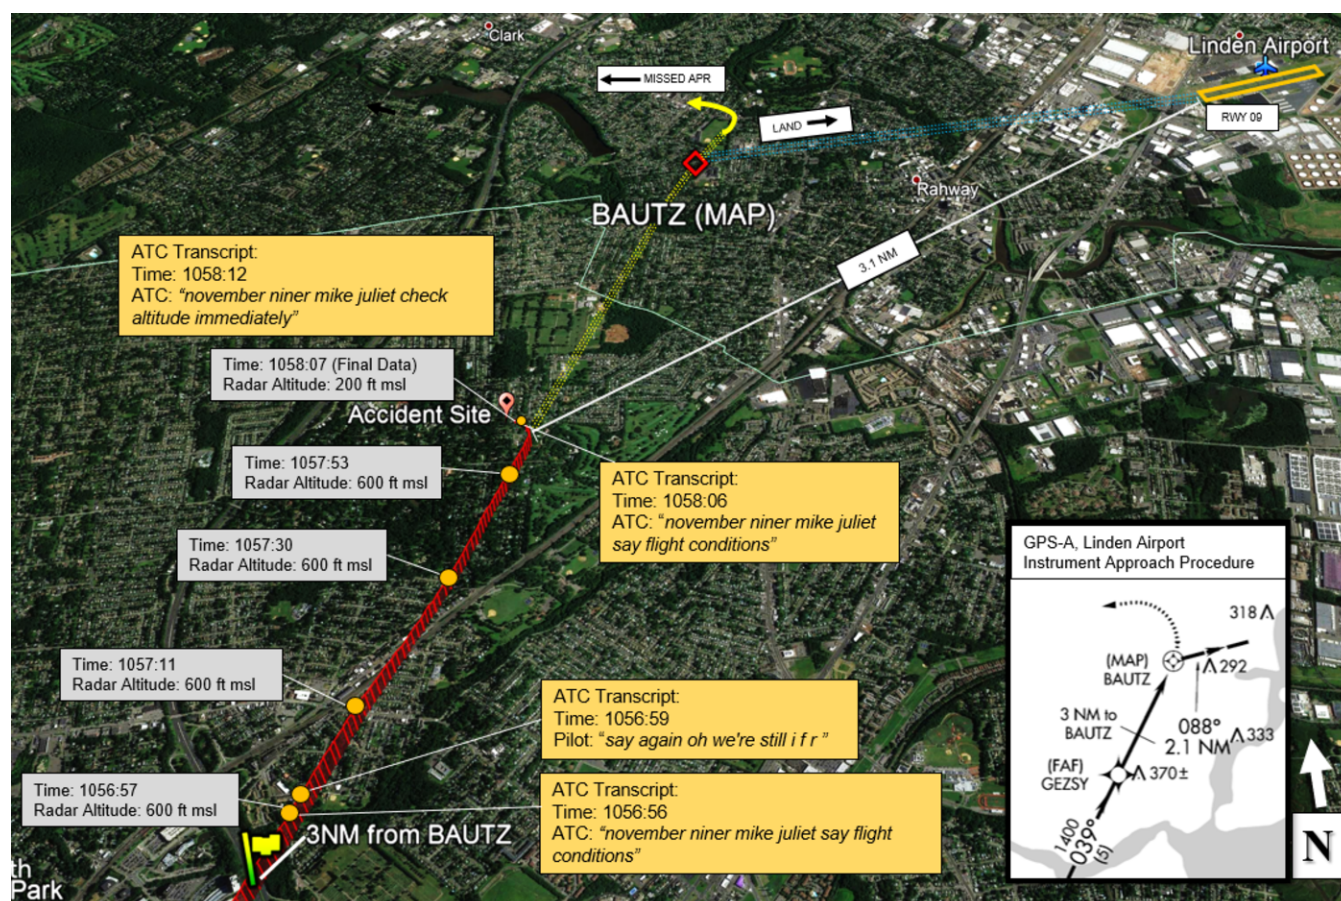
Figure 2 provides an overview of the flight track, ATC and pilot communications during the final minutes of the flight, the missed approach point (BAUTZ), and LDJ. The solid red line denotes the flight track, and the dotted yellow lines and blue lines reflect the possible courses to be flown during the approach.

Figure 2: Overview of the flight track and radar data with excerpts of the ATC transcript.
