Aviation Investigation Final Report

Location:	Springfield, Illinois	Accident Number:	CEN20FA070
Date & Time:	January 28, 2020, 15:03 Local	Registration:	N6071R
Aircraft:	Piper PA60	Aircraft Damage:	Destroyed
Defining Event:	Loss of control in flight	Injuries:	3 Fatal
Flight Conducted Under:	Part 91: General aviation - Personal

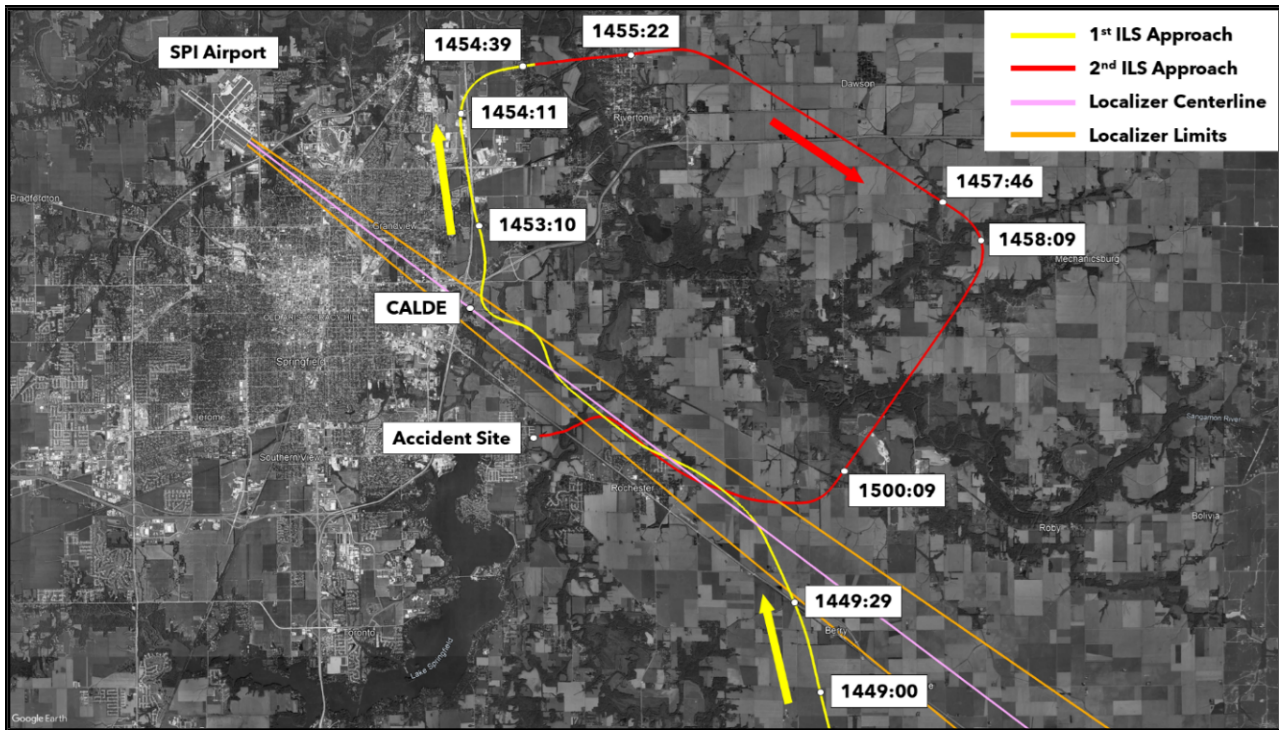
Figure 1. ADS-B track data with localizer centerline and limits.

At 1449:29, the pilot transmitted, "we're not picking these navs [navigation signals] on thirty one." At that time, the airplane was still flying along the assigned 340° heading to intercept the localizer and was about 0.6 nautical miles (nm) left of the localizer, as shown in figure 1. At 1449:36, the approach controller asked the pilot to repeat his previous transmission, and the pilot replied, "we still got neg nav [negative navigation] lights on thirty one." At 1449:53, the approach controller transmitted "we're getting green indications here... (unintelligible) just to verify that you are on one one zero point one five on the localizer?"

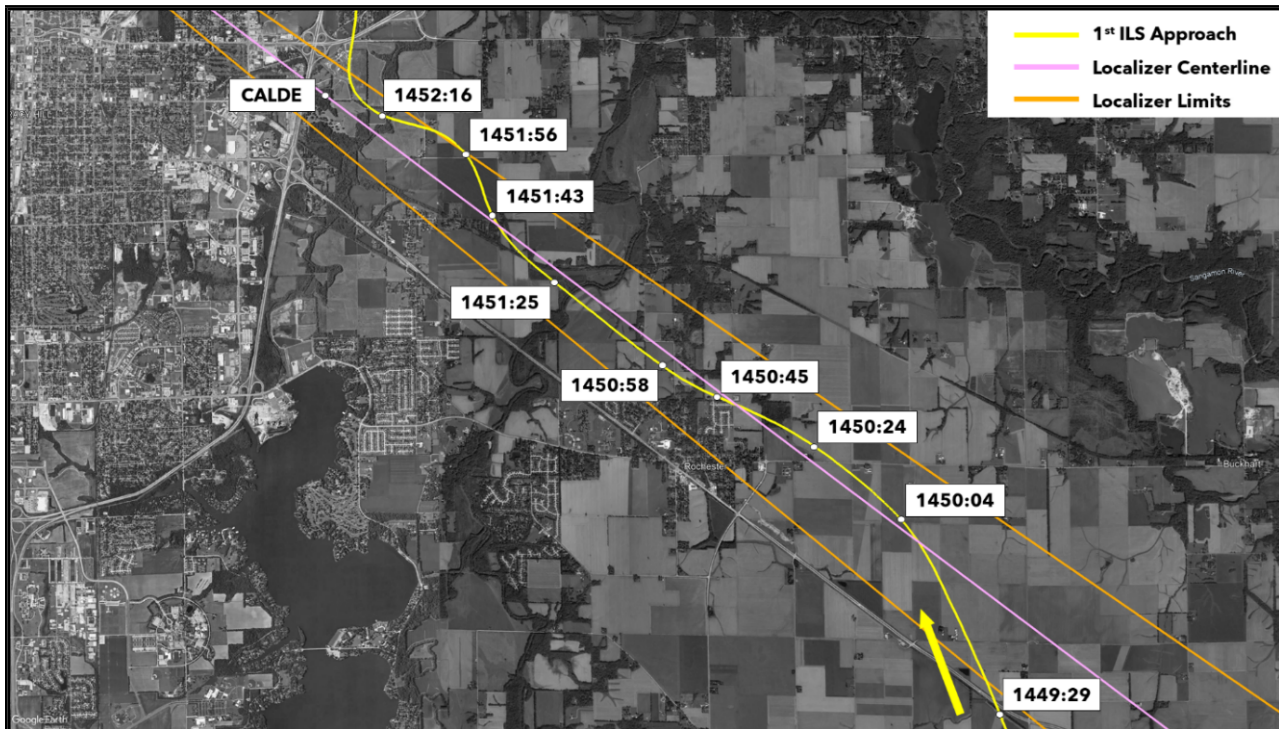
Figure 2. ADS-B track data for first ILS approach to runway 31.

At 1449:59, the airplane flew through the localizer centerline while still on the assigned 340° heading, as shown in figure 2. After crossing through the localizer centerline, the airplane made a left turn to a 295° course.

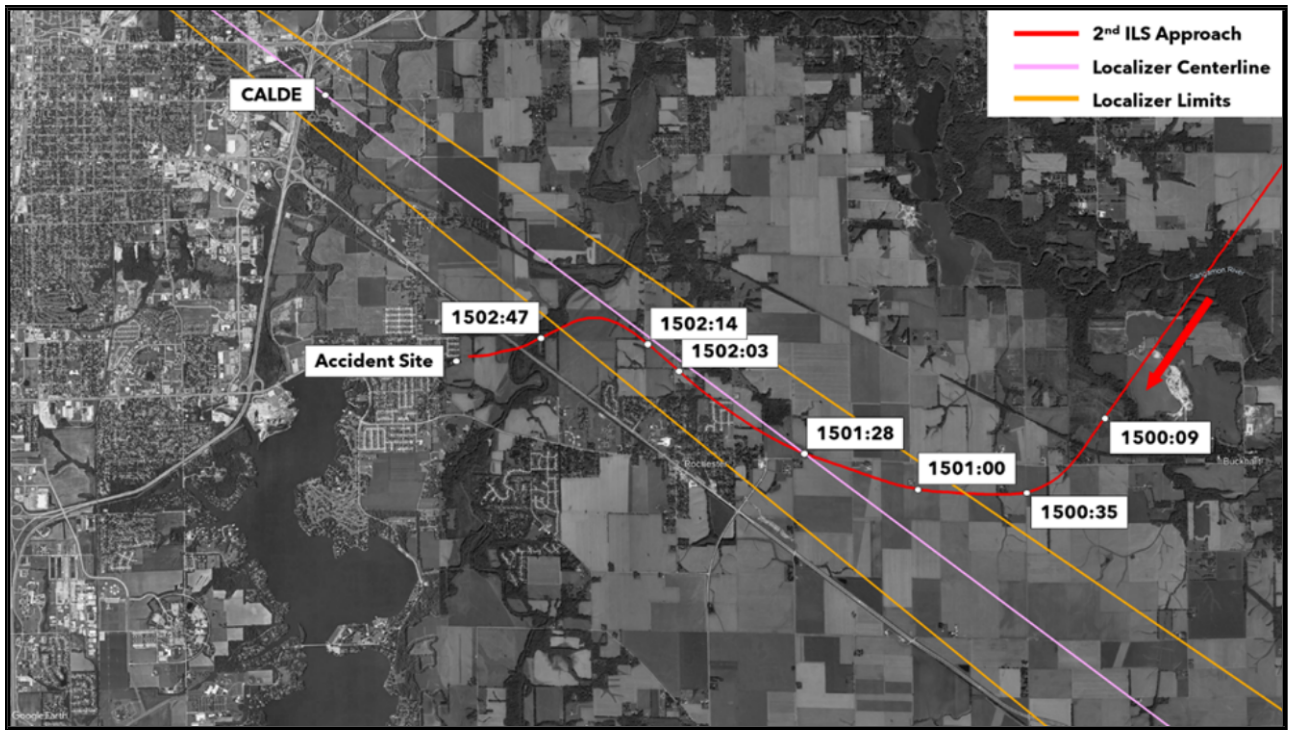
Figure 3. ADS-B track data for second ILS approach to runway 31.

Between 1500:35 and 1501:00, the airplane's course was about 270° as it approached the localizer from the east, as shown in figure 3. At 1501:00, the airplane turned right to a 290° course and subsequently flew through the localizer centerline at 1501:28. When the airplane flew through the localizer centerline, about 4.4 nm from CALDE, the airplane was descending through 2,650 ft msl. The airplane continued toward CALDE slightly left of the localizer centerline. At 1502:03, the approach controller transmitted, "Aerostar seven one romeo, is everything looking good now, we are showing you on course." At 1502:07, the pilot replied, "yup, looking good."

At 1502:11, the approach controller instructed the pilot to contact Springfield tower, and the pilot acknowledged this instruction. At that time, the airplane was about 3 nm from CALDE, descending through 2,300 ft msl, and 0.05 nm to the left the localizer centerline. About 1502:16, the airplane entered a left turn away from the localizer and descended below the glideslope intercept altitude (2,100 ft msl), as shown in figures 3 and 4.

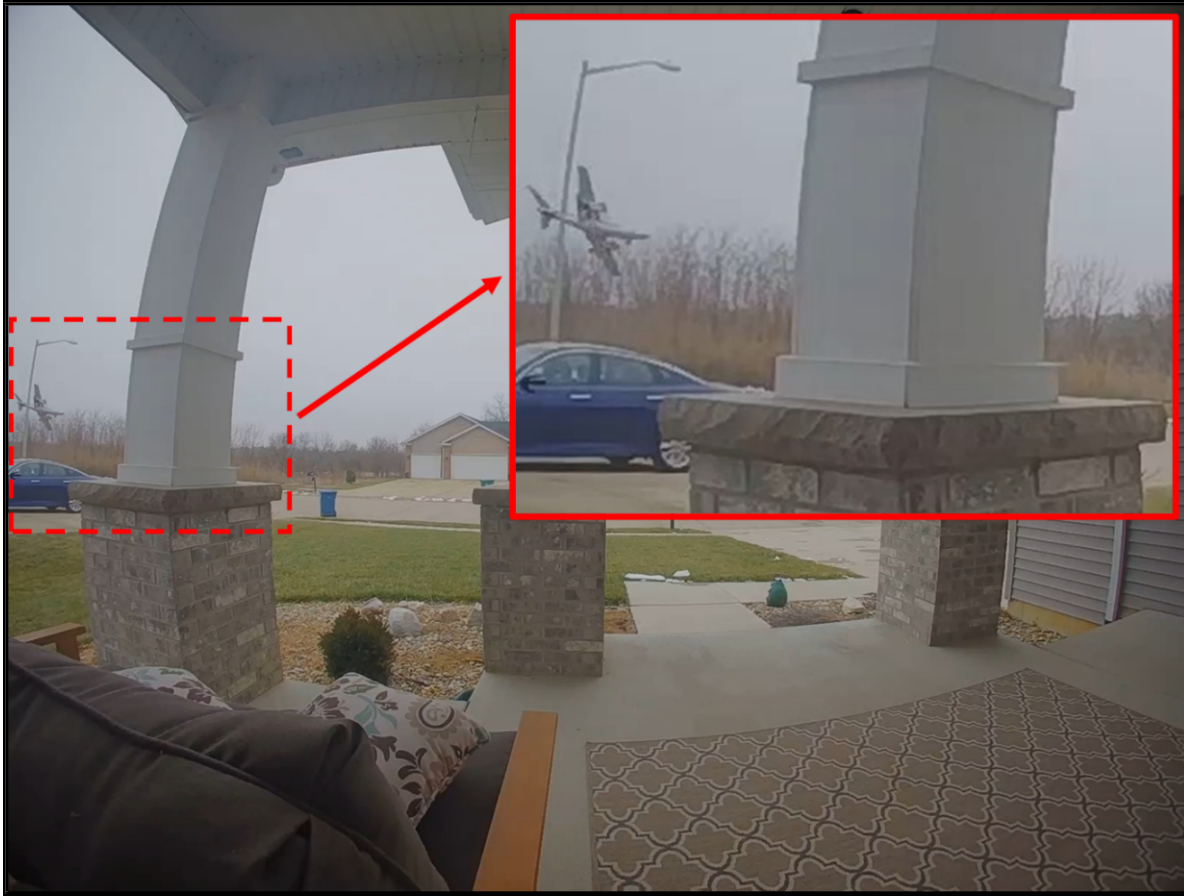
Figure 6. Doorbell camera image of accident airplane shortly before impact.

A doorbell security camera located about 260 ft north of the accident site captured video and audio of the final seconds of the flight. A review of the camera footage revealed that the airplane descended toward the ground in a left-wing-down and slightly nose-down attitude, as shown in figure 6. All three landing gear were observed to be extended before impact. The initial impact with the ground was obscured by a porch post and trees; when the airplane reemerged, it was sliding on its lower fuselage. Smoke from a postimpact fire was observed seconds after the accident.
