Aviation Investigation Final Report

Location:	Urbana, Ohio	Accident Number:	CEN21FA376
Date & Time:	August 20, 2021, 14:40 Local	Registration:	N700DT
Aircraft:	Socata TBM 700	Aircraft Damage:	Destroyed
Defining Event:	Loss of control in flight	Injuries:	1 Fatal
Flight Conducted Under:	Part 91: General aviation - Personal

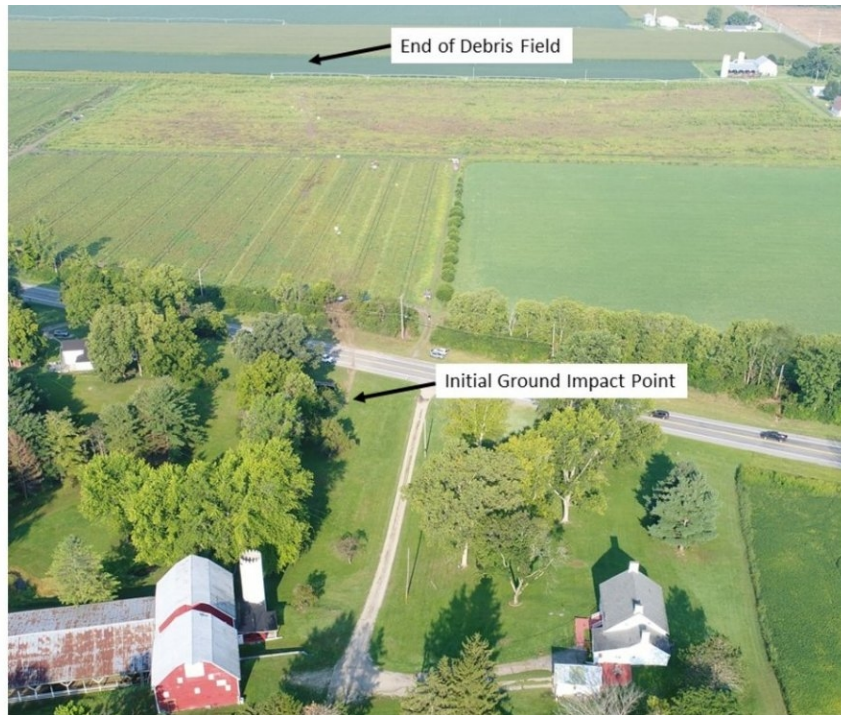
The accident site was located 1.3 miles northwest of the last radar contact, and on scene evidence indicated the airplane impacted two powerlines, trees, and the terrain in a shallow descent with a slightly left-wing low attitude. (See figures 1 and 2.)

Figure 1. Accident site

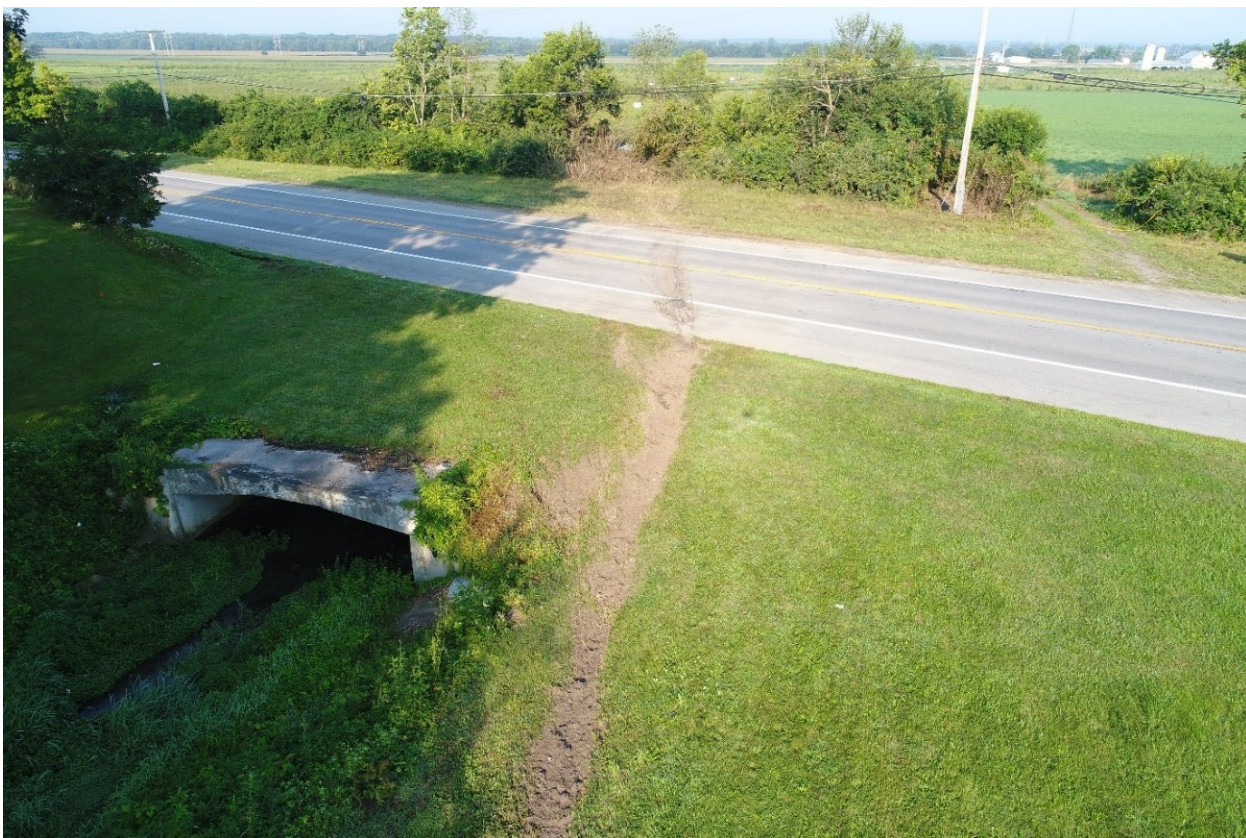
Figure 2. Accident site and initial impact point

The initial ground scar, located in a residential yard, contained separated components of the left wing. From the initial ground scar, a debris path continued across a highway, through trees and a ditch, and then continued into mature potato and soybean fields. The airplane wreckage, which was highly fragmented, was scattered over a distance of about 2,050 ft along a measured magnetic heading of 275°. An odor of Jet A aviation fuel was noted at the accident site by first responders.
