ACCIDENT

Aircraft Type and Registration:	Britten Norman 2B-26 Islander, J8-VBI	
No & Type of Engines:	2 Lycoming 0-540-E4C5 piston engines	
Year of Manufacture:	1980 (Serial no: 2025)	
Date & Time (UTC):	29 September 2021 at 2133 hrs	
Location:	John A. Osborne Airport, Montserrat	
Type of Flight:	Commercial Air Transport (Passenger)	
Persons on Board:	Crew - 1	Passengers - 6
Injuries:	Crew - None	Passengers - 1 (Minor) 5 (None)
Nature of Damage:	Aircraft damaged beyond economic repair	
Commander's Licence:	Commercial Pilot's Licence	
Commander's Age:	42 years	
Commander's Flying Experience:	2,650 hours (of which 712 were on type) Last 90 days - 105 hours Last 28 days - 22 hours	
Information Source:	AAIB Field Investigation

Synopsis

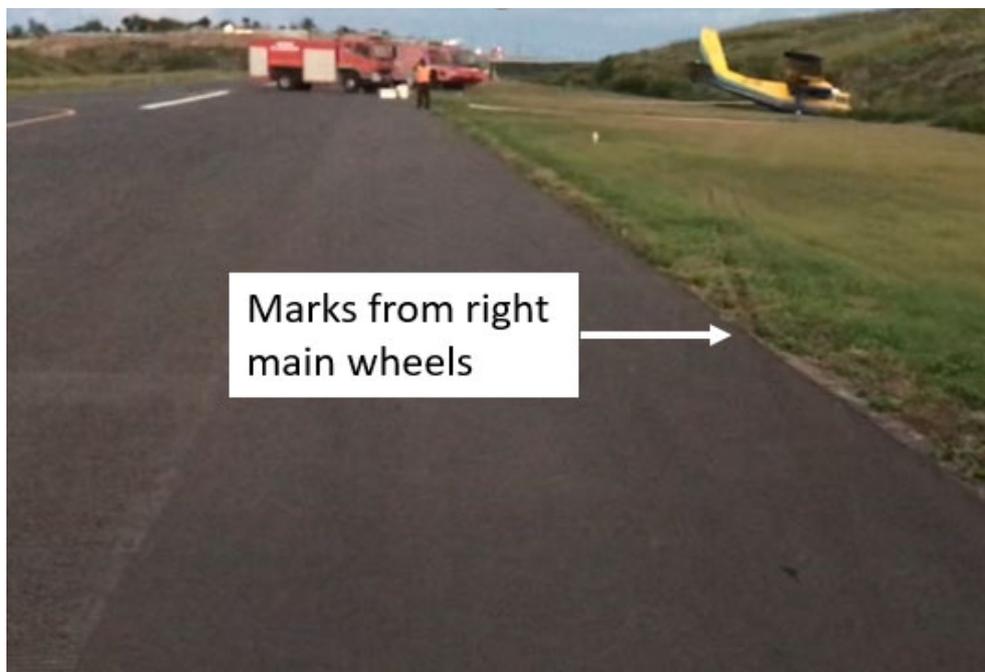
Figure 1

The pilot reported he commenced the approach, flying an approach speed of 65 kt, reducing to 60 kt as the aircraft touched down. The runway surface was dry and the pilot described the landing as “smooth”. After the main landing gear touched down, but prior to the nosewheel contacting the runway, the pilot applied the brakes. He reported that the left brake felt “spongy” and did not seem to act, but that the right brake felt normal. The pilot was unable to maintain directional control of the aircraft which veered to the right two seconds after touchdown, departing the runway a further three seconds later. The aircraft continued across the adjacent grassed area before impacting an embankment close to the runway (Figure 1).

Still image captured from a video showing the aircraft's departure point from Runway 10 and final resting place

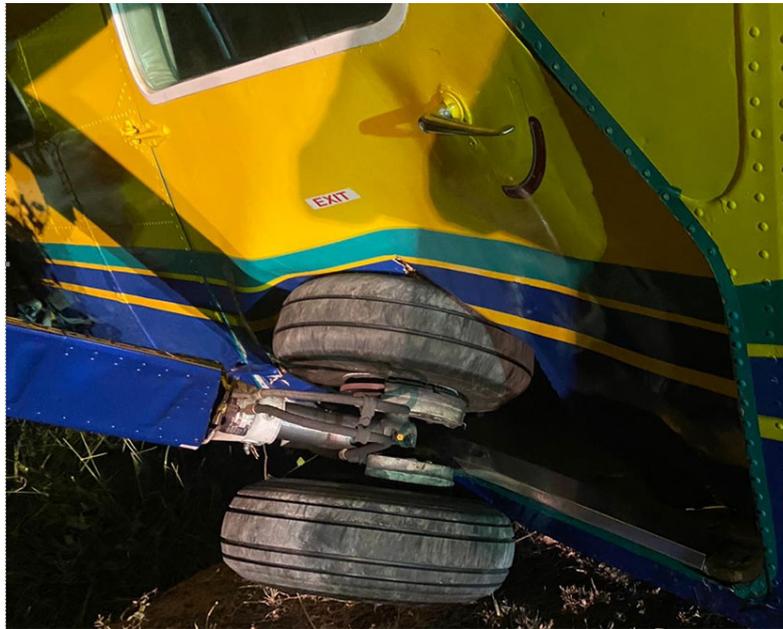
Figure 2

After the aircraft had come to a stop, the pilot shut down the engines using the normal shut down procedure. The left main gear had collapsed and rendered the left cabin exit unusable (Figure 2). The pilot evacuated through the flight deck door which was on the left

Collapsed left main landing gear blocking left cabin door

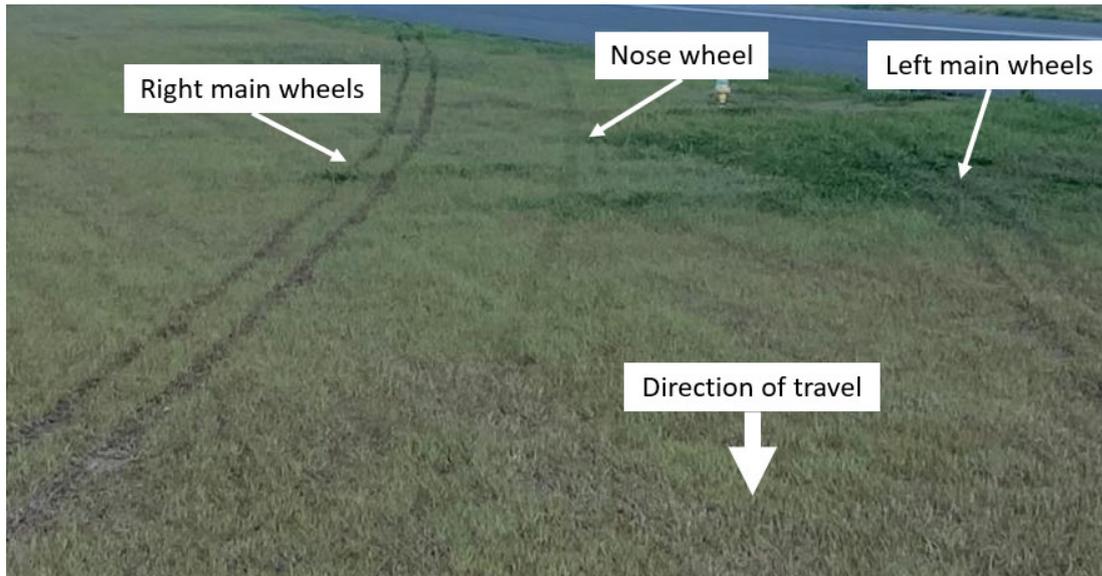
Figure 3

After the aircraft departed the paved surface, marks in the grass show that the right main wheels continued to be braked more than the left main wheels, whose marks more closely match those of the unbraked nose wheel (Figure 3).

Wheel marks in grass beside runway showing evidence of asymmetric braking

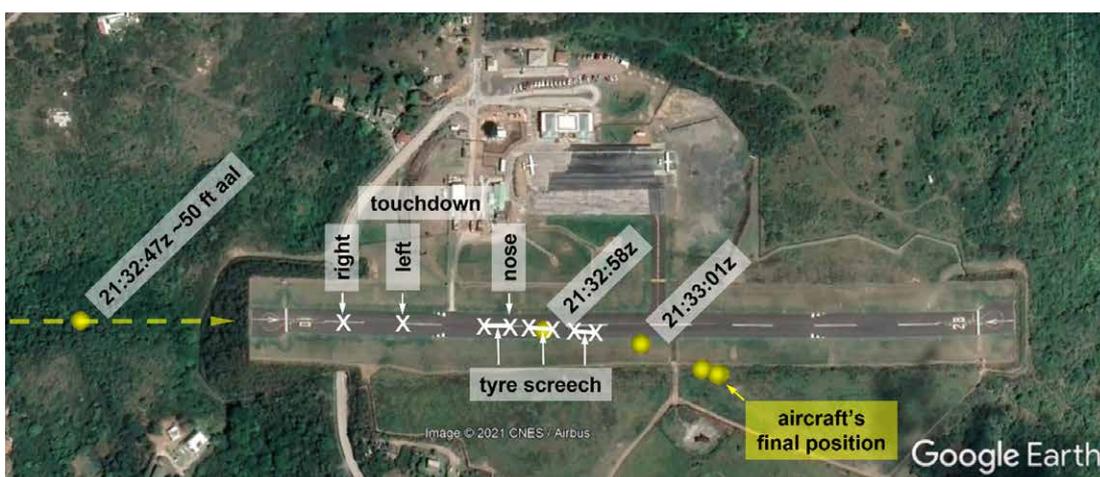
Figure 4

GPS ground track based on CCTV (white crosses) and GPS (yellow circles)

The last point recorded on the GPS device before touchdown positioned the aircraft on the approach at about 50 ft aal. The next recorded point, 11 seconds later, was after the aircraft had landed, and about three seconds before it went off the edge of the runway. From the CCTV footage it was evident the aircraft first touched down on the right main landing gear and then the left, less than a second later. After a period of three seconds, tyre screeching can then be heard on the onboard passenger video which lasted for about half a second, after which the nose gear touched down. This was quickly followed by a second short period of tyre screeching and then another (each about half a second in duration) before the aircraft was seen to veer off the righthand edge of the runway.

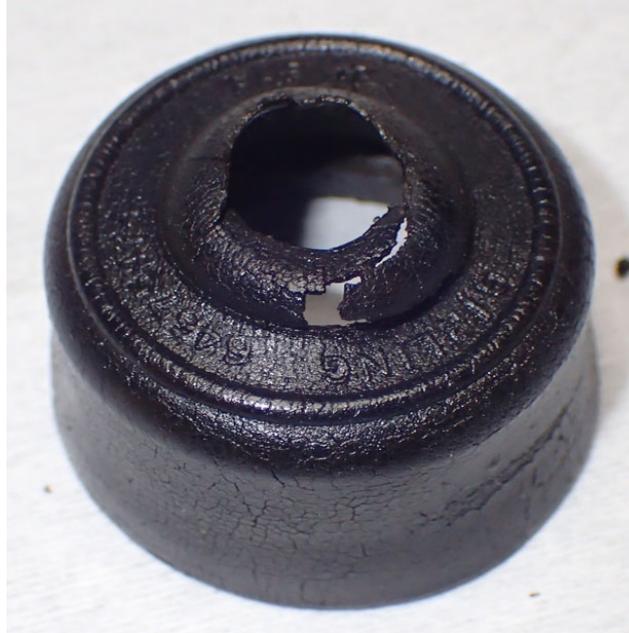
Figure 6

whether it was there before the accident. The main seals and main bores were in satisfactory condition. The dust seals around the input rod from the pilot's pedals were in poor condition (Figure 6).

A dust seal from one master cylinder showing degraded condition

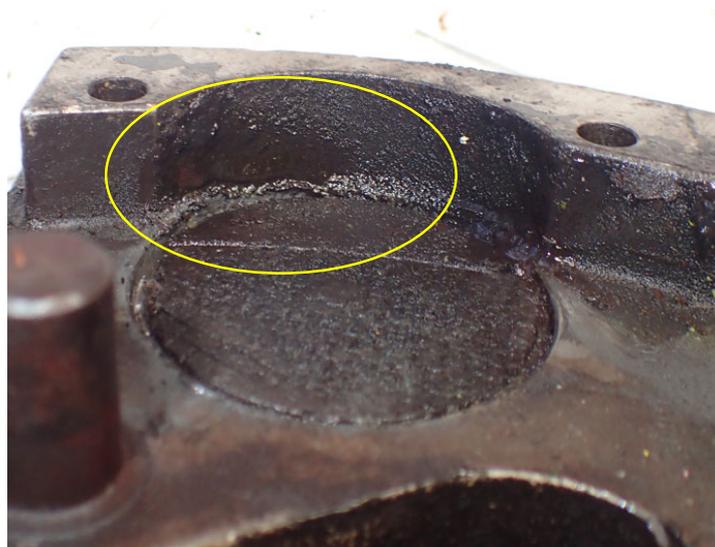
Figure 7

The calliper assembly of the left outboard brake was examined as it appeared to have a slight leak from one of its pistons (Figure 7). When the piston was removed, the piston bore had scoring in the area where the leak was apparent (Figure 8). The piston's 'O' ring seal was found to be flattened rather than the circular cross section of a new seal (Figure 9).

Leak apparent from piston of left outboard calliper

Examination of the left brake components determined that the 'spongy' feel and lack of effectiveness reported by the pilot was most likely due to a slight brake fluid leak from one of the pistons in the left outboard brake calliper. This leak prevented full brake pressure being achieved and therefore reduced the braking effect from the left brakes.

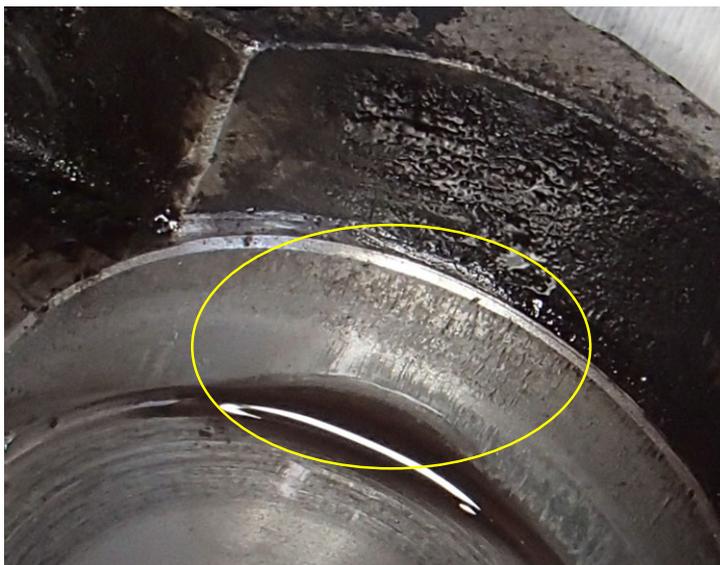
Figure 8

Scoring in piston bore in area of leak

There were no reported issues with the brakes for the first six flights after the friction pad replacement and the leak appears therefore to have developed after these flights. The leak was likely due to scoring of the piston bore and the flattened piston seal, both of which could not be identified unless the calliper was disassembled.

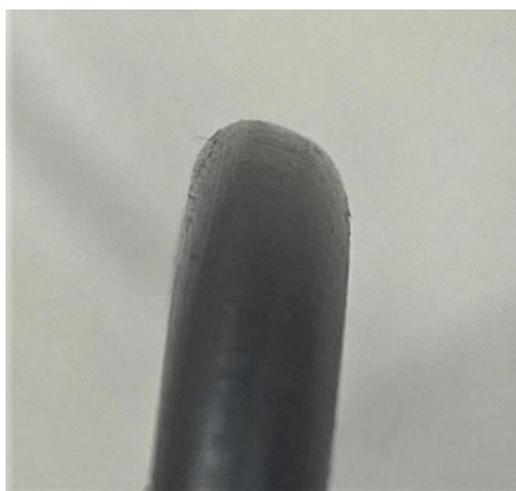
Figure 9

Flattened cross-section of piston 'O' ring seal
