Aviation Investigation Final Report

Location:	Marathon, Florida	Accident Number:	ERA22LA097
Date & Time:	December 29, 2021, 16:22 Local	Registration:	N1596U
Aircraft:	Cessna 207	Aircraft Damage:	Minor
Defining Event:	Loss of engine power (total)	Injuries:	1 Serious, 2 Minor
Flight Conducted Under:	Part 135: Air taxi & commuter - Non-scheduled

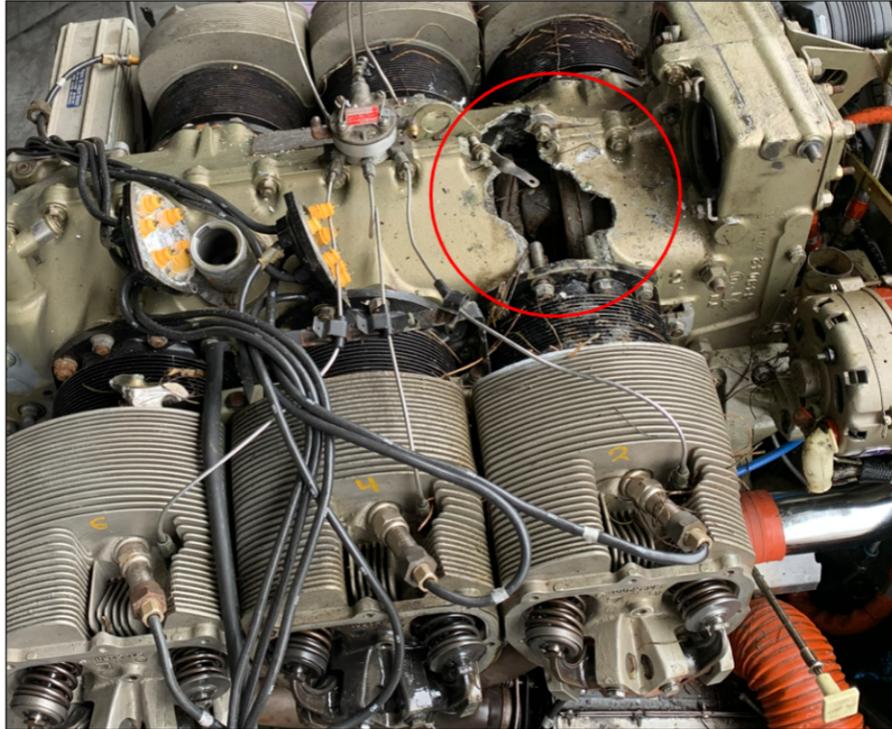
Examination of the engine revealed a fracture hole near the No. 2 cylinder, which was likely the result of the No. 2 cylinder connecting rod fracturing in fatigue as a result of high heat and high stress associated with failure of the No. 2 bearing. The fatigue fracture displayed multiple origins consistent with relatively high cyclic stress, which likely occurred as excessive clearances developed between the bearing and the crankshaft journal.

The airplane was subsequently recovered from the water and examined by the National Transportation Safety Board (NTSB). A large fracture hole and loose internal engine components were observed at the top aft portion of the engine case, in the area of the No. 2 cylinder. The engine showed little sign of impact damage. Saltwater corrosion was present throughout the engine and its accessories, consistent with the engine being submerged in the ocean for multiple days while awaiting recovery. Figure 1 provides an overview of the engine damage.

Figure 1: View of the engine damage originating at the No. 2 cylinder area.

The No. 2 cylinder connecting rod crankshaft end was found to be heavily fragmented and had broken into several pieces. Several fragments of the connecting rod were located in the oil pan and bearing material belonging to the No. 2 cylinder connecting rod attachment area was also located in the oil pan.

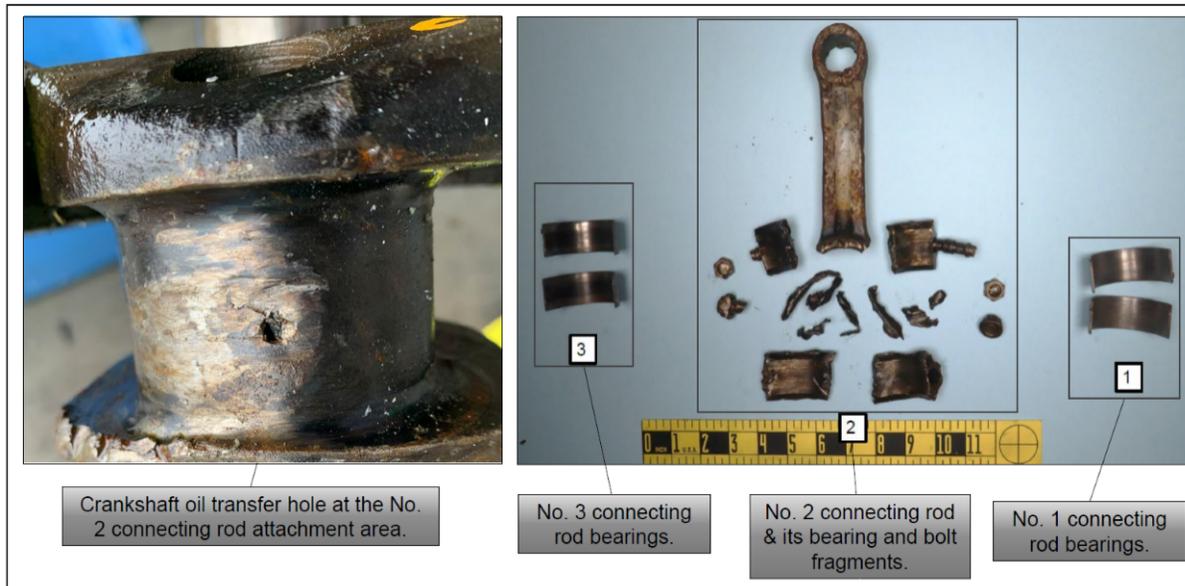
The No. 2 connecting rod bearing may have failed due to a material defect in the bearing itself or due to a disruption in the oil lubrication supply to the bearing/journal interface. Either situation can cause similar damage patterns to develop, including excessive heating and subsequent bearing failure.

The crankshaft journal for the No. 2 connecting rod and its oil transfer hole displayed wear marks, heat transfer, and deformation of the oil transfer hole. There was a small fragment of debris located in the oil transfer hole that was consistent in color to the fragmented bearing material located in the oil pan. This oil transfer hole displayed no other deformation or blockage at the other end of the oil entry hole. All other oil transfer holes along the entirety of the crankshaft appeared normal.

The examination found that the crankshaft end of the No. 2 connecting rod was tinted black, consistent with exposure to high heat during operation, and its bearing was thinned, fractured, and severely deformed with dark heat tinting. The bearing halves for the No. 3 connecting rod were darkened near the middle of the bearing around the circumference with displaced and

smears of babbitt material observed on the interior surfaces. The bearing halves for the No. 1 connecting rod had a nominal appearance with no indication of abnormal wear or damage.

Portions of the No. 2 connecting rod and its connecting rod bolts exhibited areas of substantial post-fracture damage; however, both components exhibited features consistent with fatigue. Figure 2 provides an overview of the crankshaft oil transfer hole at the No. 2 connecting rod/ bearing attachment area and an overview of the submitted components to the NTSB Materials Laboratory.

Figure 2: View of the crankshaft oil transfer hole at the No. 2 connecting rod/ bearing attachment area and view of the No. 2 connecting rod and Nos. 1 and 3 connecting rod bearings.
