Investigation Report

Type of Occurrence: Accident

Type: Cessna 401A

State File Number: BFU20-0721-CX

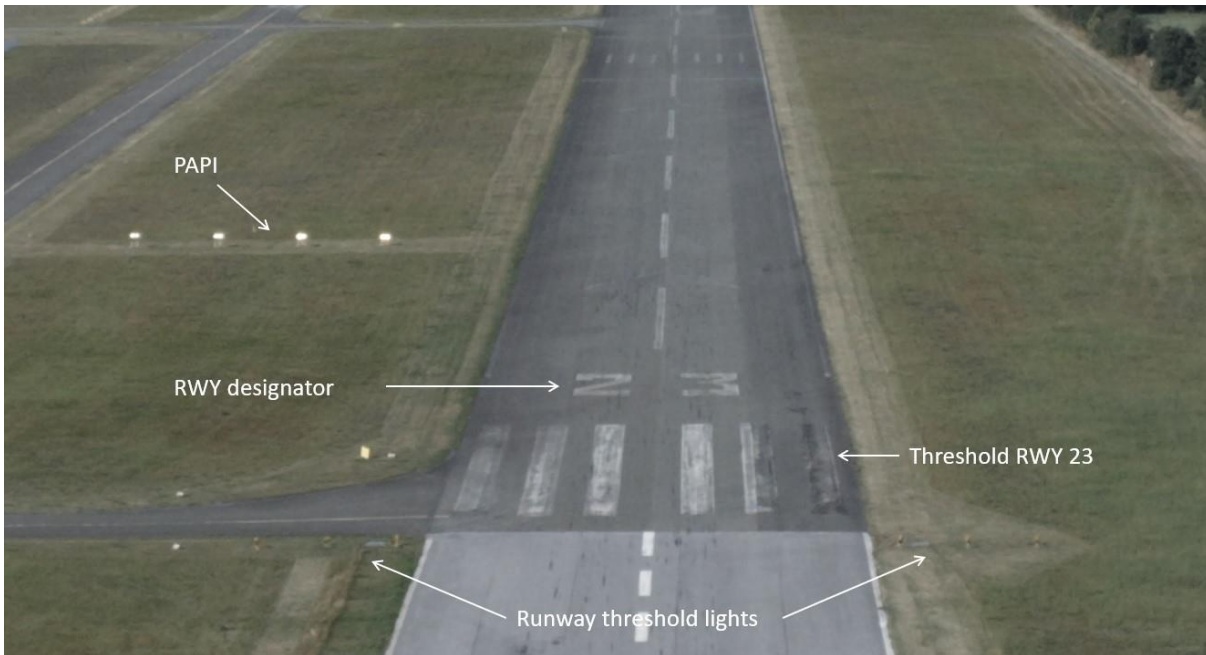
The BFU documented the condition of runway 23 (Fig. 4) during the on-site investigation. It was determined that an asphalt strip of about 80 m length and about 20 m width was located in front of the threshold of runway 05. In front of the threshold of runway 23 there was an asphalt area of about 200 m length and 20 and 25 m width, respectively. These areas were covered with several white markings. Between the runway threshold 23 and an area of approximately 20 m x 15 m painted white, were several white centre line markings. At the north-east end of the asphalt area was another white painted area of 25 m x 10 m (Fig. 5).

Fig. 4: Runway 23 markings and lighting (taken on 29 August 2020)

markings on the pre-threshold asphalt areas were visually much more distinctive than the much older, faded markings of the threshold and runway markings of runway 23 itself. The BFU is of the opinion that this underscores the fact that the markings on the pre-threshold area could cause confusion and distraction for approaching pilots.

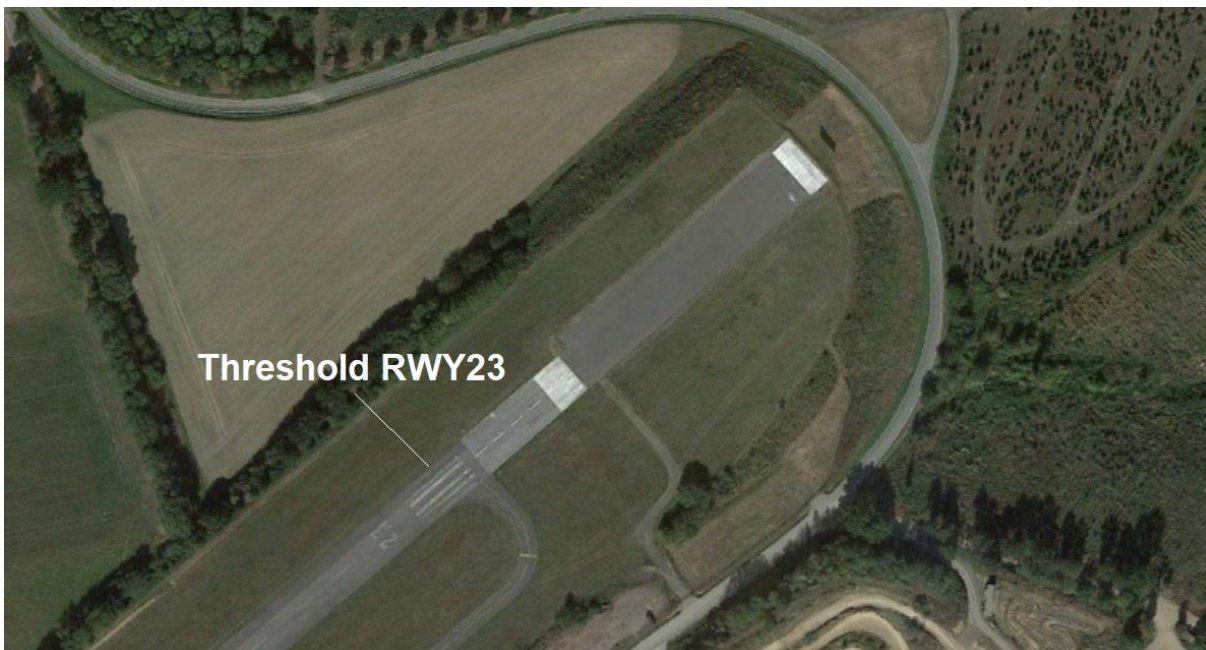
The aerodrome operator stated that the markings and the yellow light metal construction at the slope in front of the asphalt area and its lighting were installed to serve as visual approach references, especially at dusk and during night flights (Fig. 5 and Fig. 6). The asphalt area had not been part of the airfield's operating areas. The metal construction should make the steep slope more recognizable for pilots. According to the aerodrome operator, the markings were based on the example of various foreign airports.

Fig. 5: Markings in front of runway 23 (taken on 18 September 2020)

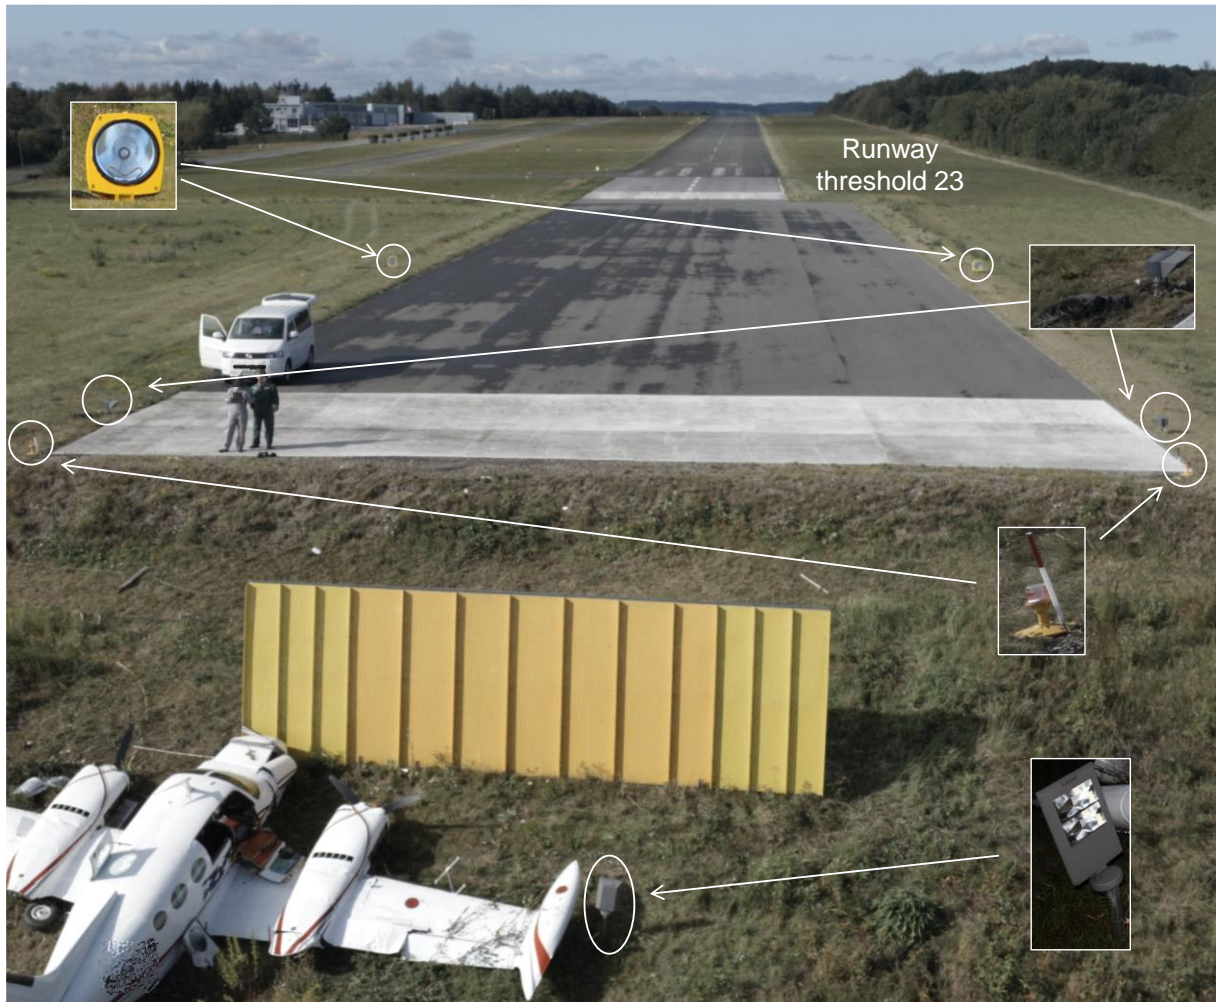
The pre-threshold asphalt area of runway 23 was equipped with lighting. Two non-directional lights were located at the edges of the north-east end of it. A light each was installed at the centre of the white area in 90° to the approach direction, facing the extended runway centreline. At the northern and the southern end, about half the

length of the asphalt area, a light was located and directed towards the approach sector of runway 23 (Fig. 6).

Fig. 6: Lighting in front of runway 23 and metal construction at the slope

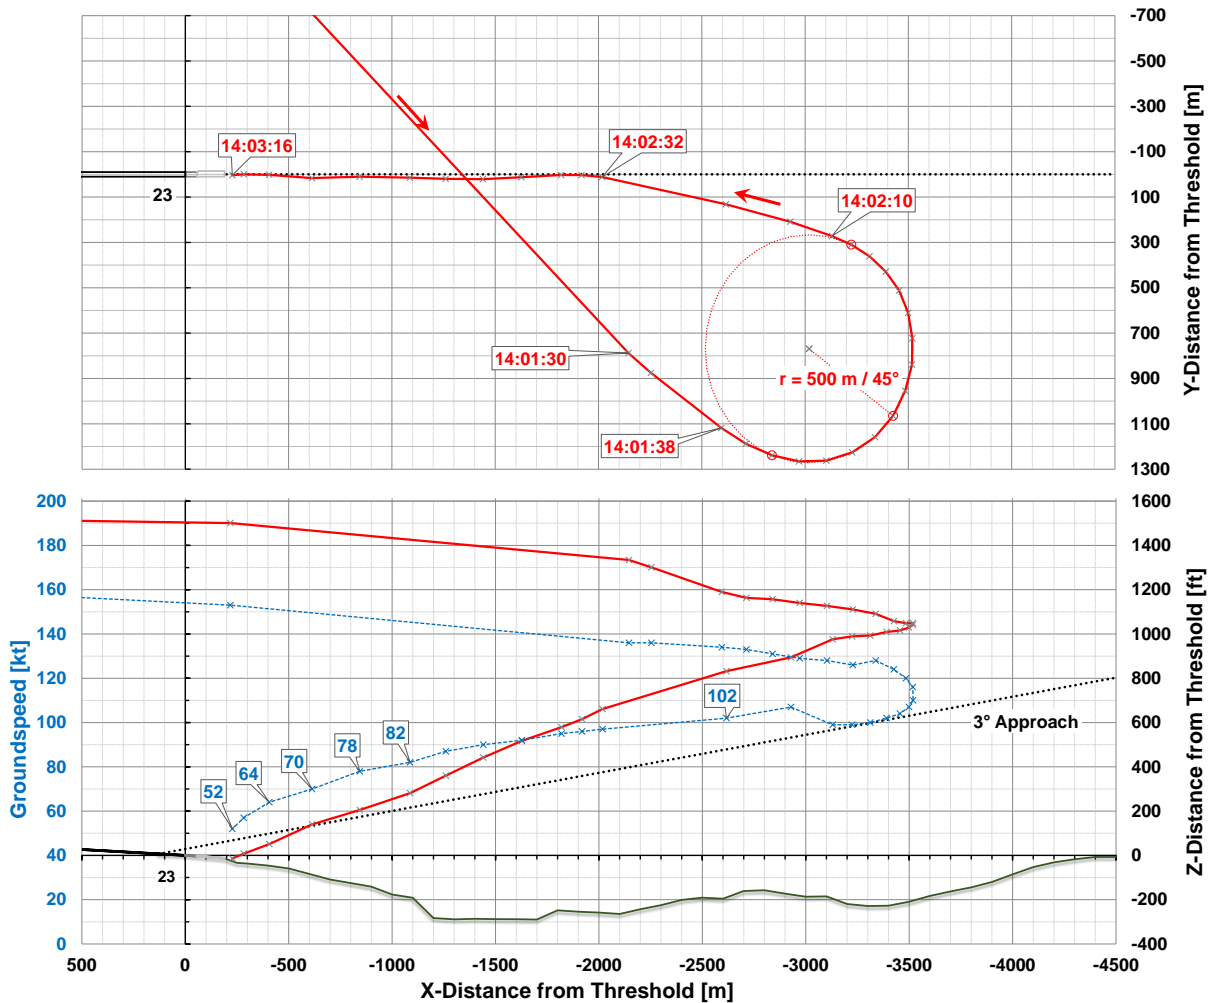
Fig. 7 shows the top view, the vertical profile and the ground speed of the accident flight. For comparison, the lower depiction of the vertical profile also shows the 3° PAPI approach angle.

The calculated turn radius was 500 m; considering the ground speed, this corresponds with a bank angle of 45°.

Fig. 7: Top view and vertical profile with 3° PAPI approach angle and ground speed

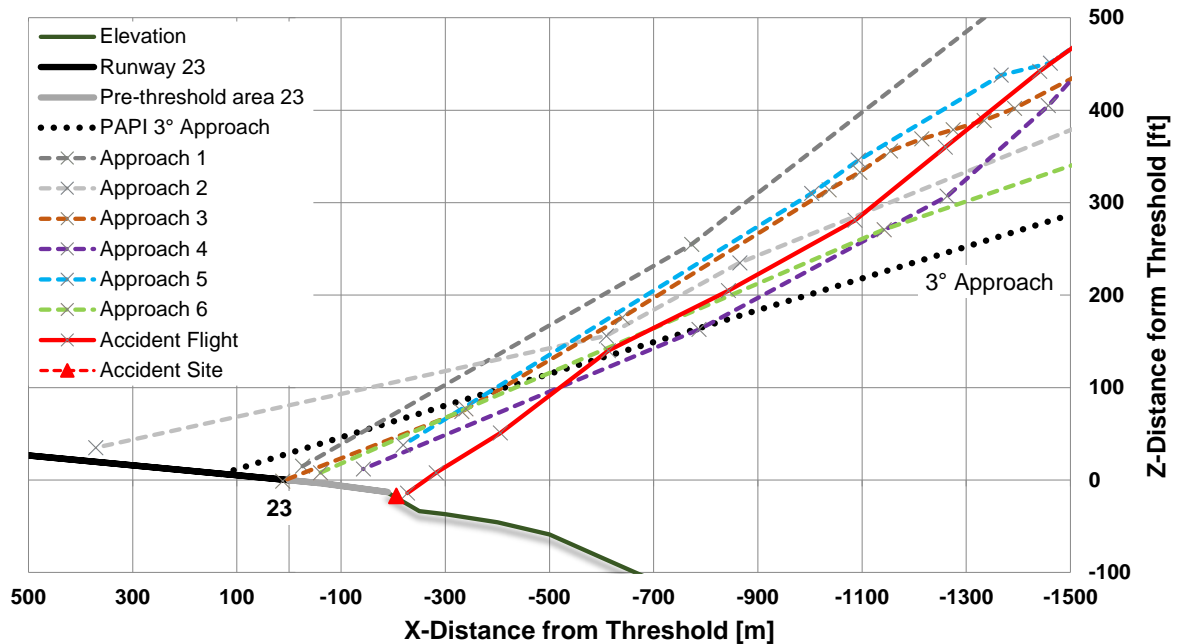
The vertical profiles of the flights show that the airplane had come short in five of them during the final approach (Fig. 9). For one of the six landings (Approach 2) it is not possible to make a statement in this regard due to a missing data point.

Fig. 9: Vertical profile of the six approaches to runway 23 at Arnsberg-Menden Airfield (accident flight red)

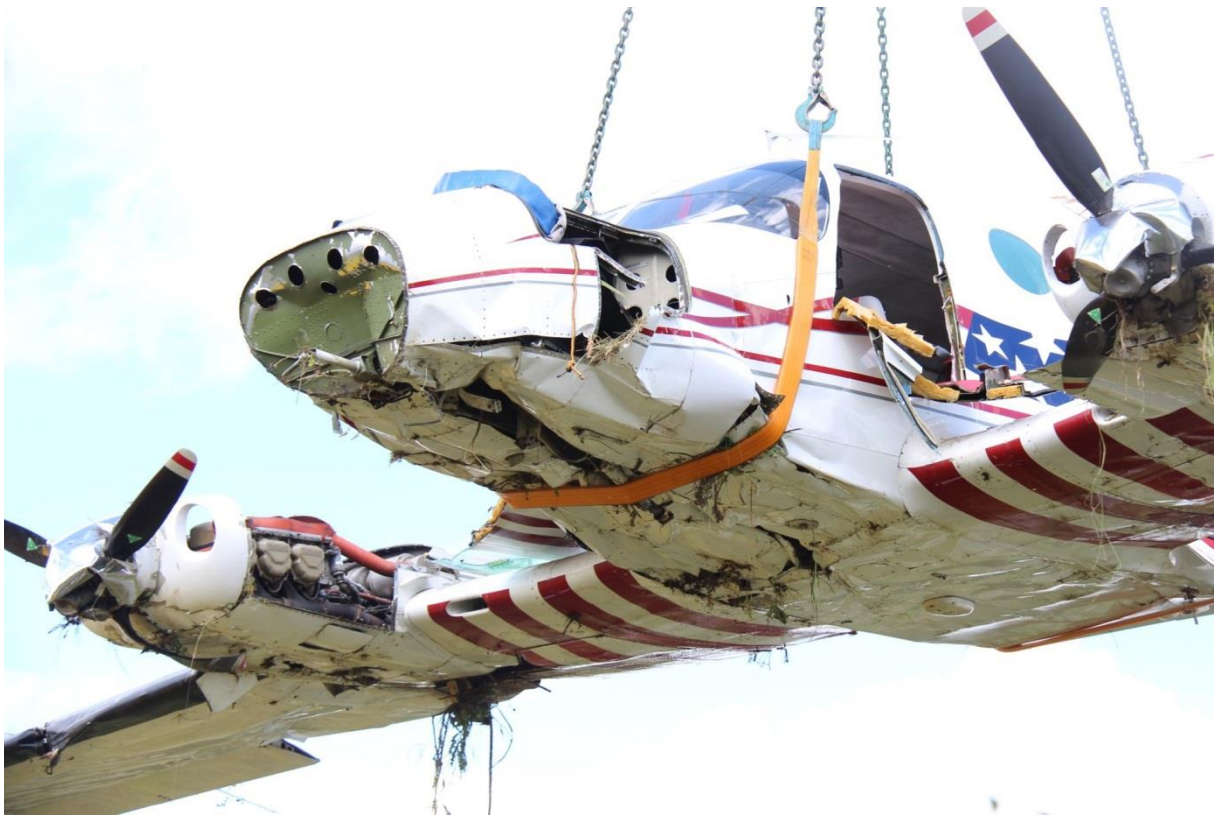
The fuselage underside showed substantial damage, especially the front part up to approximately the wing roots (Fig. 11). On the left propeller two blades were bent backwards and on the right one. The drive shafts of both propellers were fractured. The rotation plane of the propellers had been bent forward by about 45°. The spinners were damaged.

The landing gears were fractured. The nose landing gear had been pushed into the wheel bay. The left main landing gear strut, including the severed wheel, was lying beneath the left engine nacelle. The wheel of the right main landing gear had also been severed and was lying about 2 m behind the right engine nacelle.

Fig. 11: Damage at the front of the fuselage

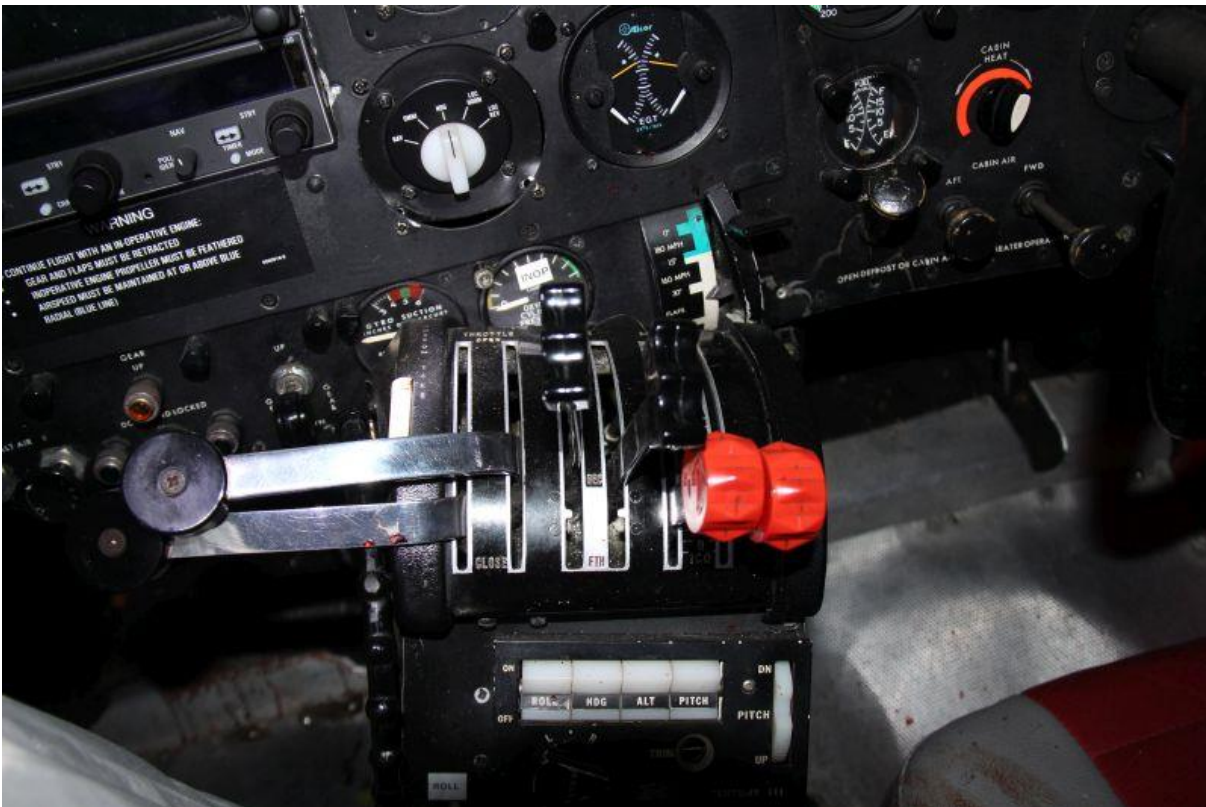
The centre quadrant with the engine control levers, trim and autopilot panel was deformed and twisted (Fig. 12). The elevator trim wheel was in a slight nose-up position. Both power levers were bent left by about 60°. The left power lever was about 1 cm and the right about 3 cm away from the aft stop. The two propeller pitch control levers were about 1 cm away from the “high pitch” stop and the levers of the respective governor were at the “low pitch” stop. The two mixture control levers were about 1 cm from the aft stop (Idle Cut Off (ICO)), whereas the respective mechanisms at both engines were at the “full rich” stop.

Fig. 12: Twisted centre quadrant including engine control levers

The rearward position of the two power and propeller control levers and of the two mixture control levers did not reflect the condition prior to the accident but is the result of the deformation of the quadrant during the impact of the aircraft and the impact of the occupants. This is evident from the findings on the governor and the mechanics of the mixture control of both engines as well as the fuel found directly on the engines.

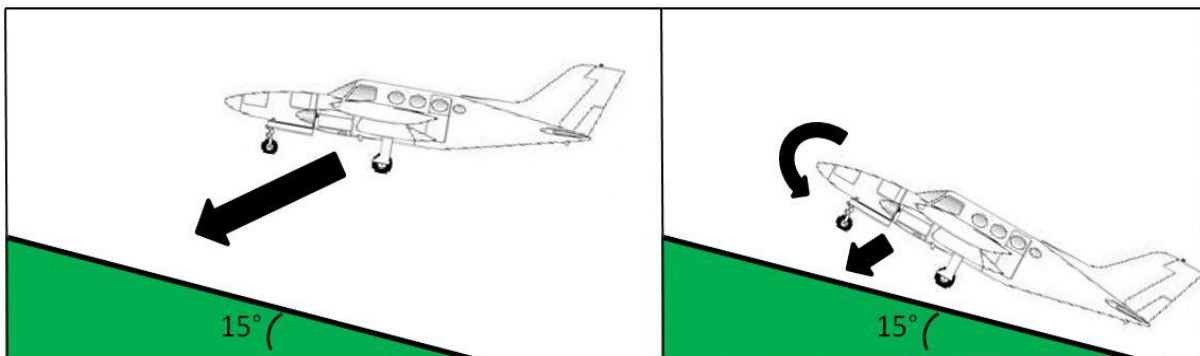
The analysis of recorded flight data, witnesses' observations at the airport and the aircraft damage showed that the airplane had impacted the ascending terrain with a high angle of attack and a high positive pitch angle. Main landing gear and fuselage

For further evaluation of the forces that occurred during the impact, the BFU roughly interpolated them for the horizontal and vertical components. The results were about 6 g for horizontal and about 2.5 g for vertical components.

Fig. 16: Schematic depiction of the airplane's impact and the resulting pitching moment of the fuselage
