AVIATION INVESTIGATION REPORT

A08C0237

LOSS OF CONTROL AND COLLISION WITH TERRAIN

BEECHCRAFT A100 C-FSNA

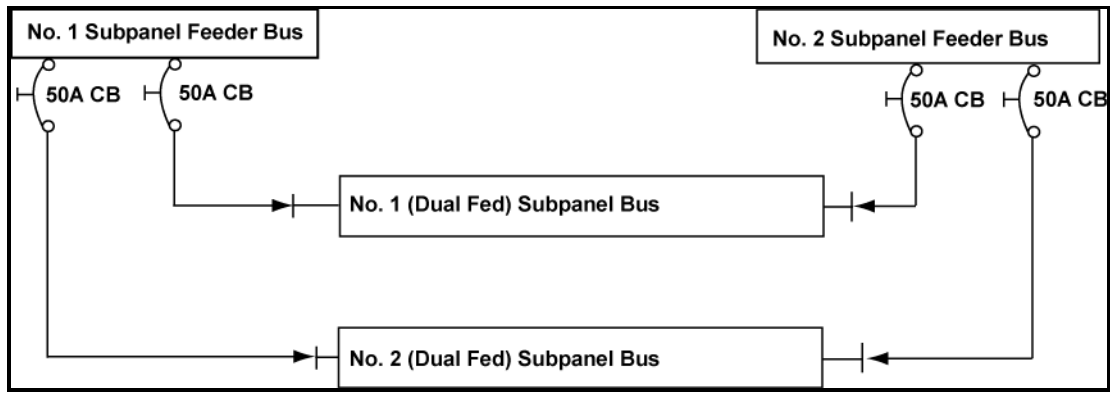
Figure 1. Simplified electrical power distribution to subpanel busses.

As shown in Figure 1, the No. 1 subpanel feeder bus provides power through a 50-amp subpanel feeder circuit breaker and a subpanel feeder diode to the No. 1 (dual-fed) subpanel bus. That same No. 1 subpanel bus is provided a second source of power from the No. 2 subpanel feeder bus through a separate 50-amp circuit breaker and diode circuit. The No. 2 subpanel bus is similarly arranged.

For either of these dual-fed subpanel busses, if the power supplied by one subpanel feeder bus fails, the alternate subpanel feeder bus will continue to provide power to the subpanel bus and all components and systems powered by that bus will continue to operate normally. No warnings or failure indications are available in the event of a single-supply failure. The four subpanel feeder circuit breakers are located in the pedestal circuit breaker panel at the aft end of the cockpit pedestal. The four subpanel feeder diodes are mounted on a heat-sink assembly inside the front-right area of the pedestal. During this occurrence, when the smoke and flames were evident, there were no warnings or indications to suggest what systems or components had failed.

One of the wires that arced and separated was an 8-gauge wire, P73A8, which transfers power from the LH subpanel feeder circuit breaker to the subpanel feeder diode in the electrical circuit for the No. 1 (dual-fed) subpanel bus. A second 8-gauge wire, P84R8, also a component of the same circuit for the No. 1 (dual-fed) subpanel bus, had an arcing separation failure. Two ten-gauge wires showed evidence of electrical arc damage at one end of each wire. One of these wires could not be identified, the other is suspected to be wire P92T10, which was attached to the input side of the LH No. 1 subpanel feeder circuit breaker and provided power to the Avionics No. 1 circuit. The arc sites for all three of the identified wires were located approximately the same distance (1.5 inches) ahead of the pedestal circuit breaker panel.

The aircraft electrical distribution system functioned as designed. When an arcing failure isolated power from one end of the No. 1 (dual-fed) subpanel bus, the bus continued to be fed electrical power from the No. 2 subpanel feeder system. The No. 1 subpanel bus continued to supply power to the aircraft systems and components on that bus. Because of this redundancy, there were no warnings or indication in the cockpit. Their absence precludes useful input into pilot decision making.
