Fuel Starvation – Mt Isa, Qld

17th July 2008

INFRA-08444

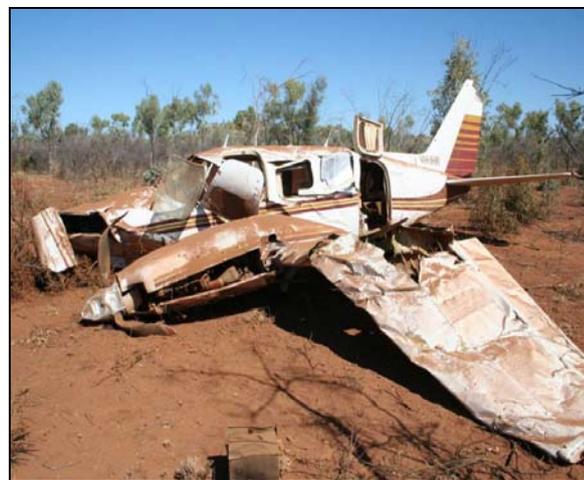
Figure 2: Aircraft wreckage

Examination of the aircraft showed no evidence of pre-impact damage. The damage to the left wing and nose area (Figure 2) of the aircraft indicated that the aircraft impacted the ground at an angle of approximately 30 degrees left-wing down and 30 degrees nose down. The aircraft fuselage showed signs of compression rippling on the under surface and the rudder mass balance weight was bent over to the right at the tip. The distance from the initial impact point to the main wreckage was 17 m. This evidence indicated that the aircraft had a very high rate of decent and low forward airspeed at the time of impact.

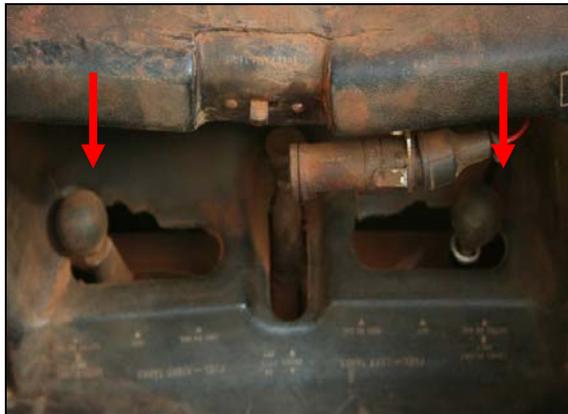
Figure 3: Fuel management panel

Both fuel selector handles were found set to the outboard fuel tank positions indicated by red arrows in Figure 3. The emergency fuel pumps were selected OFF.

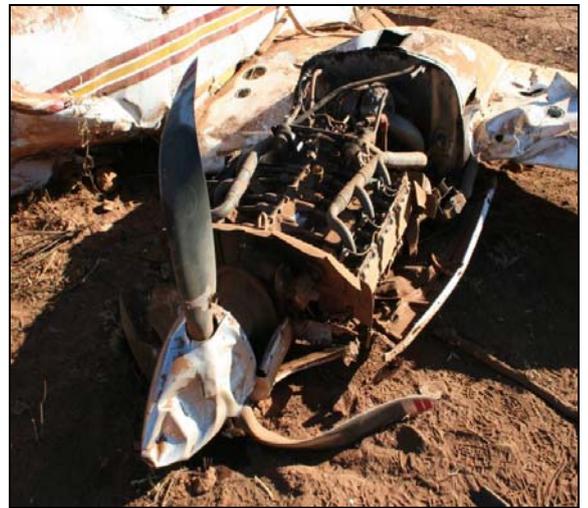
Figure 4: Left engine and propeller

The damage to the propellers indicated that they were not in the feathered position and that the engines were delivering little or no power on impact (Figures 4 and 5).
